MAINLAND ENGINEERING DESIGN CORPORATION

Date: 2024-07-26

Consultant File: WA-304

RE: Pre-Fill and Post-Fill Storm Drainage Report at 2127 State Route, Arlington, WA

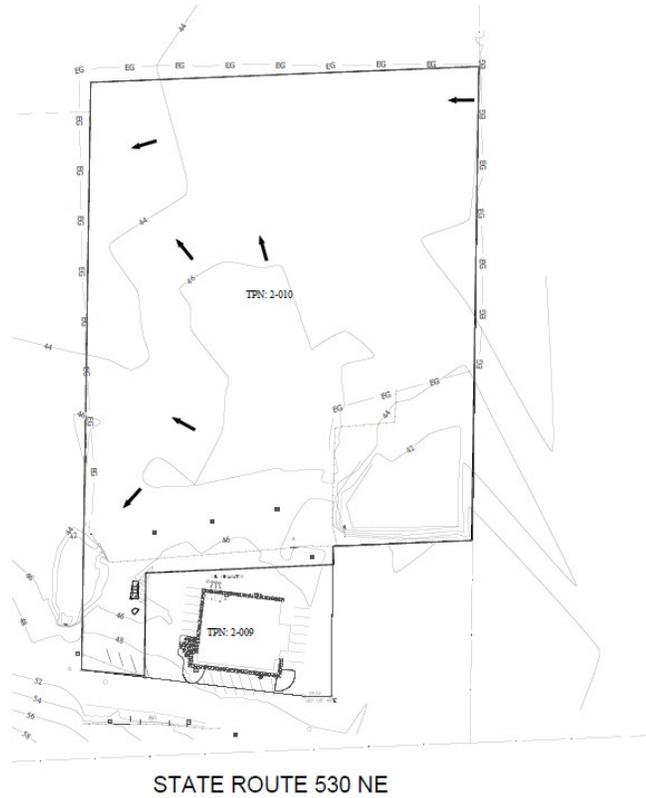
Pre-fill Site condition and Stormwater flow pattern: -

In the Pre-fill condition, as per the available data of the area, it is our understanding that the storm water flows naturally from South East towards North West of our Development (See the attached Contours in the Pre-fill condition in the Appendix A). There is a depression point in the Neighbouring Lot (Parcel Number 31050800201200), on the North West Side of our Development, where all these storm water flows directed naturally. There is also, a Stillaguamish River approximately half a mile North from our development, but the contours are higher, so it appears like no Storm water flows are entering into this River from our Development directly towards North direction. However, when the flows are above 46 feet level, then the flows will go towards the River in the North West direction.

In the Pre-fill condition, the storm water flows from our Neighbouring lot (Parcel Number 31050800200200), which is on the East side of our Site, are also towards that depression point passing through our Site. The grades are approximately 48 feet at the South East corner of the property line and approximately 43.5 feet at the North West corner of the property.

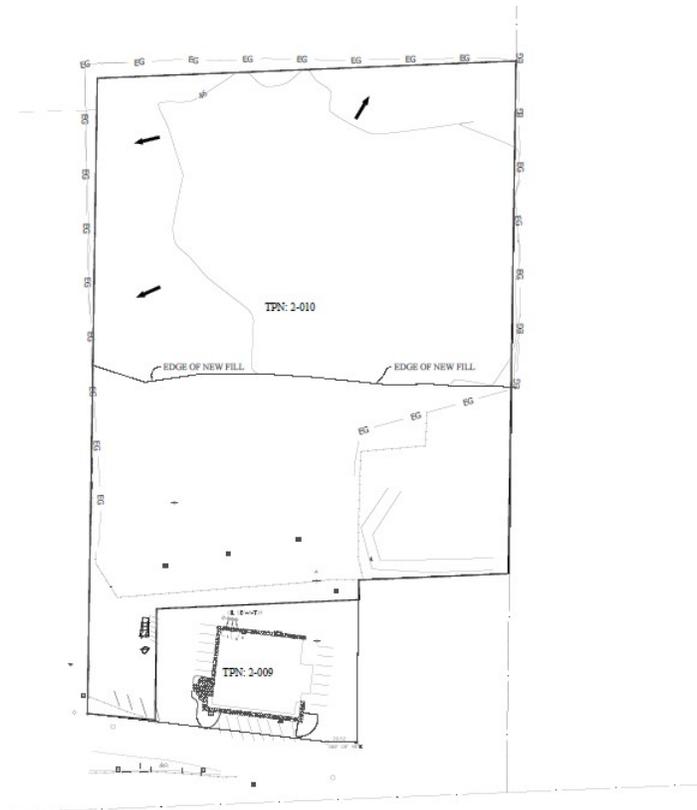
Post-fill Site condition and Altered Stormwater flow pattern after the illegal fill: -

However, in the post-fill condition, with the new illegal fill at the Site, the contours and the Storm water flows of our development gets slightly changed as compared to the pre-fill condition.

In the post-fill condition, the new maximum elevation is 46.62 feet which was approximately 46 feet in the pre-fill condition. The flow direction is still similar as pre-developed condition, and the storm water is again flowing from South East side towards the North West side into the depression point in the Neighbouring Lot (Parcel Number 31050800201200),

The flows from the Neighbouring lot (Parcel Number 31050800200200), which is on the East side of our Site, are also changed in the post-fill condition. Earlier, the Grades along the East property line varies approximately from 48 feet to 46 feet in the pre-fill condition, and now in the post-fill condition the grades vary from 48 feet to 45.82 feet approximately. Also, the maximum elevation of our site is now 46.62, therefore, any storm flows coming from the South direction will now get diverted slightly and move towards North West direction and ultimately moving towards the same depression point (See the attached Contours in the Post-fill condition in the Appendix A).
