Arborist Report

Title: Safeway Expansion – Arlington
Tree Inventory and Assessment

Date: March 8, 2022

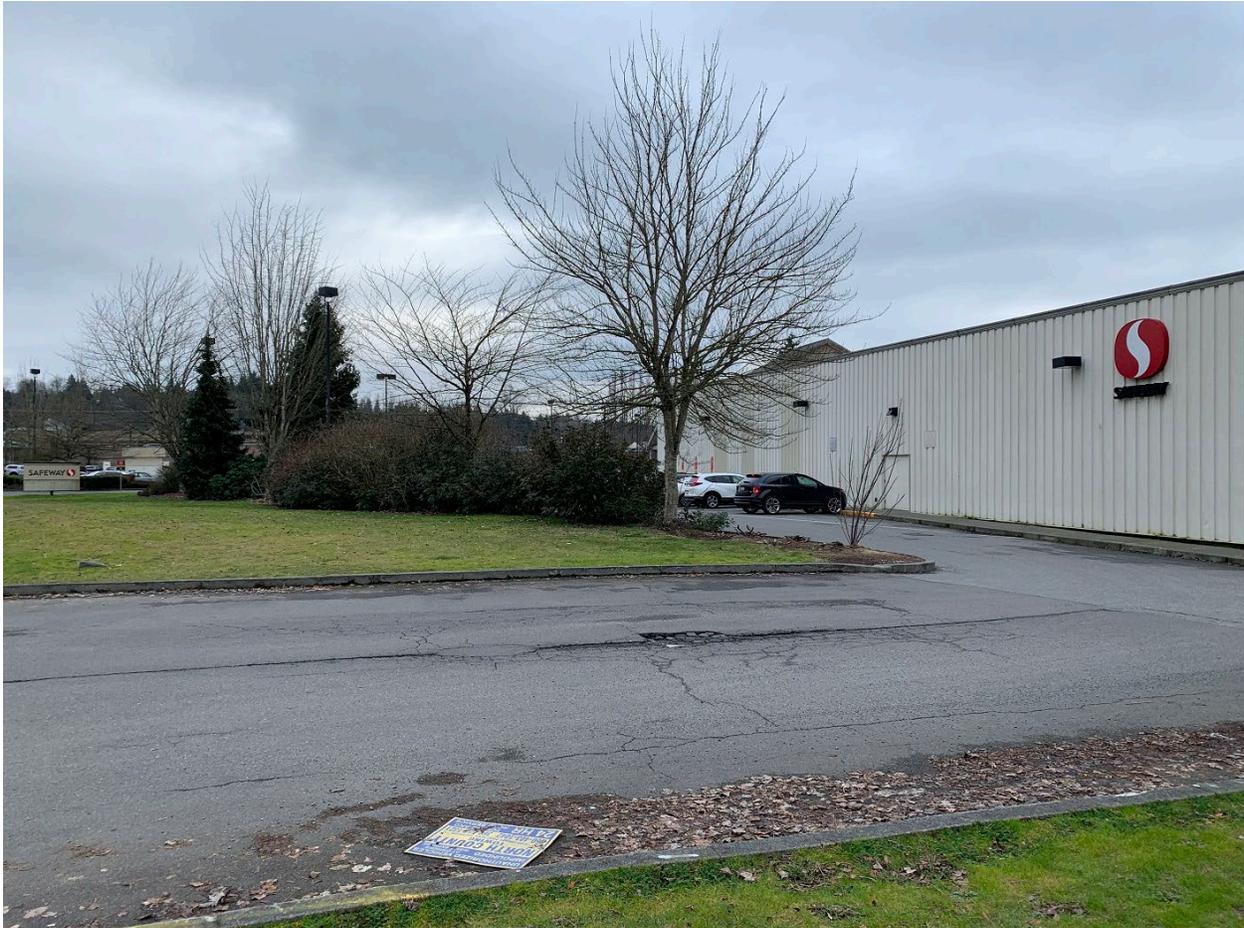
Photo 1. A group of trees (#334 through 339) on the east side of the Safeway parking area.

- Retain 29 of 30 of the assessed trees.
- Remove non-viable tree #335 and replace it with one new tree. The City code requires replacing healthy and lower risk trees at a ratio of 3:1. Given that this tree is not viable, it has a 9.2-inch trunk diameter, and its removal is not related to construction, replacing it with a single tree is expected to achieve its original ecological function.

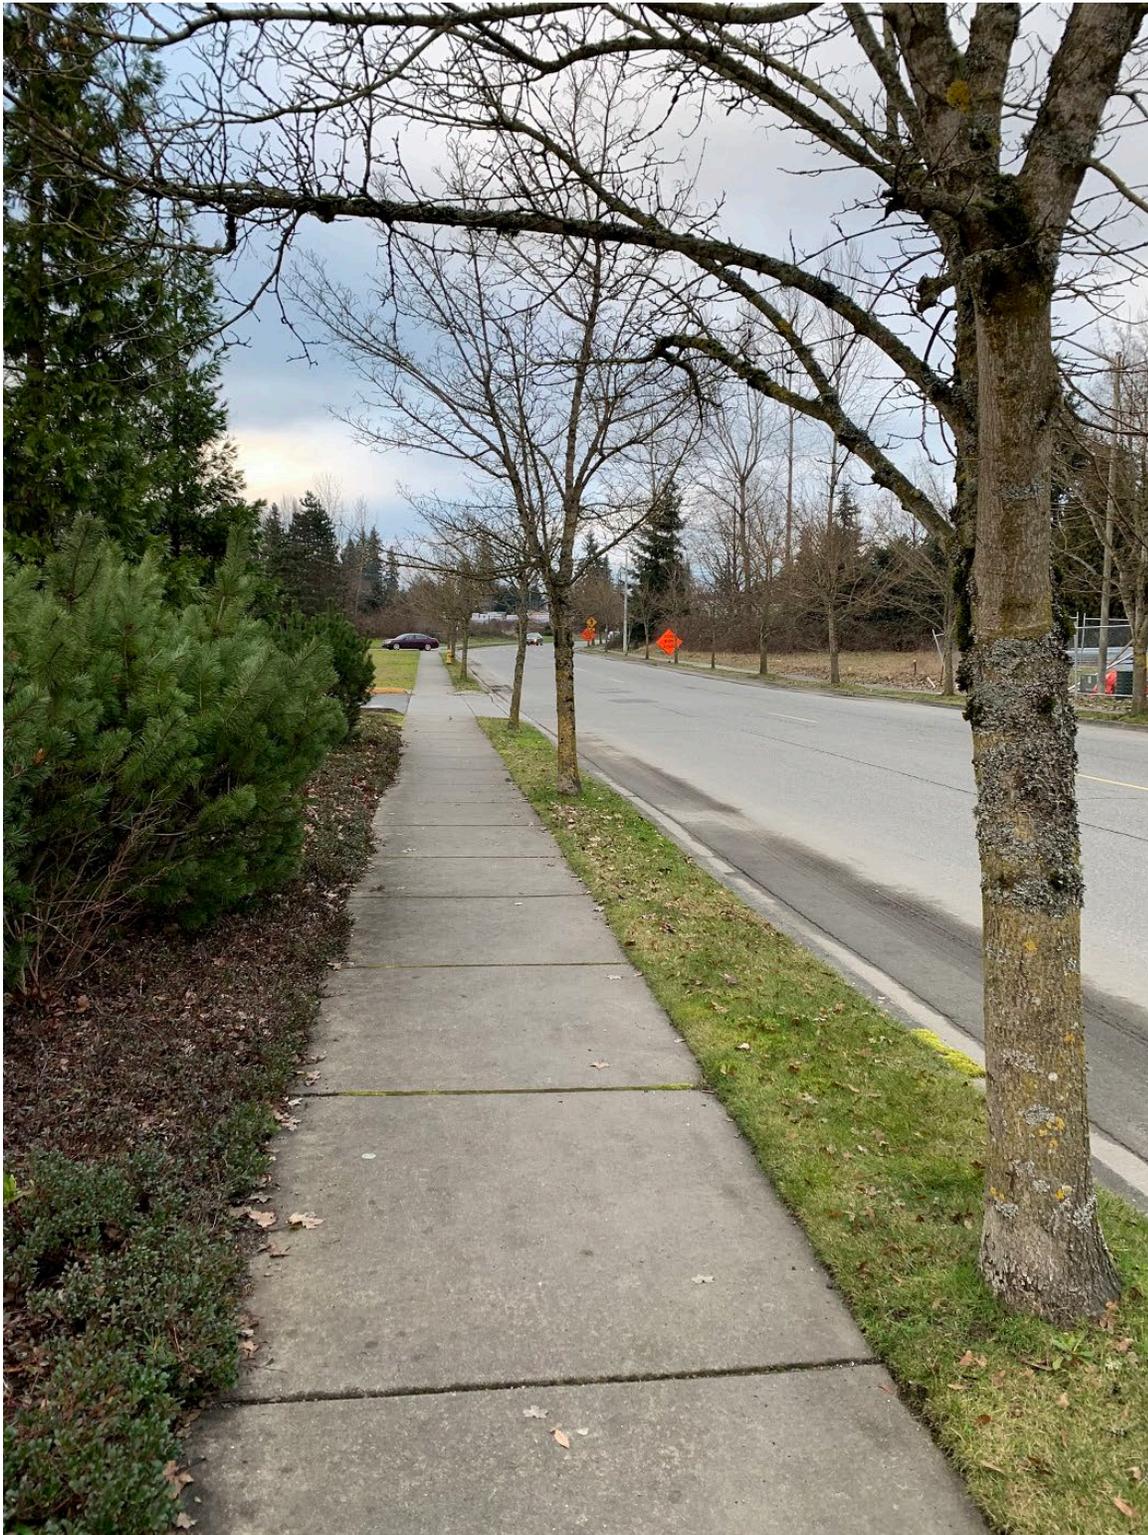
There were seven deciduous trees assessed in the right of way, which ranged in trunk diameter from 5.4 to 12.2 inches. All were Norway maple, except for tree #360, which was a linden. All the right of way trees were healthy and had a low risk rating. The Norway maple trees #354 through #359 were growing in a narrow 3-foot wide planting strip between the sidewalk and street curb.

Photo 4. A row of street trees in a narrow planting strip next to Olympic Place.

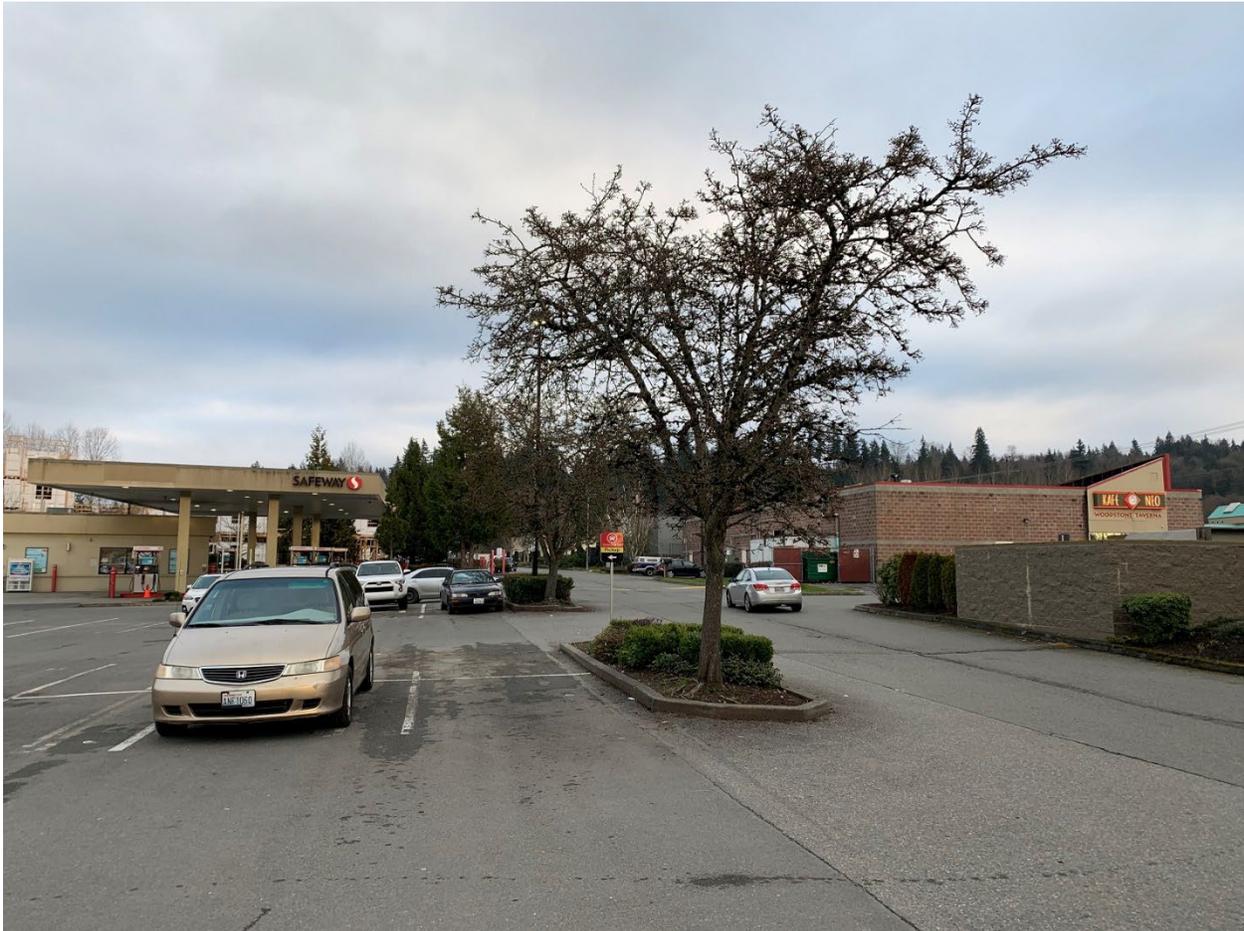
The trees on the property were all viable, except for tree #335, a red maple with a cavity and decay in its trunk. The flowering crab apple trees #346 through 349 were healthy but their roots were uplifting the asphalt next to their planting islands (Photo 5). Trees #332 and #353 had at least one weakly attached codominant stem with a higher likelihood of failure (Photo 6). All the trees had a low likelihood of causing significant damage or injury. They were a low risk at the time of the site visit.

The most relevant issue with the trees is the limited soil volume and growing space. Roots from the flowering crab apple trees were already uplifting the surrounding asphalt. Their roots would need to be pruned to repave at the same grade. There are some design alternatives, such as enlarging the planting areas or raising the grade to go over the existing roots. A similar issue will eventually occur with the Norway maples in the narrow planting strip next to the sidewalk. Maple trees can grow relatively large with large surface roots that can uplift concrete sidewalks.

Photo 5. A few of the flowering crab apple trees in planting islands at the south end of the Safeway parking area.

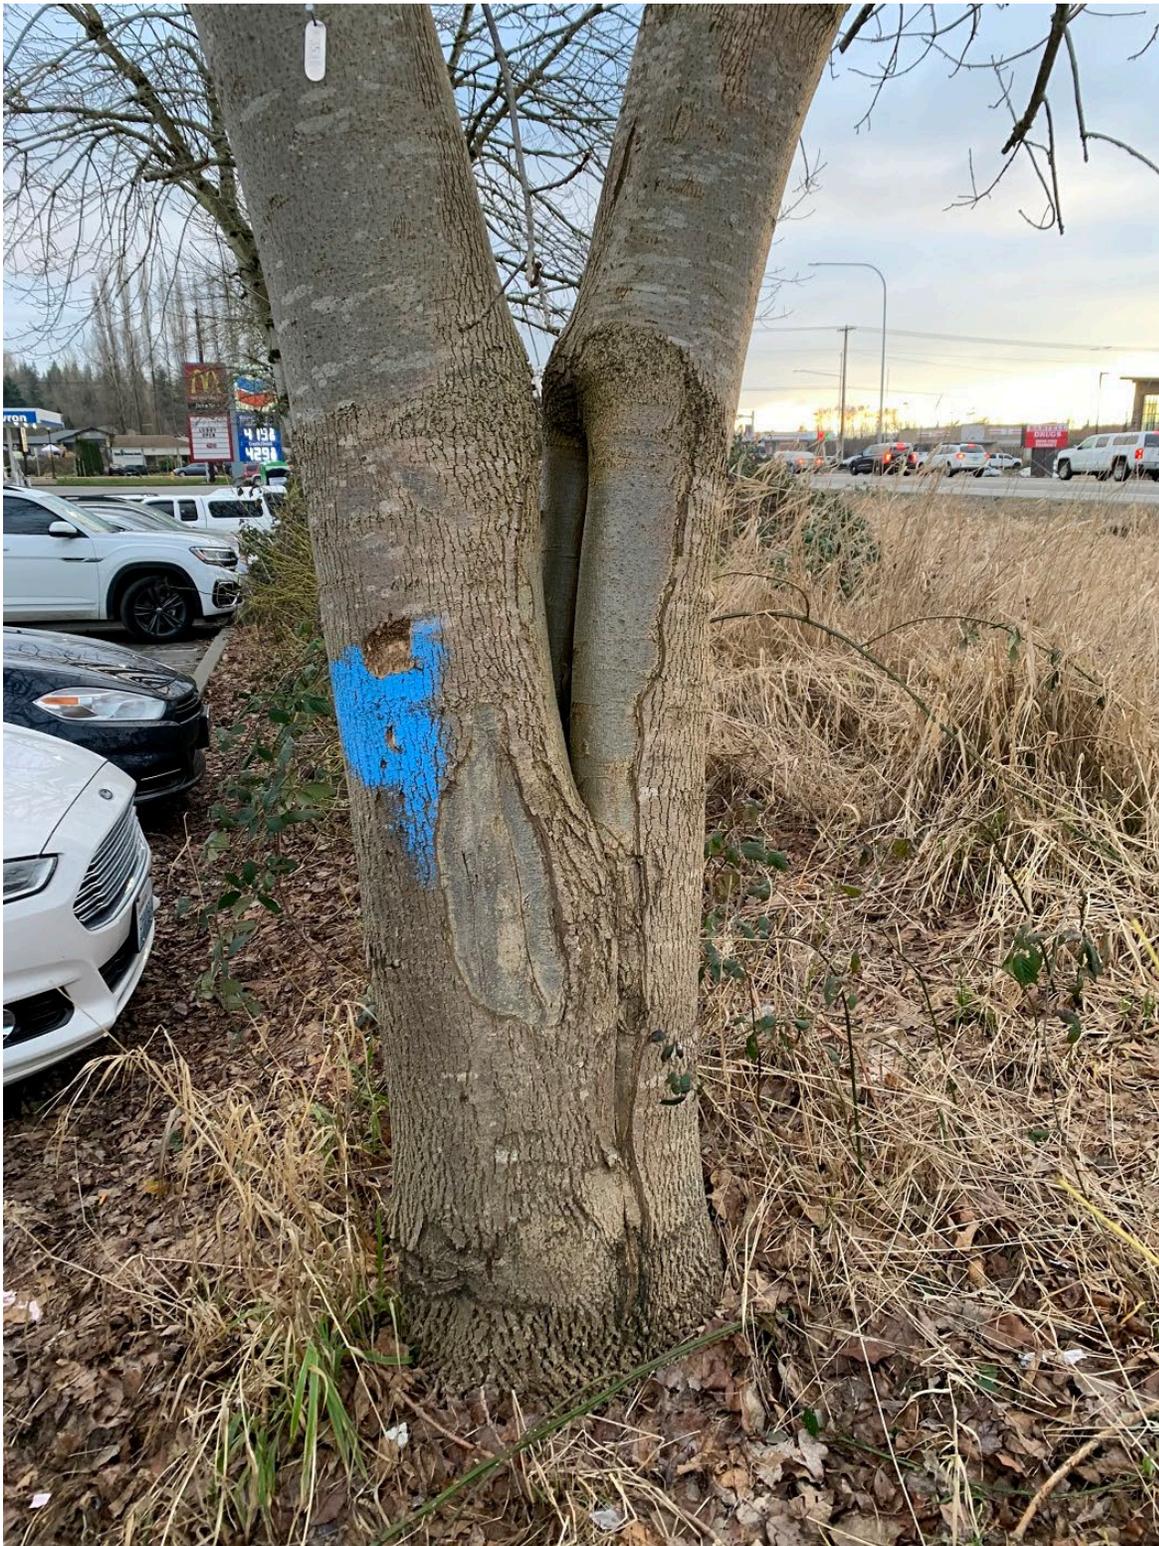
- Tree #335 is expected to eventually succumb to the trunk decay and not survive.
- Weakly attached codominant stems on #332 and 353 can be managed while still retaining the tree.

Photo 6. The trunk of tree #353 has two codominant stems with a weak attachment.
