Infiltration Assessment Report

Proposed Townhome Development
416 and 422 East Gilman Avenue
Arlington, WA 98223

December 8, 2022
Project No. 22-0872

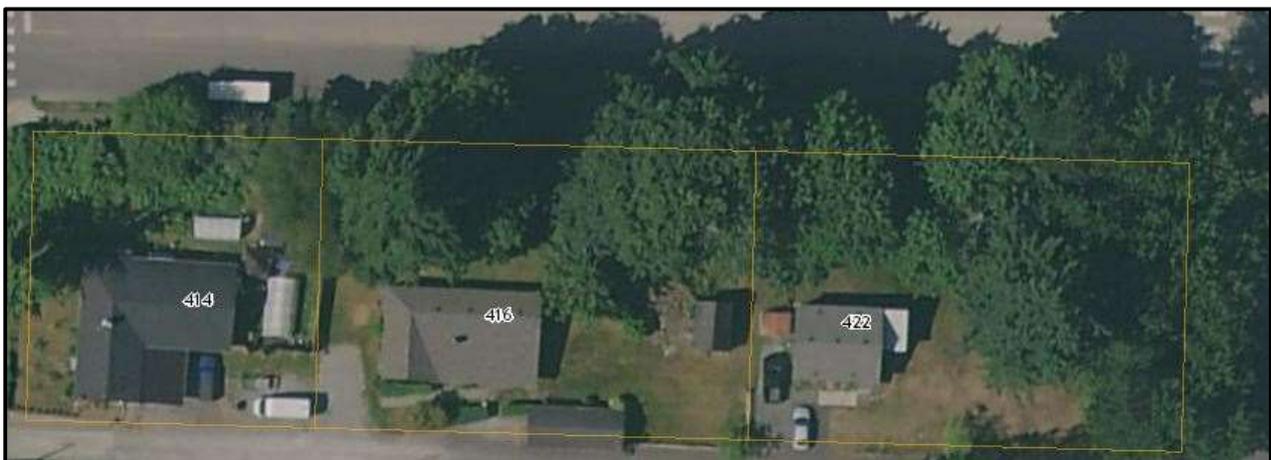
Image 1. A screenshot taken from *PDS Map Portal*, showing aerial view of the two subject parcels and the single-family residence to the west.

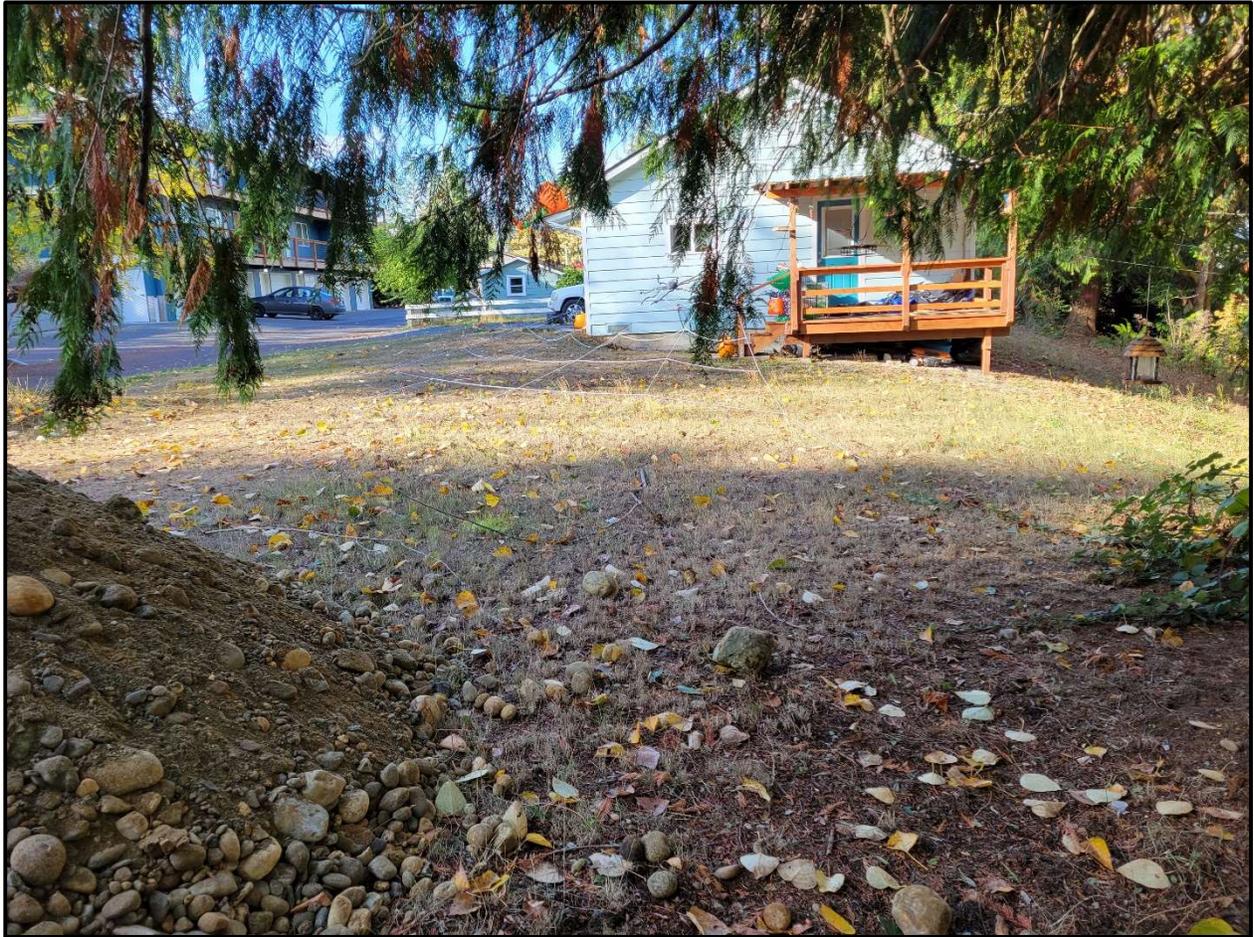
Image 2. Site conditions showing the relatively flat surface conditions and moderate slope to the north. Photo taken facing west. Images 2 and 3 taken on October 27, 2022.

The site is relatively flat with the only slope located along the northern edge of both properties. A moderately steep slope approximately 10 to 15 feet in height parallels the northern edge of both lots. The slope is covered with coniferous trees and shrubbery. It appears that this is a historic cut slope that was made for previous grading of Gilman Avenue that parallels the northern side of both lots. Along the southern edge of each lot is a shared half paved half gravel alleyway. A single-family lot borders the western of lot at 416 East Gilman Avenue. North Talcott Street borders the eastern parcel boundaries. GeoTest observed a few existing utility alignments and easements around the parcels.

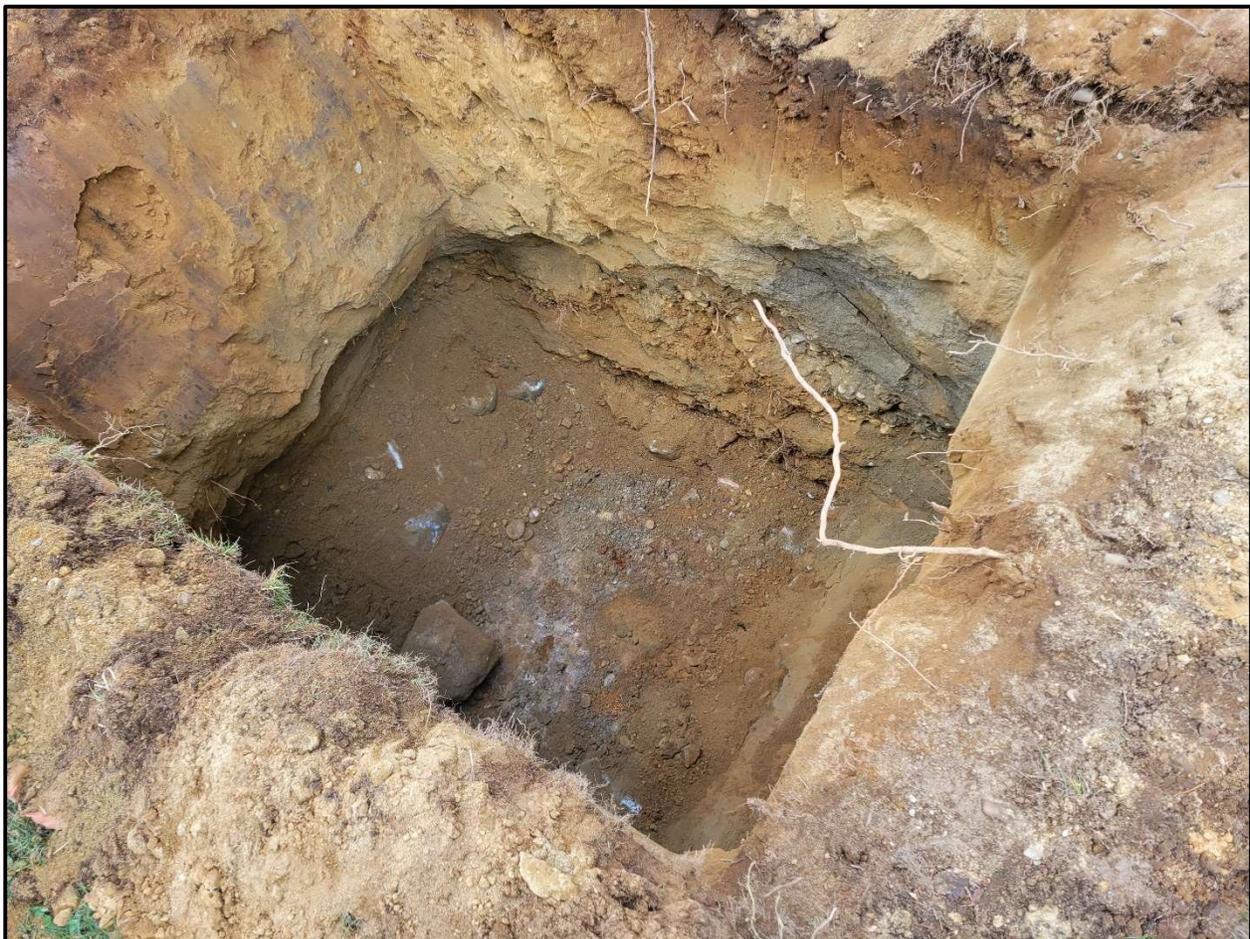
Image 3. Subsurface conditions within TP-3. Near surface soils consist of topsoil underlain by weathered silty sands and transitioning into unweathered sands with generally higher gravel contents at approximately 5 feet BGS. Note the gray blue, sandy silt at the base of the test pit.

In TP-3 and the PIT, the soils underlying the topsoil layer consisted of native, medium dense, tan to reddish brown, gravelly, silty sand, and can be interpreted as an Arlington Gravel similar to TP-1 and TP-2. These soils became unweathered at about 4 feet BGS. At the base of TP-1, TP-3, and PIT (approximately 6 to 7 feet BGS) is a hard, gray blue, gravelly, sandy silt interpreted as Till. The Glacial till was encountered to the maximum explored depth of these test pits.

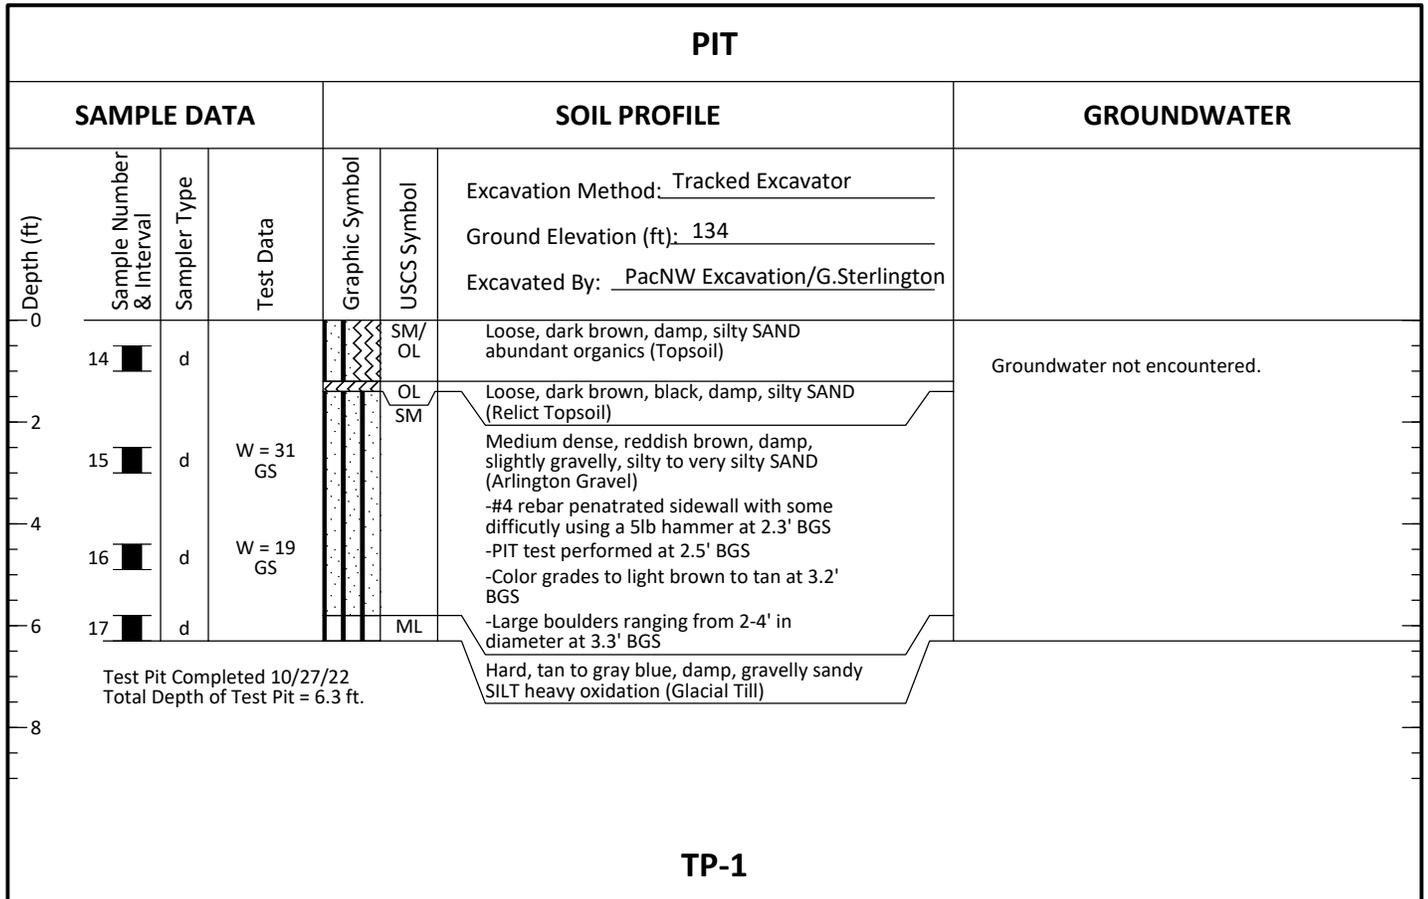
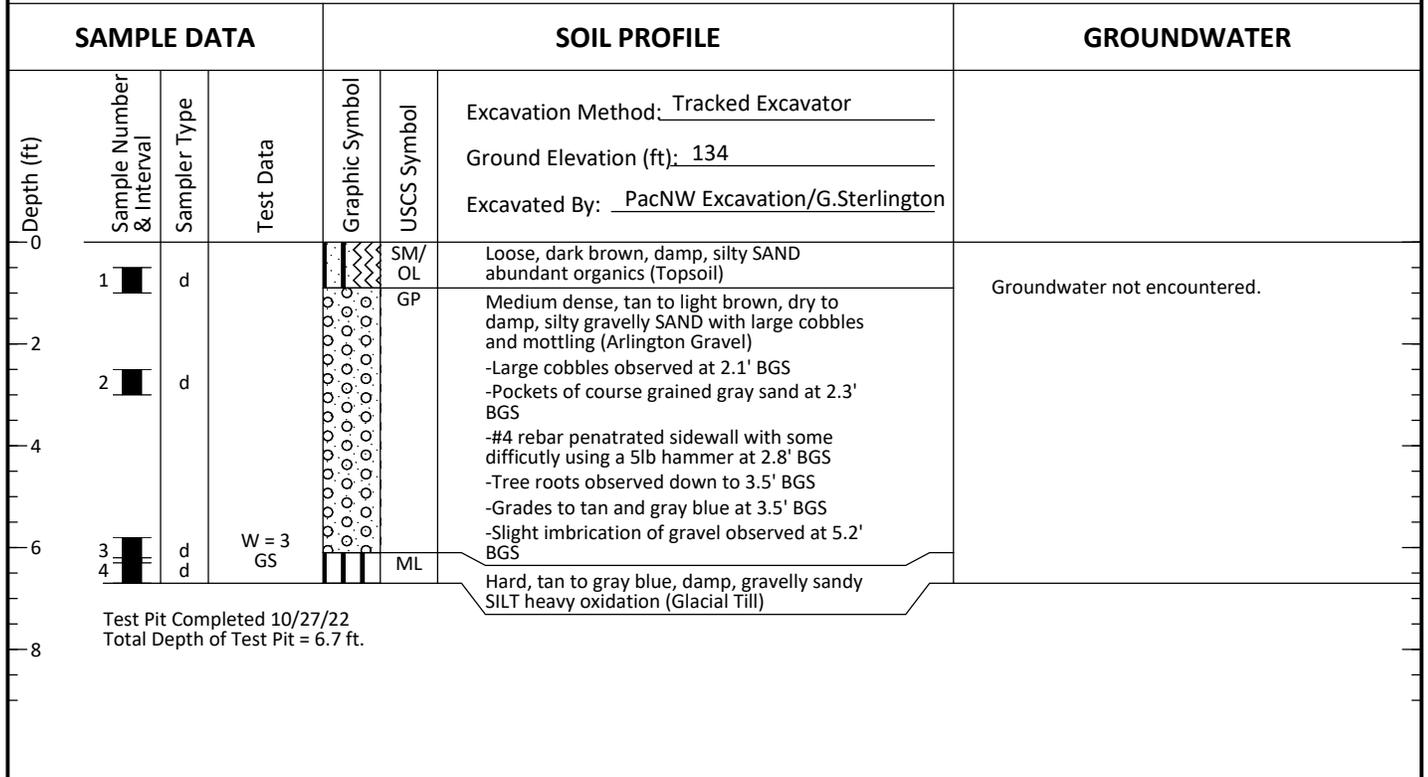
Figure
4

- Notes: 1. Stratigraphic contacts are based on field interpretations and are approximate.
2. Reference to the text of this report is necessary for a proper understanding of subsurface conditions.
3. Refer to "Soil Classification System and Key" figure for explanation of graphics and symbols.

Log of Test Pits

The on-site subsurface soils generally consisted of about 1.1 to 1.2-feet of brown, loose, silty sand with appreciable organics that were interpreted to be topsoil. Underlying the topsoil in TP-1 and TP-2, GeoTest observed native, medium dense, tan to light brown, silty sandy gravel that was interpreted as the Arlington Sand member of the Recessional Outwash (referred to in this report as Arlington Gravel). At a depth of about 3.5 to 4 feet BGS in TP-1 and TP-2, the weathered Arlington Gravel graded to gray, unweathered Arlington Gravel. This soil was encountered to the maximum explored depth of TP-2.

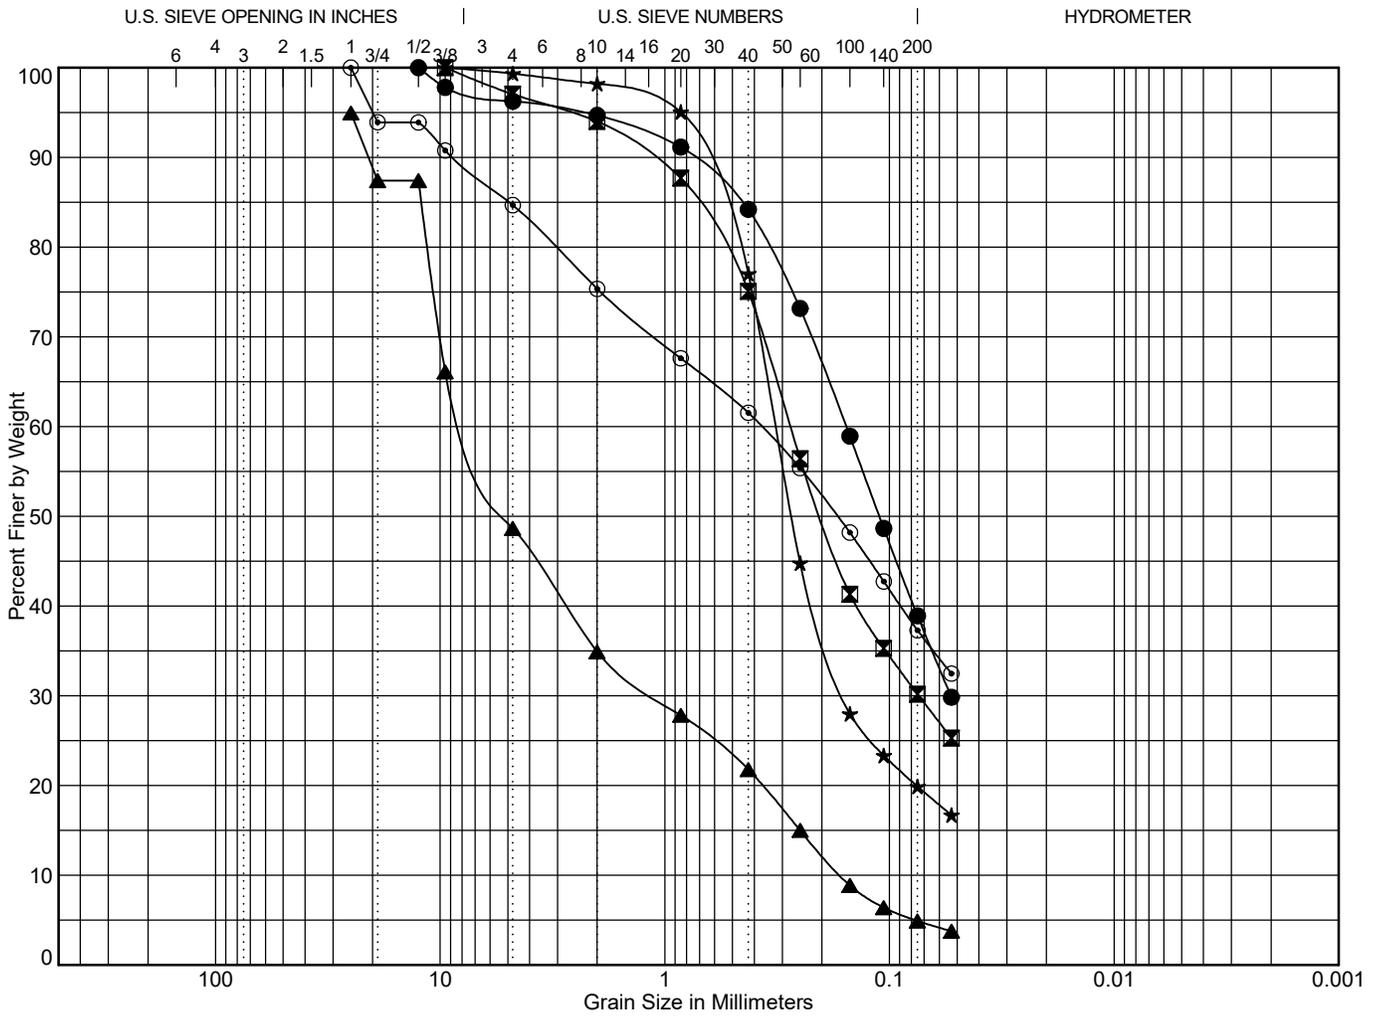
Figure
6

Point	Depth	Classification	LL	PL	PI	C _c	C _u
●	PIT 2.5	Very silty SAND, trace gravel (SM)					
☒	PIT 4.4	Very silty SAND, trace gravel (SM)					
▲	TP-1 5.8	Very sandy, poorly graded GRAVEL, trace silt (GP)				0.99	45.20
★	TP-3 3.3	Silty SAND, trace gravel (SM)					
⊙	TP-3 7.4	Very silty, gravelly, SAND (SM)

Grain Size Test Data
