Geotechnical Engineering Report  
The Point  
19402 Smokey Point Boulevard  
Arlington, WA

September 16, 2022  
Project No. 22-0727

**Regarding: Geotechnical Engineering Report  
The Point  
19402 Smokey Point Boulevard  
Arlington, WA  
(Parcel No. 31051700400600)**

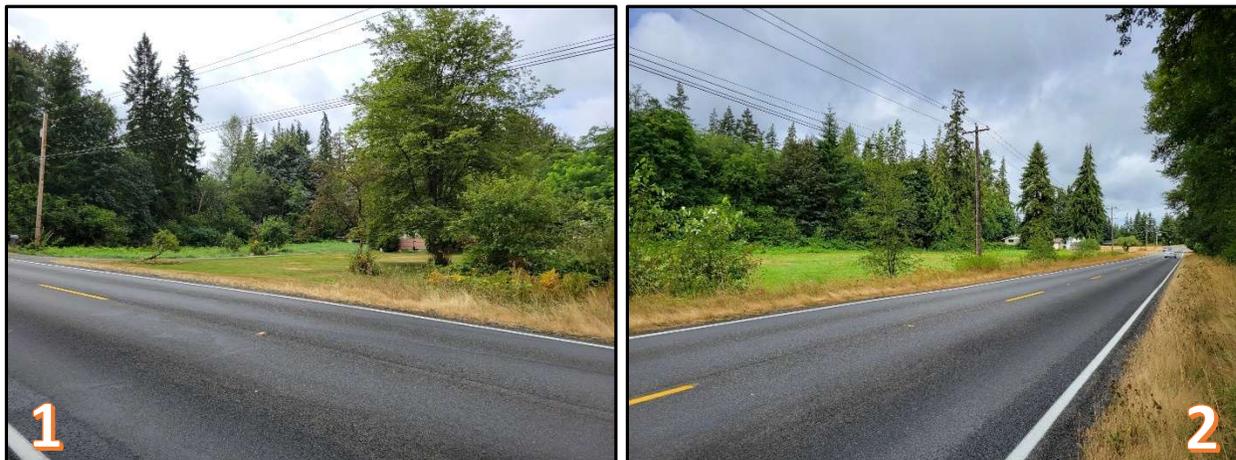
**Images 1 and 2.** A southwestern view of the upper portion of the property and the single-family residence on site (Image 1), as well as a northwestern view of the lower portion of the subject parcel (Image 2).

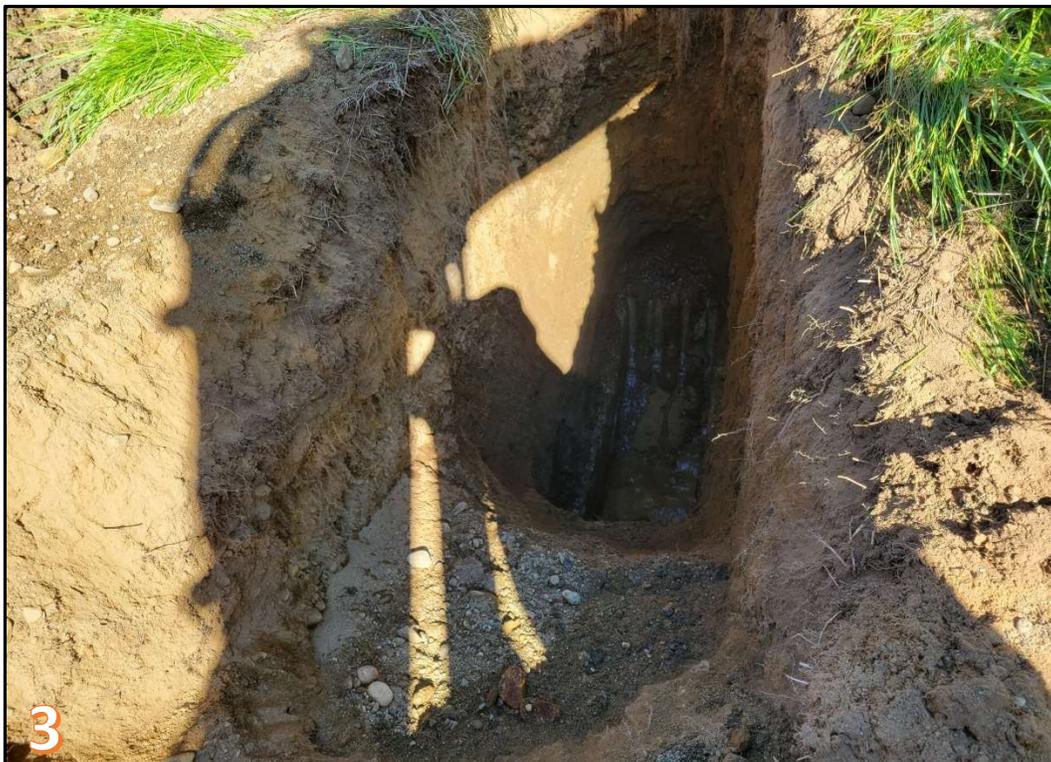
**Image 3.** Subsurface soil conditions within test pit TP-3, exhibiting granular outwash overlying slightly clayey, very sandy silt at depth, with perched groundwater atop these finer soils.

graded soils with depth. It should also be noted that Test Pit TP-3 exhibited a medium stiff, tan, dry, very sandy silt underlying the topsoil, further implying the higher silt contents of near surface, native soils throughout the project area. GeoTest interprets these granular soils as the Marysville Sand member of the Recessional Outwash mapped in the area (Minard, 1985). The Marysville Sand was encountered to the maximum explored depth of most of our explorations.

Within a few of our test pit explorations at depths ranging between 7 and 9.5 feet BGS (Test Pits TP-2 – TP-4, and TP-6), GeoTest also observed a gray, stiff, damp, slightly clayey, very sandy silt with trace gravel. Based on its existence, coupled with both the presence of perched groundwater observed in other exploration locations (refer to the *Groundwater* section of this report for more information) as well as the site’s elevation above the Stillaguamish floodplain, it appears that this silt unit is present within the upper 10 to 15 feet of the site grade within the lower half of the proposed development area. Based on regional mapping, we interpret these soils to be that of the Clay Member of the Recessional Outwash unit mapped in the area (Minard, 1985).

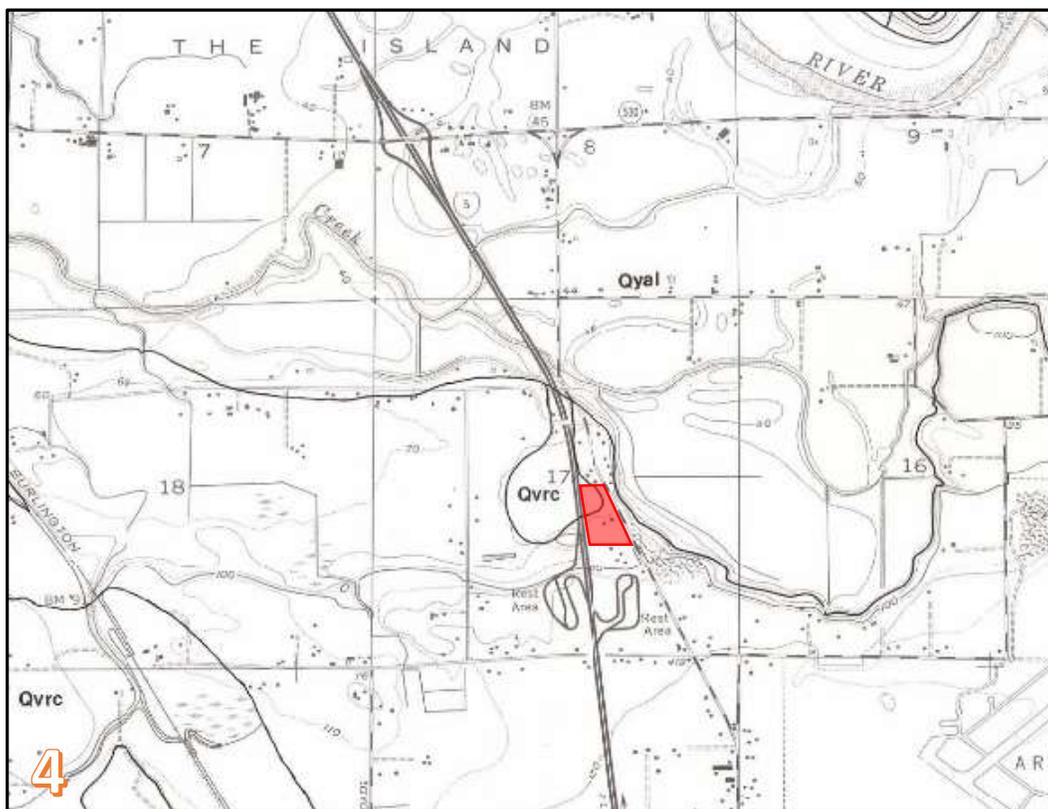
**Image 4.** Mapped geologic units within the vicinity of the project site (shown in red), as mapped by Minard, illustrating the presence of alluvium (map unit Qyal), Marysville Sand (map unit Qvrm), and the Clay Member (map unit Qvrc) in the area.

Geologic information for the project site was obtained from the *Geologic map of the Arlington West 7.5-minute quadrangle, Snohomish County, Washington* (Minard, 1985) published by the U.S. Geological Survey. This map indicates that the project site is underlain by Vashon Drift Recessional Outwash consisting of the Marysville Sand Member (map unit Qvrm) and the Clay Member (map unit Qvrc), with alluvium also mapped nearby but at lower elevations off site.

Alluvium is located within the Stillaguamish River floodplain east of and topographically below the proposed development area. This unit generally consists of stratified gravels, sands, and silts within floodplains, active channels, and historic fluvial basins at elevations near the water table.

The Marysville Sand Member of the Recessional Outwash consists of mostly well-drained, outwash sand with minor amounts of gravel. The Clay Member is comprised of gray, olive gray, mottled, massive clay to silt and is associated with the Marysville Sand Member, such that it grades into and interfingers laterally with the Marysville Sand member. Recessional outwash deposits such as these were deposited as valley fill by meltwater flowing south from the stagnating and receding Vashon Glacier during the Pleistocene Epoch. Glaciofluvial environments

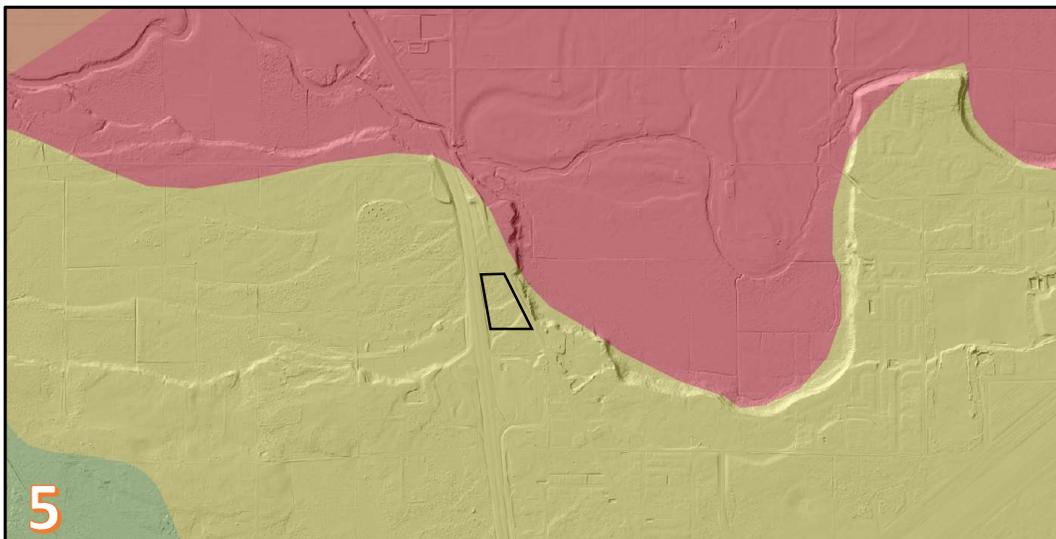
**Image 5.** Map showing liquefaction hazard susceptibility within the proposed development area shown in black. Yellow depicts “low to moderate” susceptibility in the vicinity of subject property (Data source: Washington Geologic Information Portal).

Based on our subsurface explorations, the site is underlain by native, medium dense, sandy soils with varying amounts of gravel. Groundwater seepage was encountered within medium dense, native soils. Due to these factors, it is GeoTest’s opinion that the potential for liquefaction

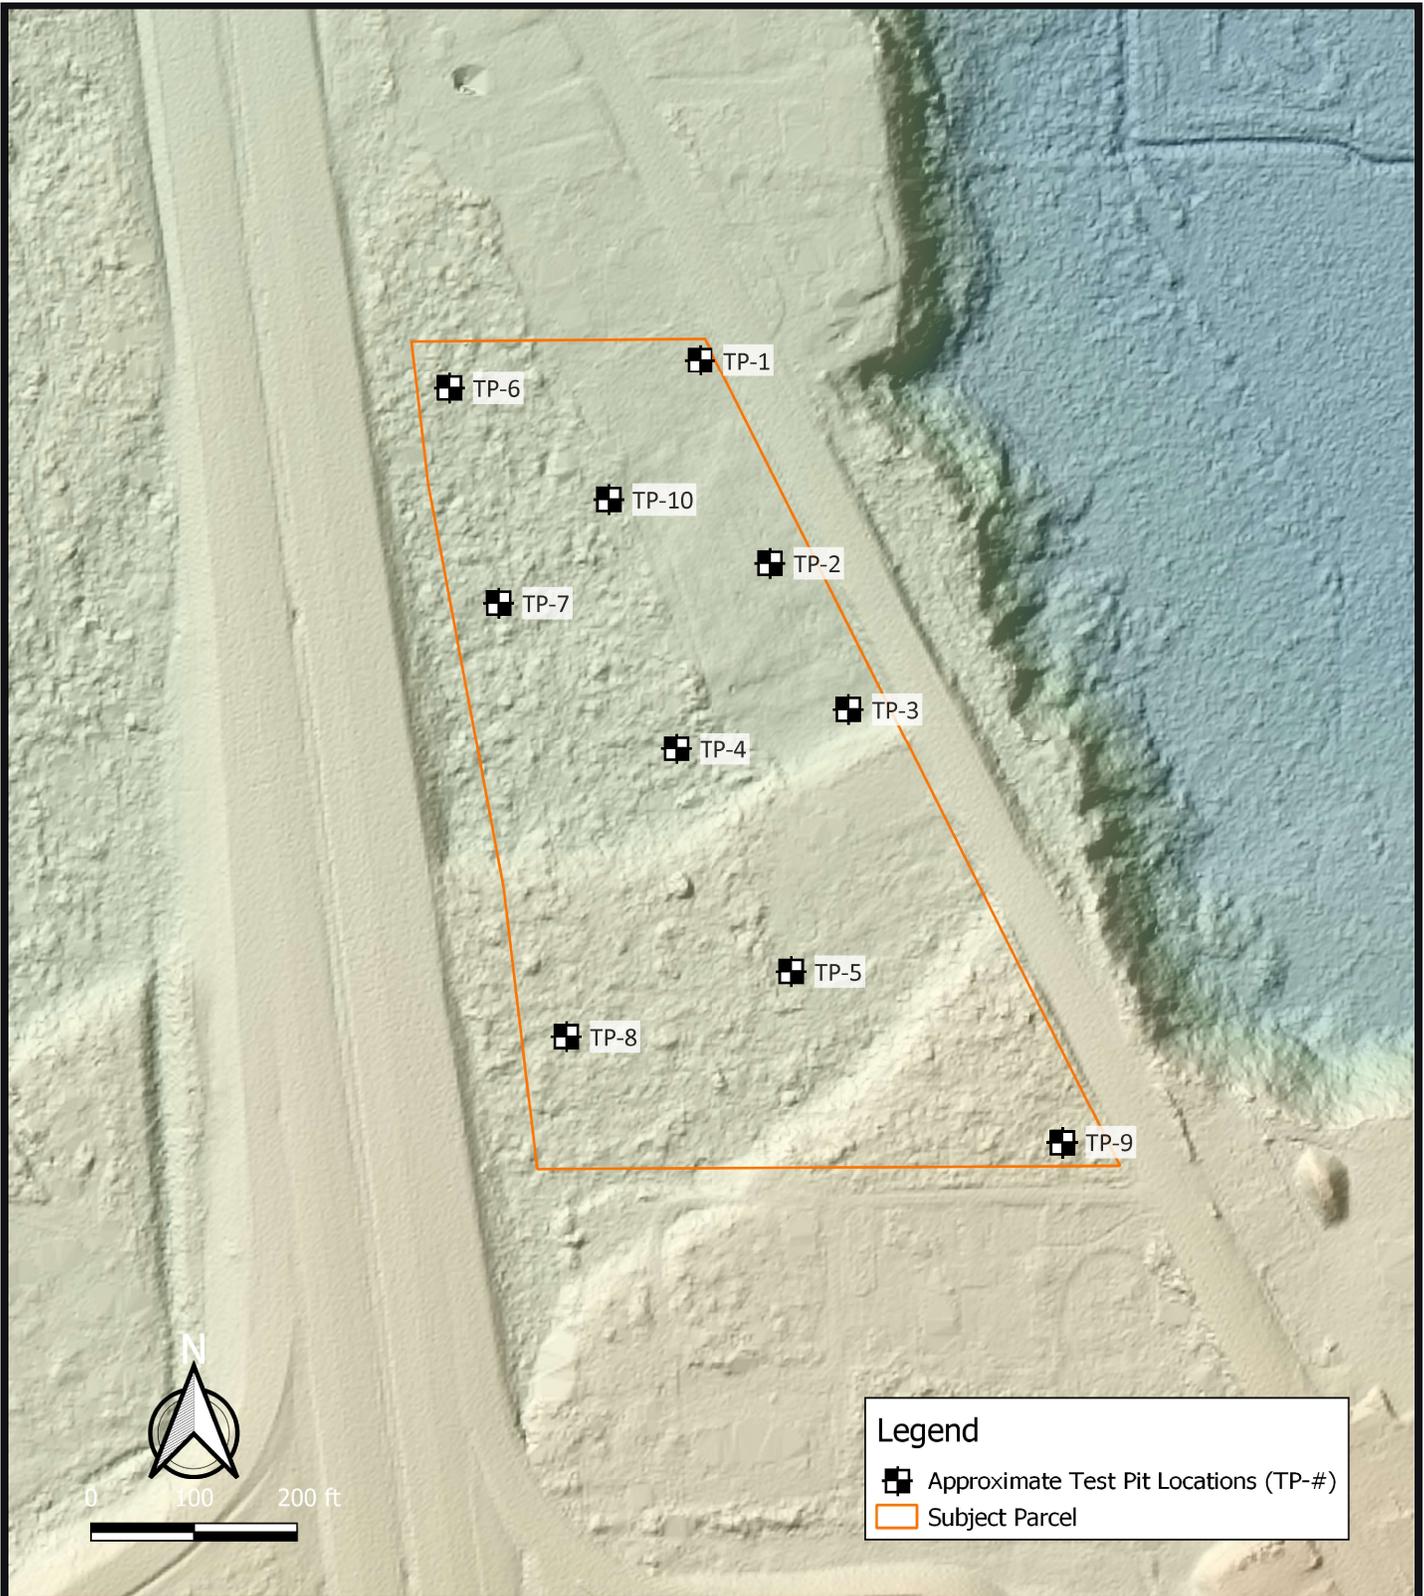
**3**

- 1) Parcel shapefile sourced from Snohomish County's PDS Map Portal
- 2) Scale, north arrow, digital elevation model, and hillshade created using North Puget 2017 digital elevation model (sourced from Washington Lidar Portal)
- 3) Map image created using QGIS 3.22.6

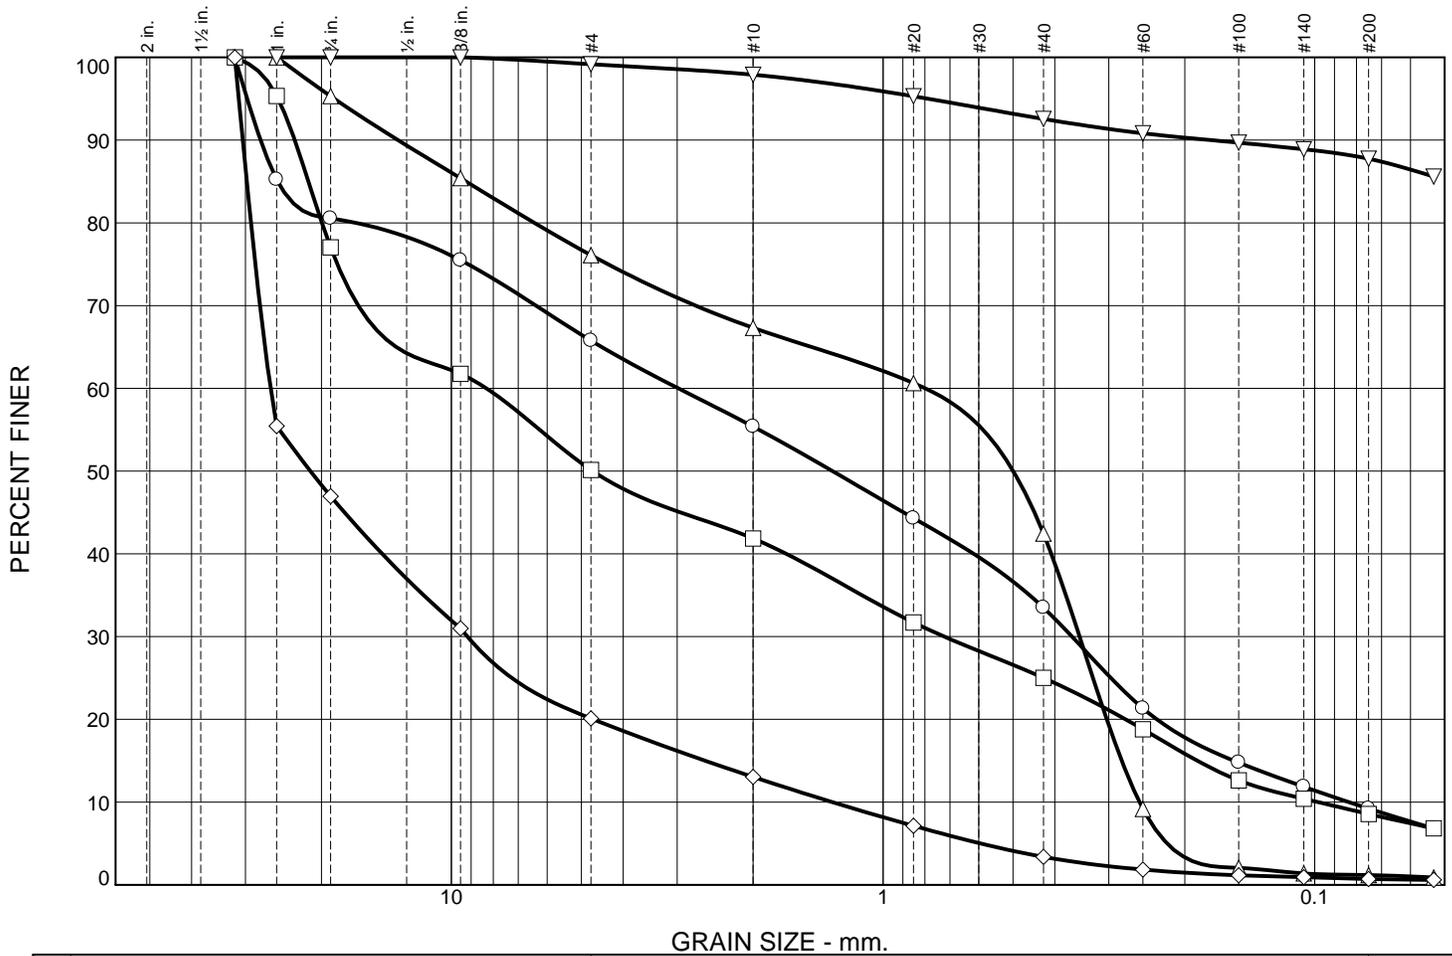
# Sieve Analysis Test Report - ASTM C136/C117

% +3"	% Gravel		% Sand			% Fines
	Coarse	Fine	Coarse	Medium	Fine	Silt
○ 0	19	15	11	22	24	9
□ 0	23	27	8	17	16	9
△ 0	5	19	9	25	41	1
◇ 0	53	27	7	10	2	1
▽ 0	0	1	1	5	5	88

SOIL DATA					
SYMBOL	SOURCE	SAMPLE NO.	DEPTH (ft.)	Material Description	USCS
○	TP-2	10	0.2	Slightly silty, very gravelly SAND, poorly graded	SP-SM
□	TP-2	11	1.3	Slightly silty, very sandy GRAVEL, poorly graded	GP-GM
△	TP-2	12	3.3	Gravelly SAND, trace silt, poorly graded	SP
◇	TP-2	15	8.0	Sandy GRAVEL, trace silt, well-graded	GW
▽	TP-2	16	10.0	Slightly sandy SILT, trace gravel	ML

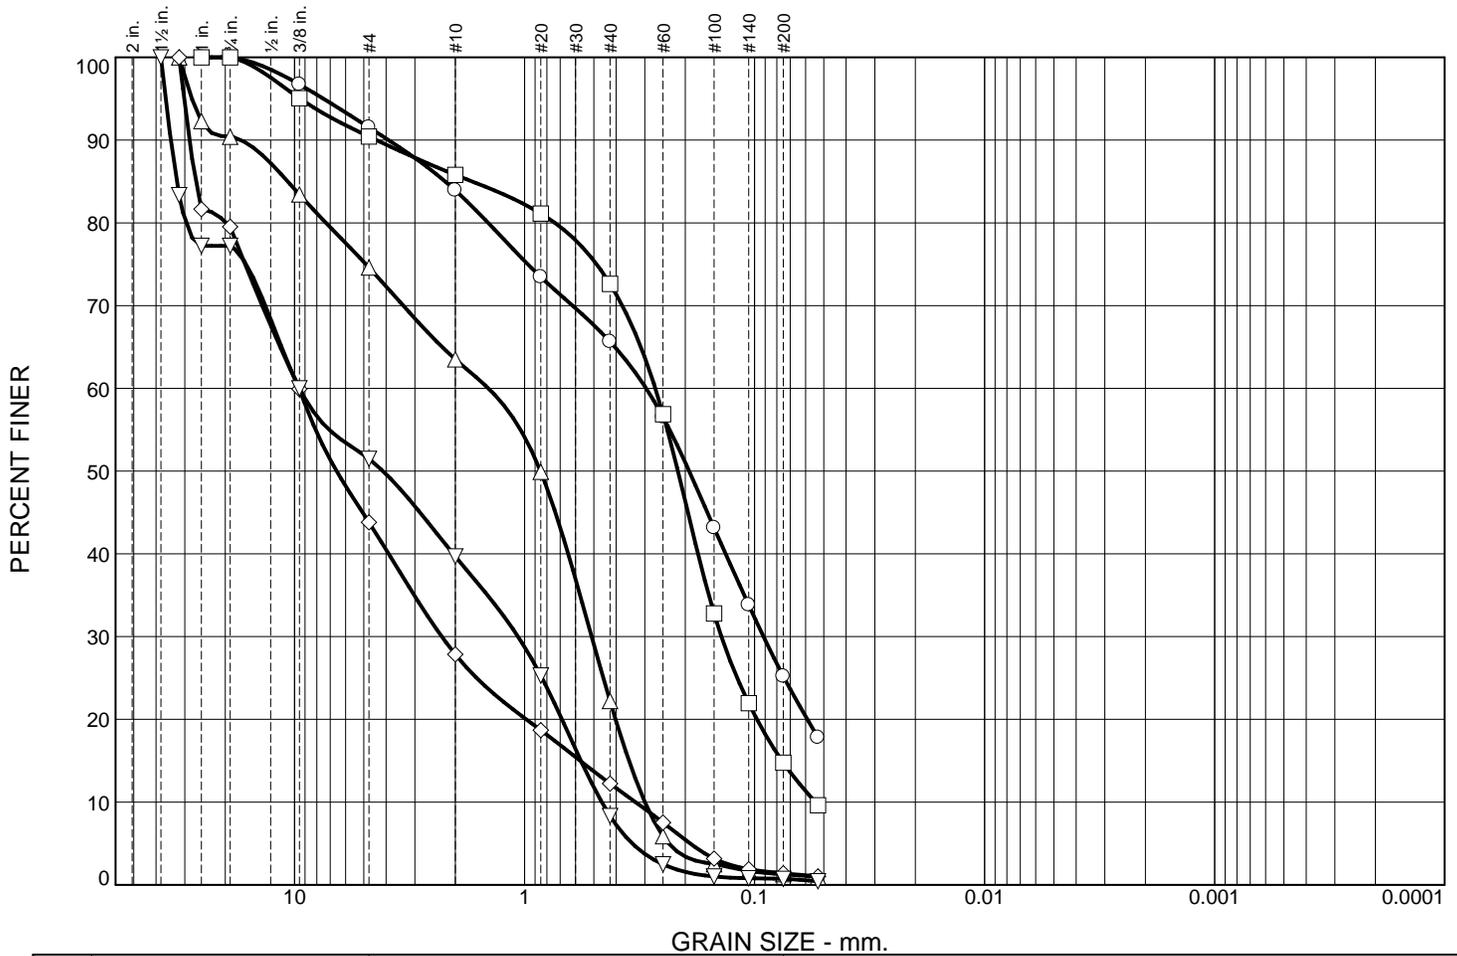
# Sieve Analysis Test Report - ASTM C136/C117

% +3"	% Gravel		% Sand			% Fines	
	Coarse	Fine	Coarse	Medium	Fine	Silt	Clay
○	0	8	8	18	41		25
□	0	10	4	13	58		15
△	0	10	11	42	21		1
◇	0	20	16	16	11		1
▽	0	23	11	32	7		1

SOIL DATA						
SYMBOL	SOURCE	SAMPLE NO.	DEPTH (ft.)	Material Description		USCS
○	TP-9	54	0.7	Slightly gravelly, silty SAND		SM
□	TP-9	55	1.5	Slightly gravelly, silty SAND		SM
△	TP-9	56	2.5	Gravelly SAND, trace silt, poorly graded		SP
◇	TP-9	58	6.0	Very sandy GRAVEL, trace silt, well graded		GW
▽	TP-9	60	9.0	Very gravelly SAND, trace silt, poorly graded		SP
