November 27, 2023
File No. 17-261

**Subject: Geotechnical Report
Proposed Warehouse Improvements
18520 67th Avenue North, Arlington, Washington**

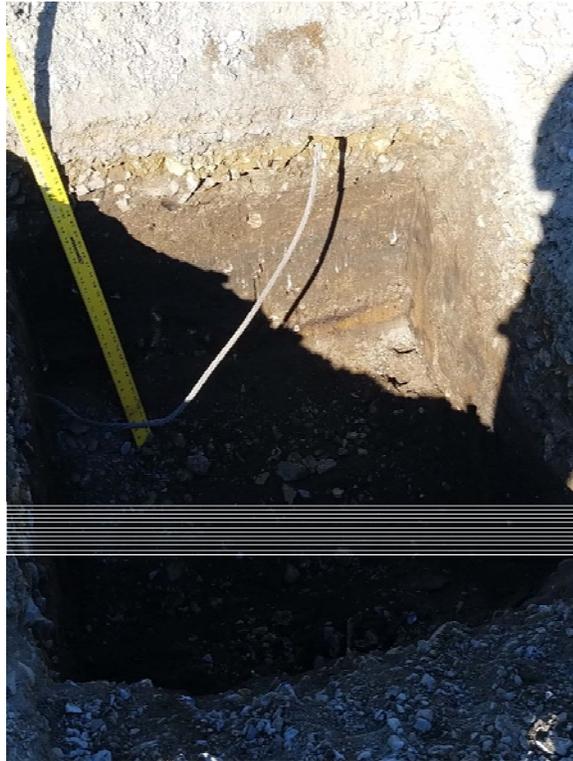
Figure A-2

Test Pit No. TP-1	
Approximate ground surface elevation: 147 feet Coordinates (WGS84): 48.163811, -122.1412745	
<u>Depth (ft)</u>	<u>Material Description</u>
0 – 1.5	Very dense, grey, sandy GRAVEL with silt: moist; poorly graded, coarse angular gravel/wash rock, steel cable [Fill]
1.5 – 3.0	Medium dense, brown to red-brown, fine to medium SAND with silt and gravel: moist; poorly graded, iron oxide staining [Qvrm – Recessional Outwash-Marysville Sand Member]

Photo TP-1: Shows TP-1 at approximately 3-feet in depth

TP-1 was terminated approximately 3 feet below ground surface.

Groundwater seepage was not observed.

The field infiltration tests were conducted in general accordance with the procedure for Small Pilot Infiltration Test (PIT) outlined in the 2016 Snohomish County Drainage Manual. Two tests were performed, one in TP-1 at the north end of the building and one in TP-3 at the south end of the building (see Figure 2). The test locations were chosen based on the proposed locations of the infiltration facilities at the time of testing.

Table 1. Field Infiltration Test Data				
Test Location/Depth	Pre-Soak Duration (hours)	Test Duration (hours)	Field Test Result (inches/hour)	Comment
TP-1 @ 4 feet	6	1.42	26.4	Test in sandy native soils (Outwash)
TP-3 @ 3 feet	6	2	11.6	Test in sandy native soils (Outwash)

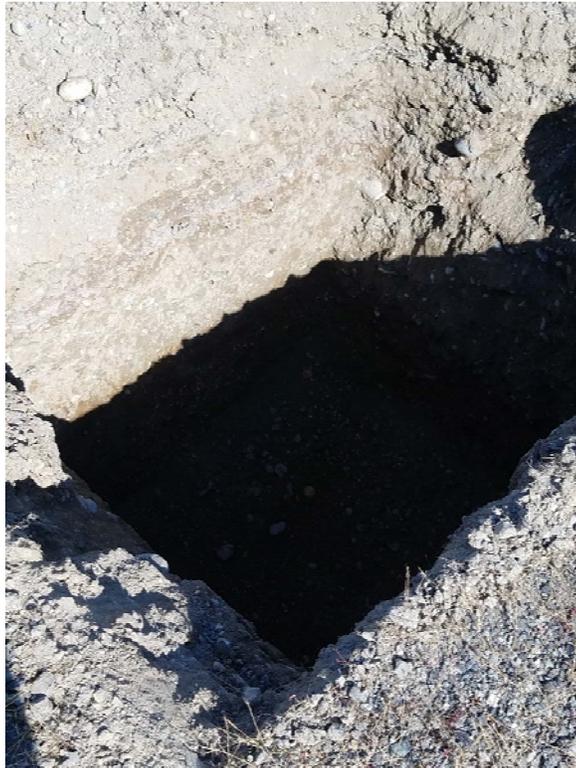
Figure A-3

<u>Depth (ft)</u>	<u>Material Description</u>
0 – 1.2	Dense, brown gray, sandy CRUSHED ROCK and GRAVEL: slightly moist [Fill]
1.2 – 4.2	Medium dense, brown gray, gravelly, fine to coarse SAND with silt: moist, homogeneous, well graded. [Qvrm – Recessional Outwash – Marysville Sand Member]

Photo TP-2: Shows TP-2 at approximately 4.2 feet in depth

TP-2 was terminated approximately 4.2 feet below ground surface.

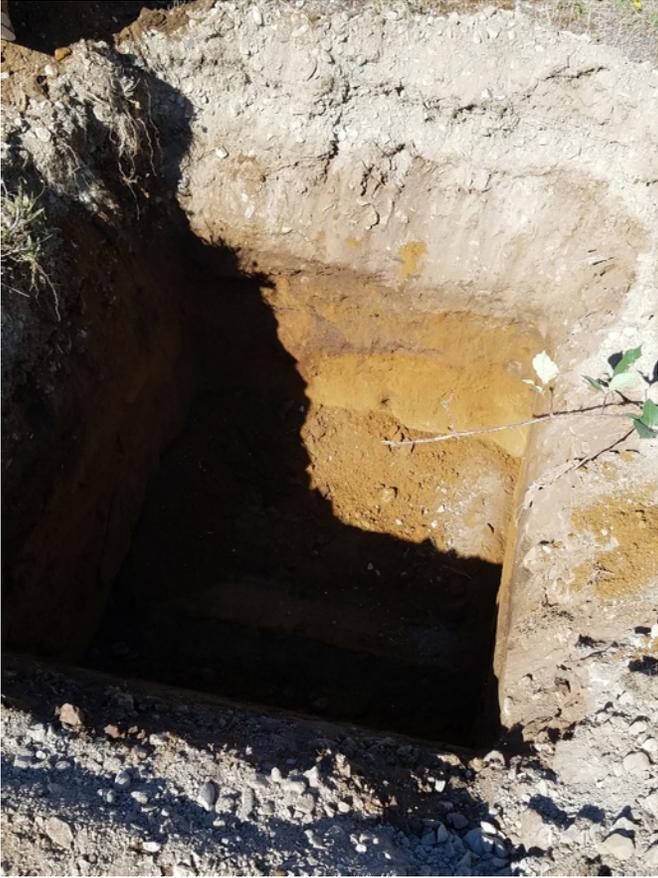
Figure A-4

Test Pit No. TP-3	
Approximate ground surface elevation: 147 feet Coordinates (WGS84): 48.162879 -122.141259	
<u>Depth (ft)</u>	<u>Material Description</u>
0 – 1.4	Very dense, grey, sandy GRAVEL with silt: moist; poorly graded, coarse angular gravel/wash rock, steel cable [Fill]
1.4 – 4.0	Medium dense, brown to red-brown, fine to medium SAND with silt and gravel: moist; poorly graded, iron oxide staining [Qvrm – Recessional Outwash-Marysville Sand Member]
<p>Photo TP-3: Shows TP-3 at approximately 4 feet in depth.</p>

<p>TP-3 was terminated approximately 4 feet below ground surface.</p> <p>Groundwater seepage was not observed.</p>

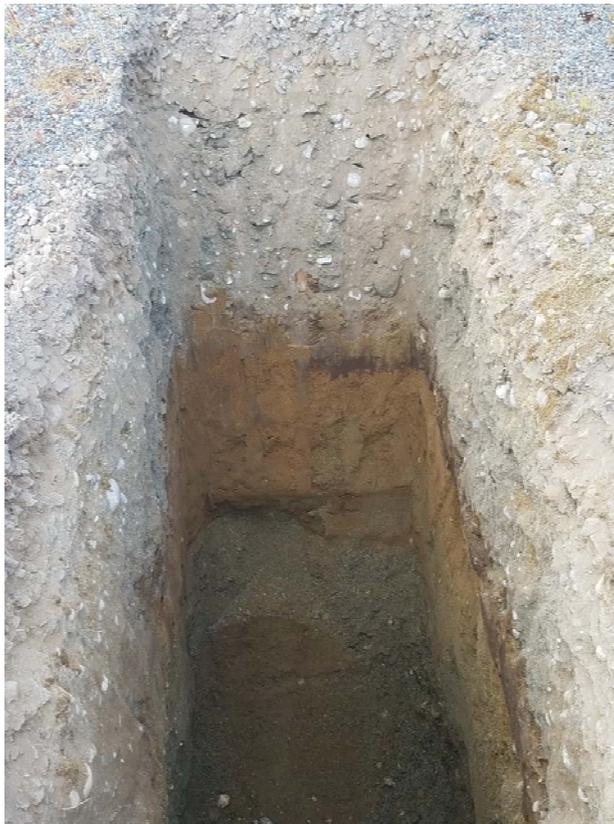
Figure A-5

<u>Depth (ft)</u>	<u>Material Description</u>
0 – 2.1	Dense, brown gray, sandy CRUSHED ROCK and GRAVEL: slightly moist. [Fill]
2.1 – 3.4	Medium dense, red brown, silty, fine to medium SAND: moist, poorly graded, trace organics in to 6 inches, trace gravel, homogeneous. [Qvrm – Recessional Outwash-Marysville Sand Member]
3.4 – 6.4	Medium dense to dense, gray, gravelly, fine to coarse SAND: moist, some silt, well graded, homogeneous, massive. [Qvrm – Recessional Outwash-Marysville Sand Member]

Photo TP-4: Shows TP-4 at approximately 6.4 feet in depth

TP-4 was terminated approximately 6.4 feet below ground surface.

Groundwater seepage was not observed.

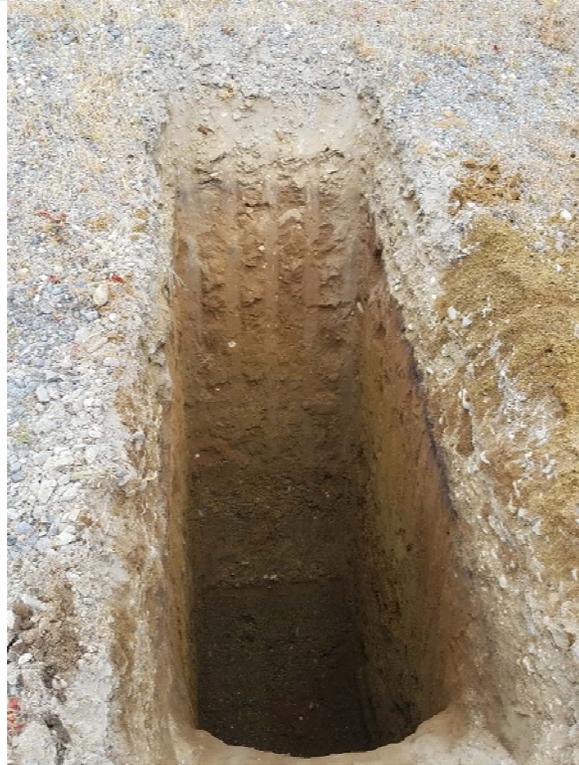
Figure A-7

<u>Depth (ft)</u>	<u>Material Description</u>
0 – 1.0	Dense, gray CRUSHED ROCK and GRAVEL with sand: dry, some silt [Fill]
1.0 – 3.3	Loose to medium dense, red brown, silty, fine SAND to fine to medium SAND with silt: slightly moist, poorly graded, trace organics in top 6 inches, massive, non-plastic fines. [Qvrm – Recessional Outwash-Marysville Sand Member]
3.3 – 3.6	Medium dense, yellow brown, fine to medium SAND with silt: moist, poorly graded, some gravel, homogeneous, massive. [Qvrm – Recessional Outwash-Marysville Sand Member]
3.6 – 6.9	Medium dense to dense, red brown to brown, gravelly, fine to coarse SAND: moist, well graded, trace to some silt, homogeneous, massive. [Qvrm – Recessional Outwash-Marysville Sand Member]

Photo TP-6: Shows TP-6 at approximately 6.9 feet in depth

TP-6 was terminated approximately 6.9 feet below ground surface.

No groundwater observed.
