Critical Areas Report

SR 9 and 204th Street NE Tracts A, B and D Project
Arlington, WA

Prepared for:
Reserve at Arlington Partners LLP

March 29, 2019
PBS Project No. 41391.004

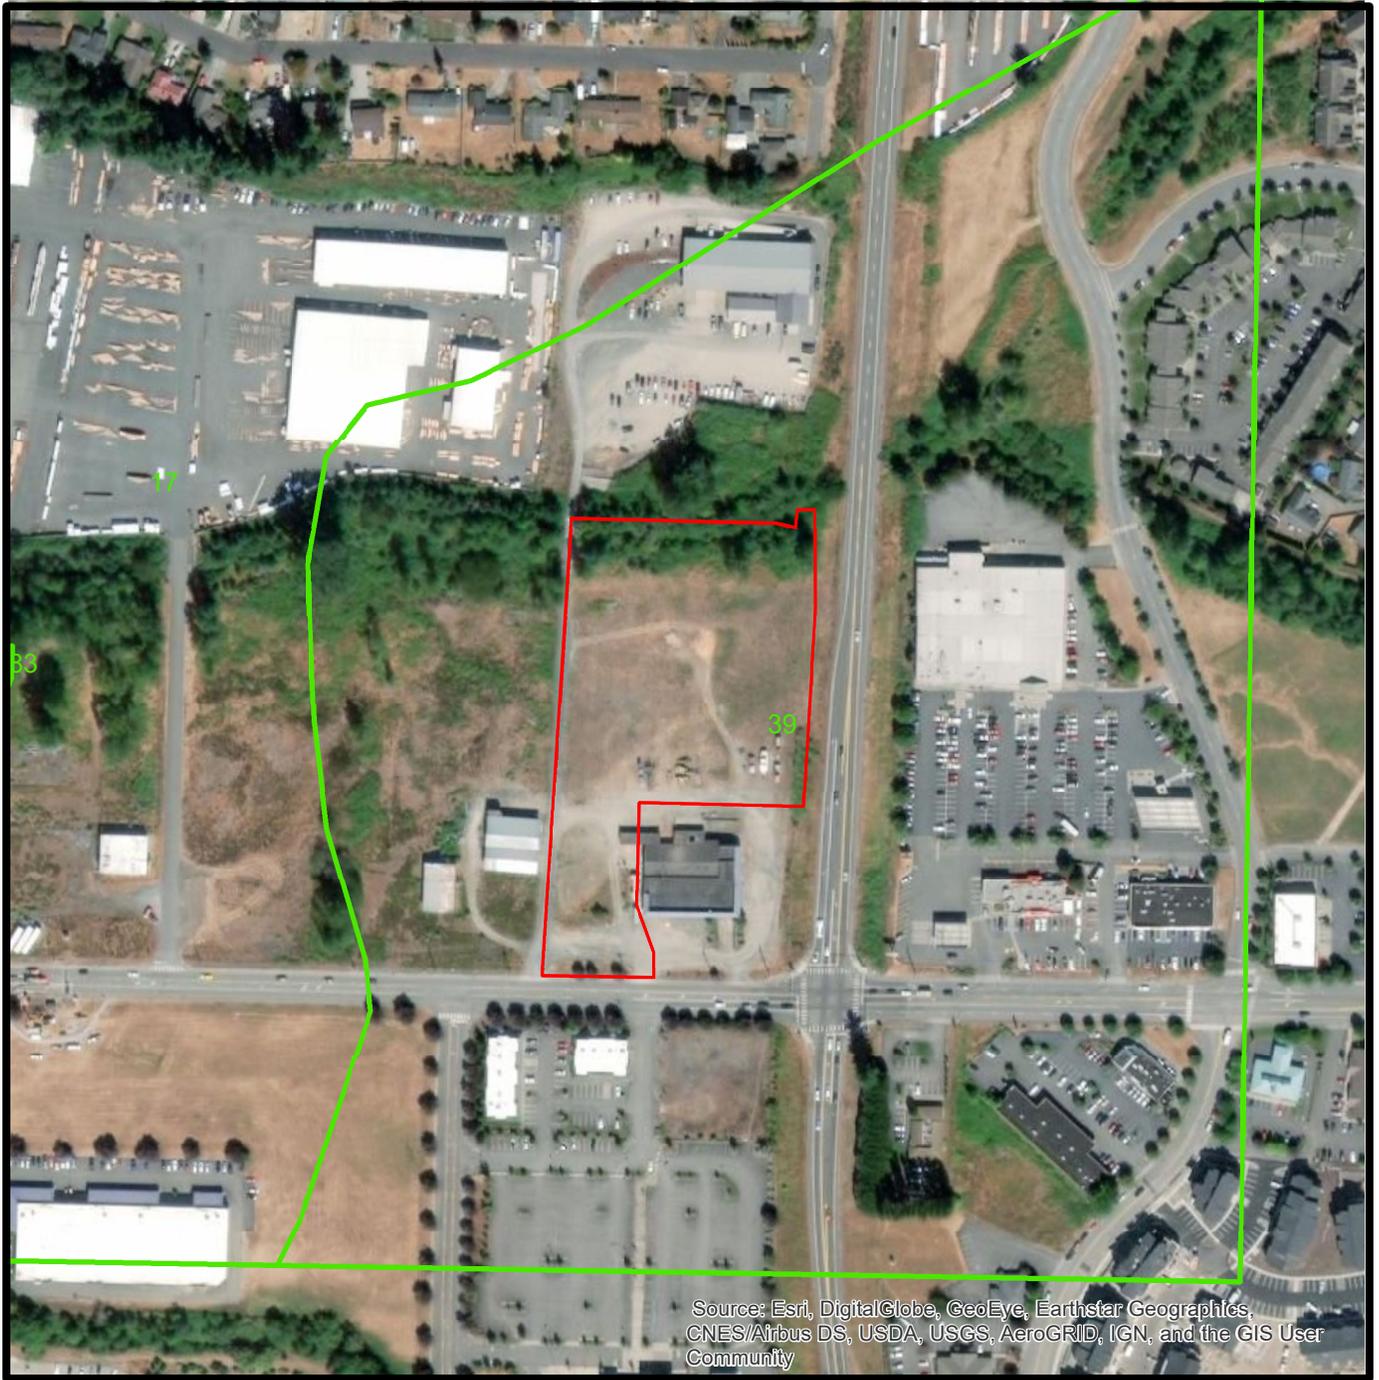
NRCS SOIL MAP

Natural Resource Conservation Service soil maps for the property (USDA NRCS 2019a) indicate that the only soil mapped on the site is Norma Loam, which is a hydric soil (Figure 3). The NRCS description of Norma Loam is detailed below.

Norma Loam (39)- The Norma, undrained component makes up 85 percent of the map unit. Slopes are 0 to 3 percent. This component is on depressions, drainageways, and till plains. The parent material consists of alluvium. Depth to a root restrictive layer is greater than 60 inches. The natural drainage class is poorly drained. Water movement in the most restrictive layer is moderately high. Available water to a depth of 60 inches (or restricted depth) is moderate. This soil is not flooded, but is frequently ponded. A seasonal zone of water saturation is at 0 inches during January, February, March, April, November, and December. Organic matter content in the surface horizon is about 10 percent.

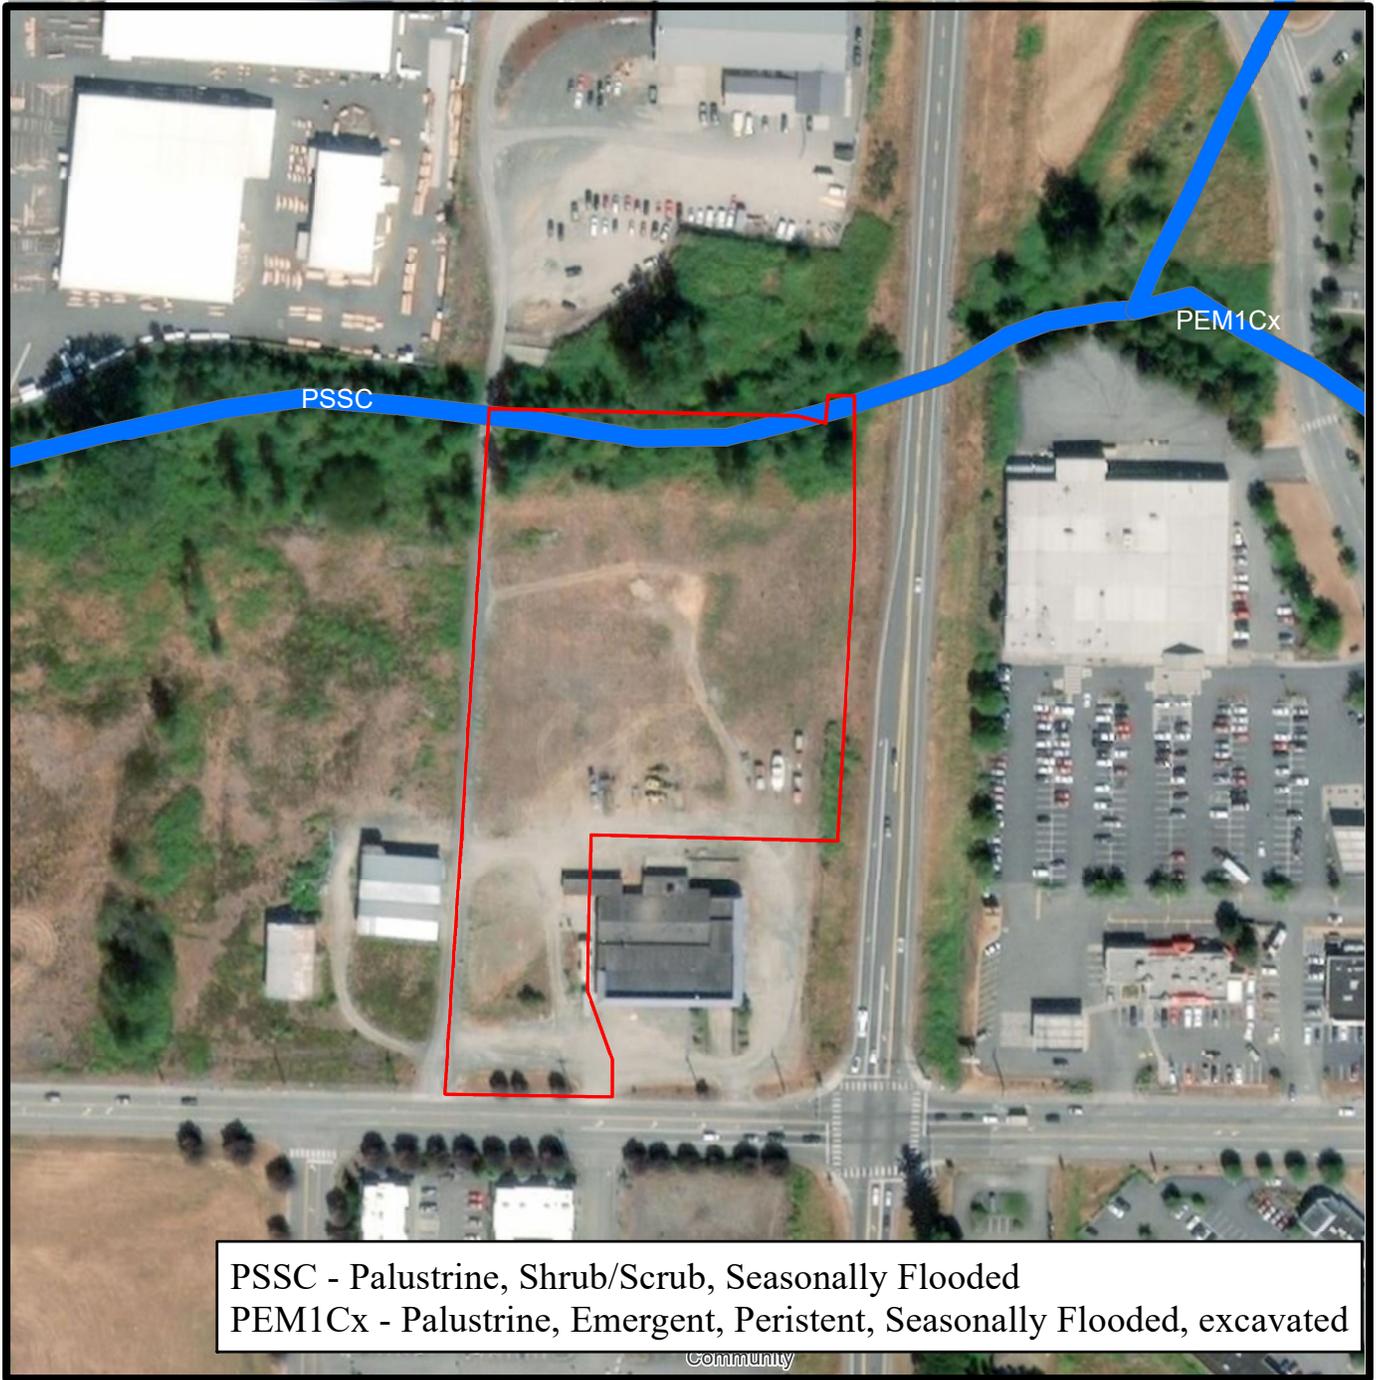
NATIONAL WETLANDS INVENTORY MAP
 SR 9 and 204TH STREET NE TRACTS A, B and D PROJECT
 ARLINGTON, WASHINGTON

The U.S. Fish and Wildlife National Wetland Inventory (NWI) Maps identify a Palustrine, Shrub-Scrub, Seasonally flooded wetland (PSSC) in the northern portion of the study area (Figure 4). This wetland is likely the channel of Portage Creek that flows west through the property in this general location. It should be noted that NWI wetlands are created through aerial photograph interpretation and are not meant to represent the extent of jurisdictional wetlands on a site. The Snohomish County Wetland Inventory (Snohomish County, 2019) does not show wetlands on or immediately adjoining the site.

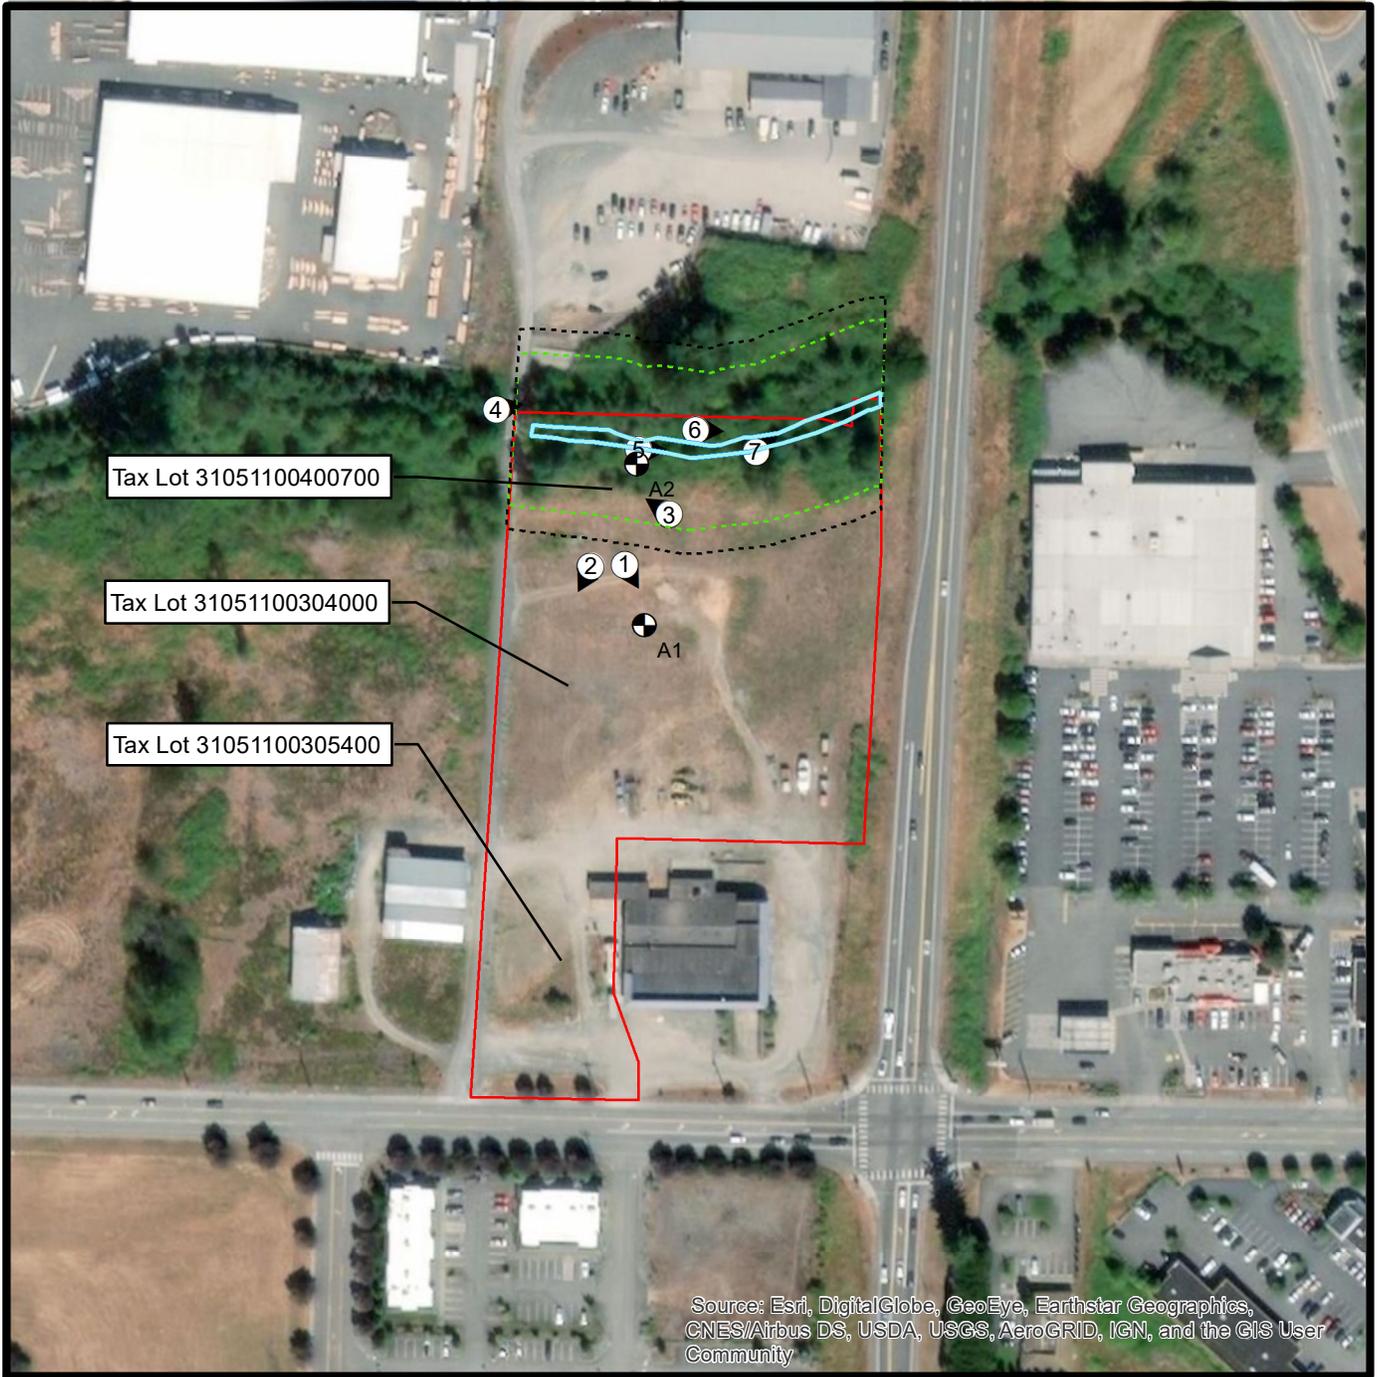
CRITICAL AREAS MAP

Portage Creek flows west through the northern portion of the project area (Figure 5). The ordinary high water mark (OHWM) of the creek was delineated and recorded with orange survey pin flags and orange survey flagging. The OHWM was readily identifiable through rapid changes in vegetation and topography (Photo 5). Portage Creek is approximately 6-feet wide as it flows through the project area and at the time of the field work had a depth between 12 and 20 inches.

Type F streams have a 100-foot stream buffer as per Table 20.93-3 of the CAMC. This buffer is required to be retained in a natural vegetated condition. This buffer may be reduced in certain conditions through an approved buffer averaging plan provided that the width of the buffer is not reduced more than 25% of the base buffer width. This 100-foot base buffer is illustrated in Figure 5.

During the Pre-application meeting for the project, the City of Arlington requested that Parcel A be set aside as a Native Growth Protection Area (NGPA) (Personal Communication, Marc Hayes [City of Arlington] to Carmel Gregory [CG Engineering], March 13, 2019). The City had indicated in previous conversation with the real estate broker that this was consistent with the boundary line adjustment application for the property from 2014, which set aside a 75-foot buffer for Portage Creek in this location. This 75-foot NGPA is illustrated in Figure 5.

PBS was hired to determine the presence or absence of jurisdictional wetlands and water features on 4.9-acre project site located within the City of Arlington, Washington. Based on the results of the background and on-site investigation a small Type F stream was identified and mapped in the northern portion of the site (Portage Creek, Figure 5). No wetlands were identified on the site.

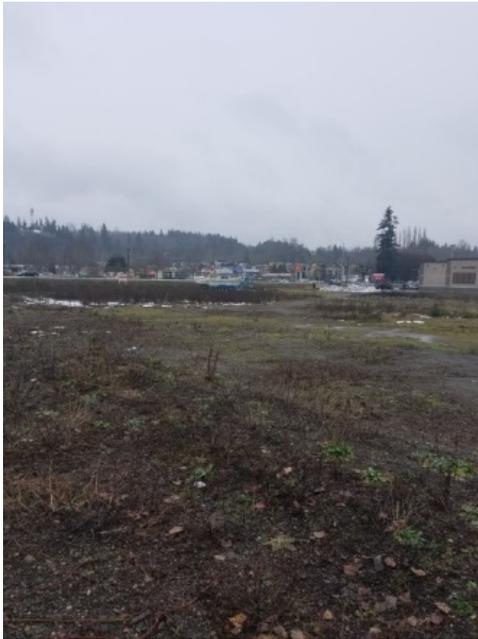
Photo 1. SE portions of site, facing south

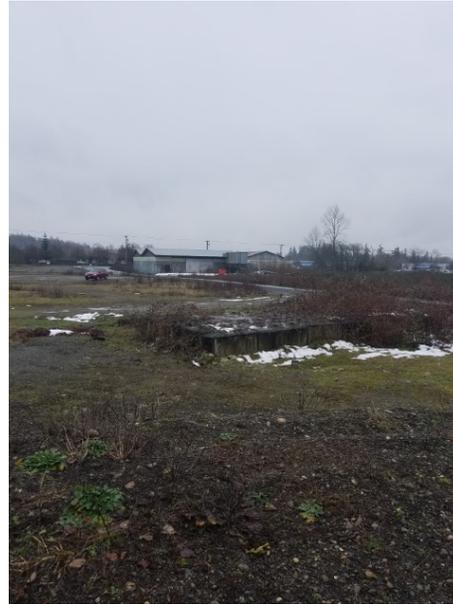
Photo 2. SW Portions of Site, facing south

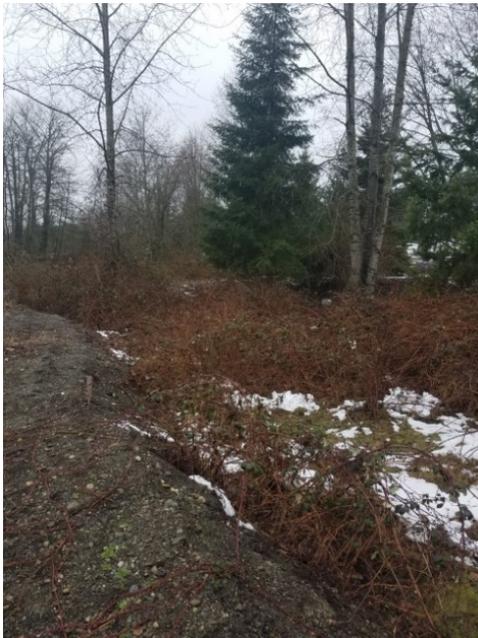
Photo 3. Berm Adjacent to Riparian Corridor

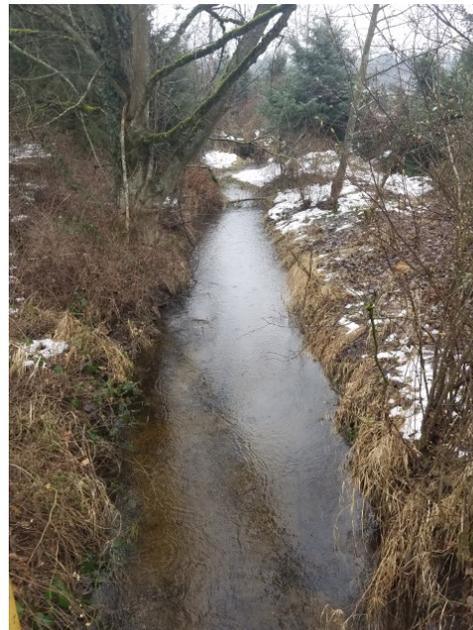
The channel as it flows through the project area has very little sinuosity and at the flow rates observed during the site visit exist as one long glide. Substrate is dominated by sand, silt, and small amounts of cobble. Sections of the creek are being choked by bittersweet nightshade (Photo 7). Flow restrictions in some of these

Photo 4. Portage Creek typical channel form

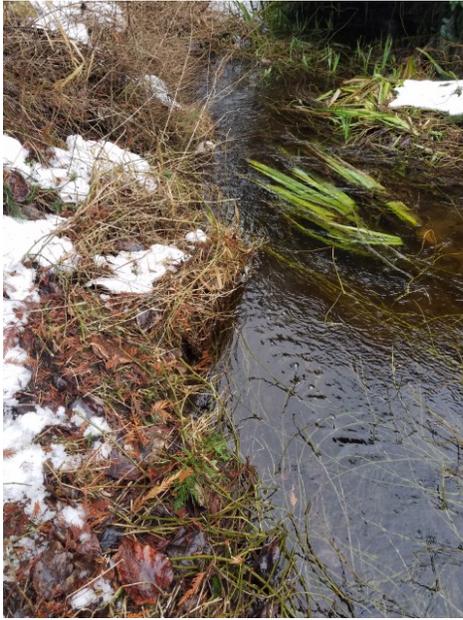
Photo 5. Obvious OHW mark

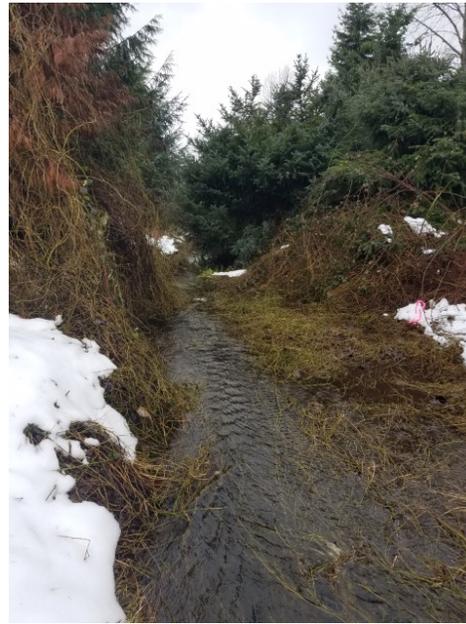
North of the gravel berm has not been subject to historic disturbance and has canopy, understory, and emergent vegetation layers. Canopy tree species include Douglas-fir (*Pseudotsuga menziesii*), red alder (*Alnus rubra*), and black cottonwood (*Populus trichocarpa*). Overall canopy closure is approximately 70%. Shrub understory scrub vegetation is a combination of native and non-native invasive species. Native shrubs include red-osier dogwood (*Cornus alba*), willow (*Salix sp.*), nootka rose (*Rosa nutkana*), pacific ninebark (*Physocarpus capitatus*), and isolated snowberry (*Symphoricarpos albus*). Non-native species include Himalayan blackberry and bittersweet (or climbing) nightshade (*Solanum dulcamara*). It is noteworthy that there are several locations in the eastern portion of the riparian corridor that have become overgrown with nightshade to the extent that it is likely interfering with normal channel flow and survival of native vegetation (Photos 6 and 7).

Photo 6. Bittersweet Nightshade Infestation

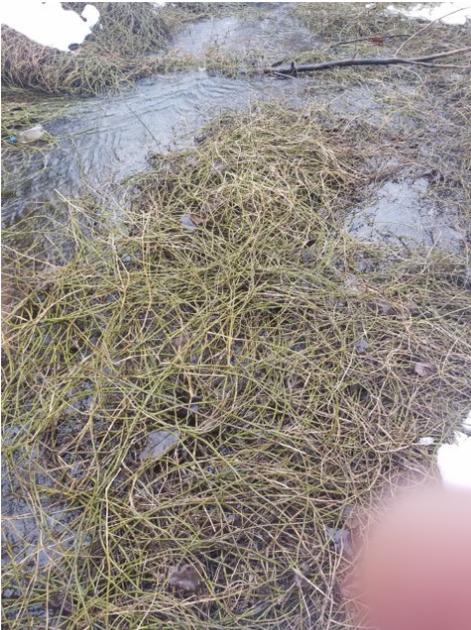
areas is causing small-scale localized bed scour due to constriction of the channel and resulting increases in water velocity. Large woody debris (LWD) in the creek are minimal although it should be noted that Portage Creek is a small perennial stream and does not typically have the hydraulic energy necessary for transport of LWD.

Photo 7. Nightshade Clogging Stream Channel
