Draft Drainage Report

Snohomish County PUD 25MW BESS

Draft Drainage Report
For
Snohomish County PUD 25MW BESS

DRAFT DRAINAGE REPORT

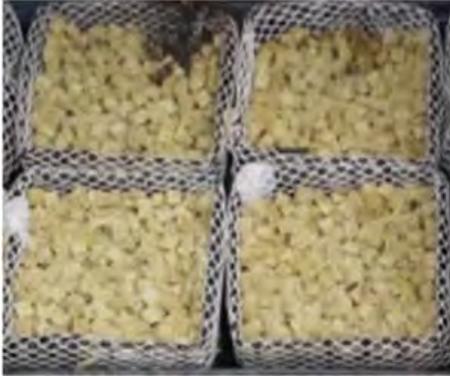
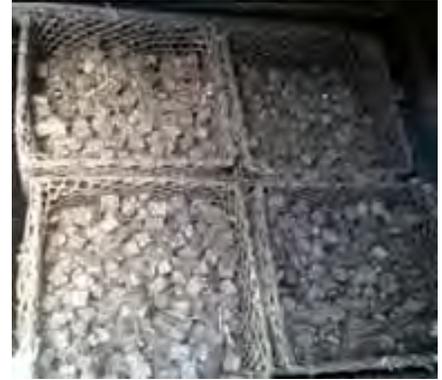
Exhausted
BioMediaGREEN
100%

5. Through visual observation, inspect the condition of the pre-filter cartridges. Look for excessive build-up of sediment on the cartridges, any build-up on the tops of the cartridges, or clogging of the holes. Record this information on the inspection form. The pre-filter cartridges can be further inspected by removing the cartridge tops and assessing the color of the BioMediaGREEN filter cubes (requires entry into pre-treatment chamber - see notes previous notes regarding confined space entry). Record the color of the material. New material is a light green color. As the media becomes clogged, it will turn darker in color, eventually becoming dark brown or black. The closer to black the media is the higher percentage that the media is exhausted and in need of replacement.

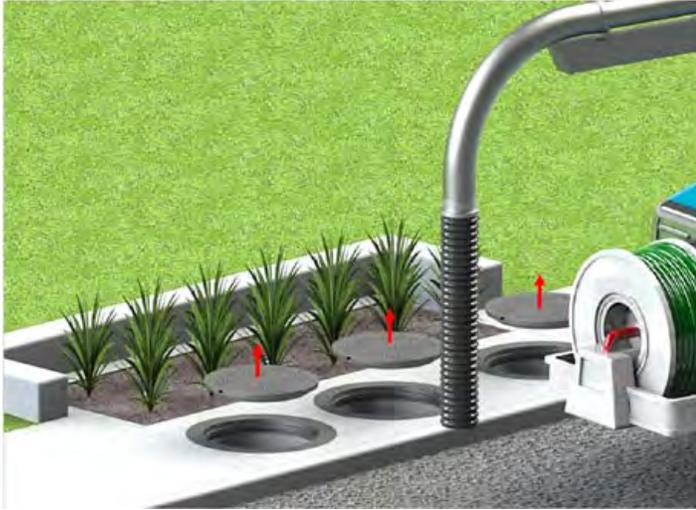
1. ACCESS COVER REMOVAL

Upon determining that the vault is safe for entry, remove all access cover(s) and position the vacuum truck accordingly.

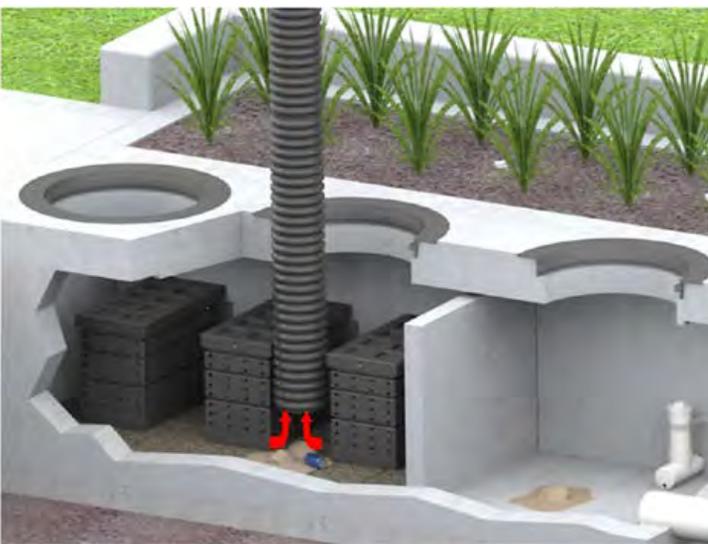
With the pressure washer, spray down pollutants accumulated on the walls and floors of the pre-treatment and discharge chambers. Then wash any accumulated sediment from the pre-filter cartridge(s).

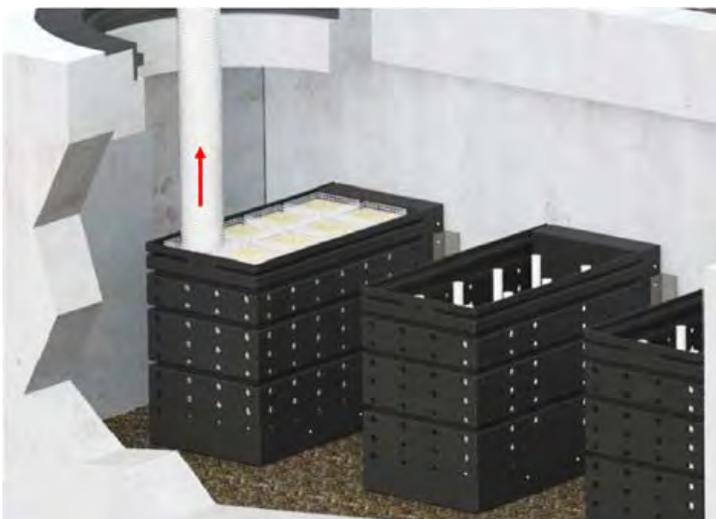
4. PRE-FILTER CARTRIDGE LID REMOVAL

After successfully cleaning out the pre-treatment chamber, enter the chamber and remove the lid(s) from the pre-filter cartridge(s) by removing the two thumb screws. (Older pre-filter cartridges have two bolts holding the lids on that require a 7/16" socket to remove)

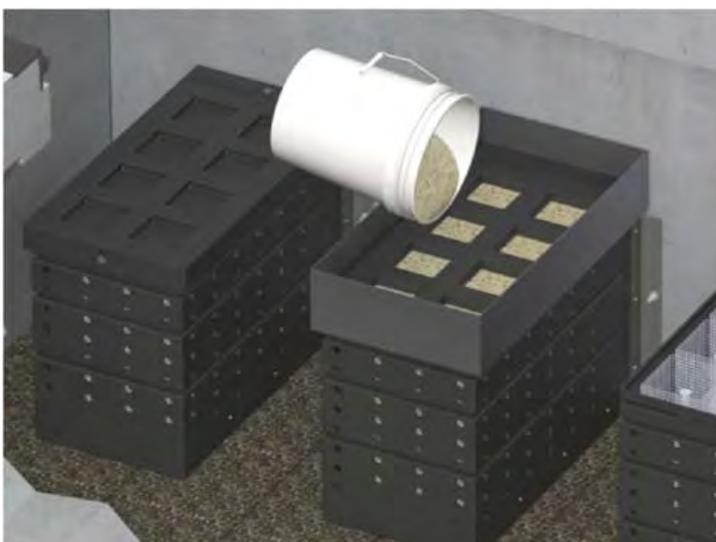
Utilize the vacuum truck hose or hose extension to remove the filter media from each of the individual media cages. Once filter media has been sucked out, use a pressure washer to spray down the inside of the cartridge and its media cages. Remove cleaned media cages and place to the side. Once removed, the vacuum hose can be inserted into the cartridge to vacuum out any remaining material near the bottom of the cartridge.

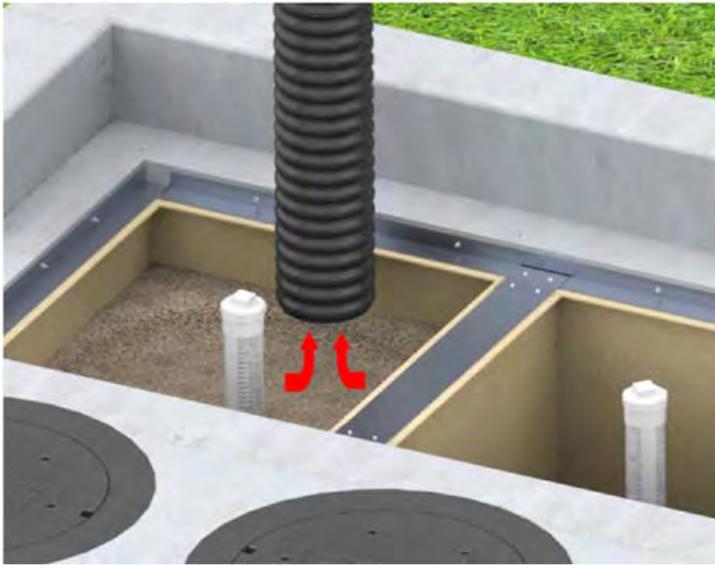
As with all biofilter systems, at some point the biofiltration media will need to be replaced, either due to physical clogging or sorptive exhaustion (for dissolved pollutants) of the media ion exchange capacity (to remove dissolved metals and phosphorous). The general life of this media is 10 to 20 years based on site specific conditions and pollutant loading, so replacing the biofiltration media should not be a common occurrence. In the event that the biofiltration media requires replacement, contact one of Contech's Maintenance Team members at <https://www.conteches.com/maintenance> to order new biofiltration media. The quantity of media needed can be determined by providing the model number and unit depth. Media will be provided in super sacks for easy installation. Each sack will weigh between 1,000 and 2,000 lbs. Biofiltration media replacement can be done following the steps below:

1. VACUUM EXISTING BIOFILTRATION MEDIA

Remove the mulch and vegetation to access the biofiltration media, and then position the vacuum truck accordingly. Utilize the vacuum truck to vacuum out all the media. Once all media is removed, use the pressure washer to spray down all the netting and underdrain systems on the inside of the media containment cage. Vacuum out any remaining debris after spraying down netting. Inspect the netting for any damage or holes. If the netting is damaged, it can be repaired or replaced with guidance by the manufacturer.

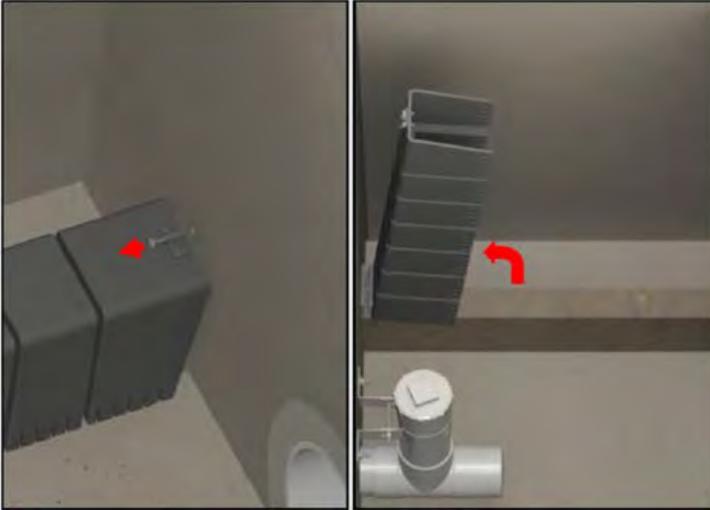
1. REMOVE EXISTING DRAIN DOWN MEDIA

Pull knob back to unlock the locking mechanism and lift the drain down filter housing to remove the used BioMediaGREEN filter block.

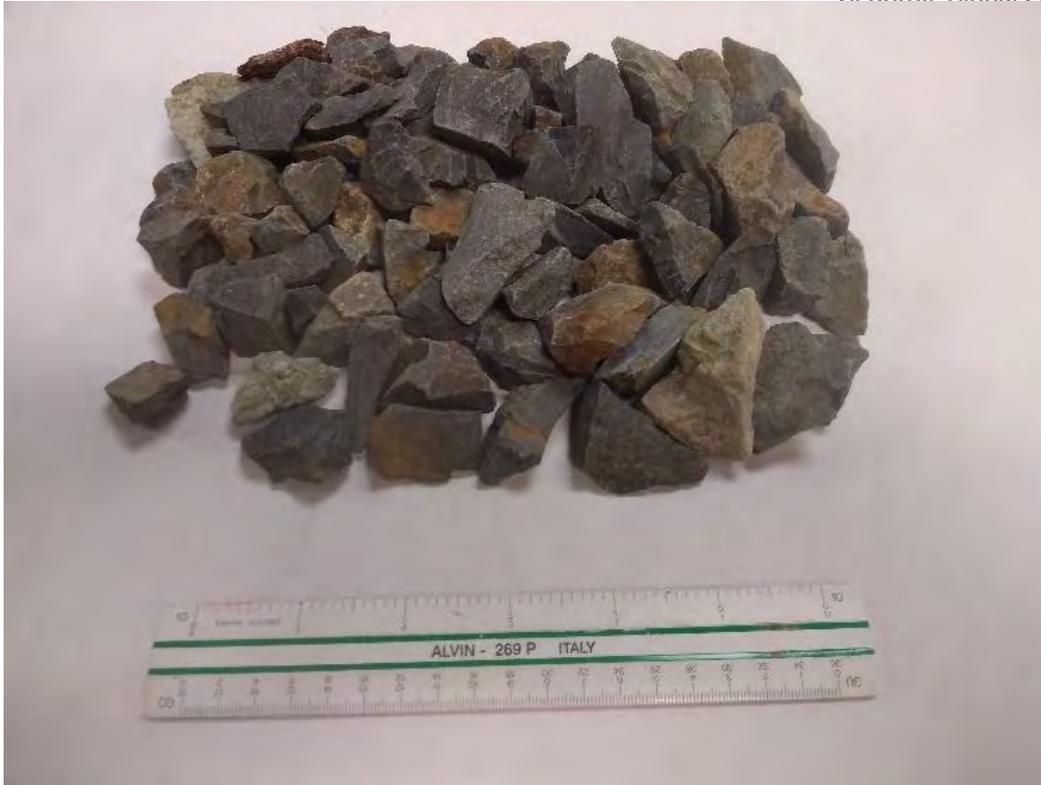
In 2013, ZGA tested what Iron Mountain Quarry was selling as "substation rock" at the time. This was a 1.5-inch minus product, all crushed, and just slightly coarser than the 1.25-inch minus CSBC. The tested material had a void ratio of 45 percent. A photograph of this substation rock is shown below as a means to illustrate its angularity and obvious functional high void ratio even when compacted.
