GEOTECHNICAL ENGINEERING REPORT NORTH COUNTY SPECIAL USE PERMIT 17601 – 59th Avenue NE Arlington, Washington

Project No. 2679.01
2 August 2023

Prepared for:
Snohomish County PUD No. 1

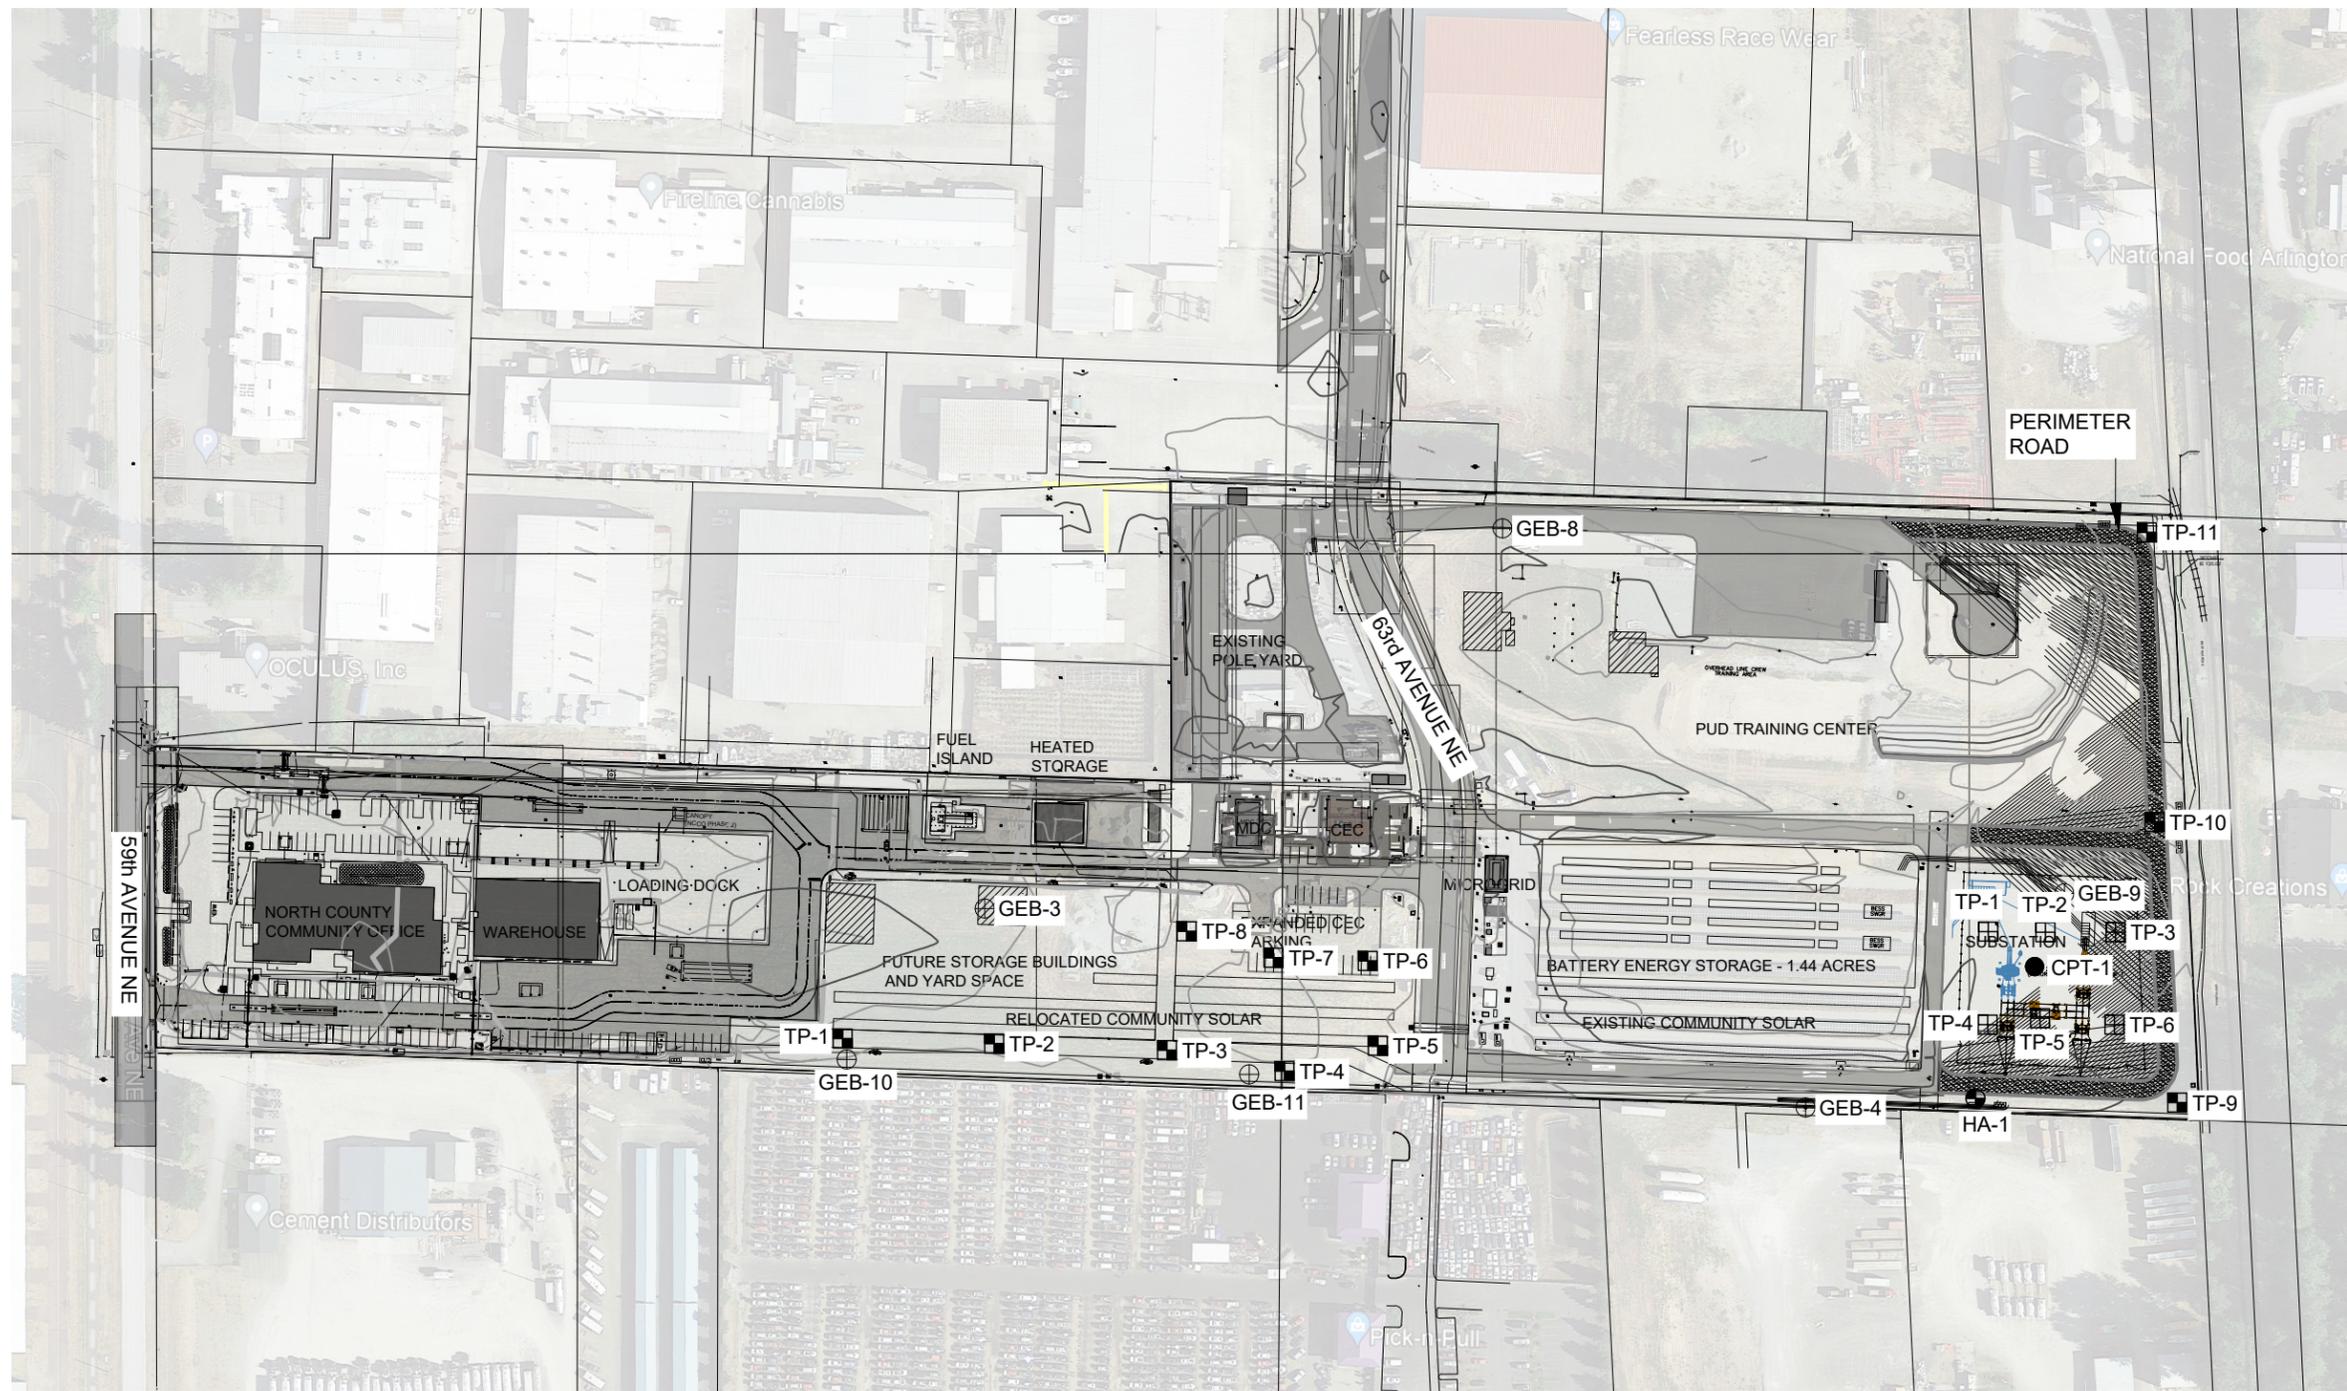
Our understanding of subsurface conditions is based upon observation of eleven test pits and one hand boring. In addition, we reviewed the logs of borings and test pits completed by GeoEngineers through most of the site and explorations recently completed by ZGA at the Crosswind substation site. Approximate exploration locations, as well as pertinent surface features, are shown on Figure 1. Soil conditions are summarized below.

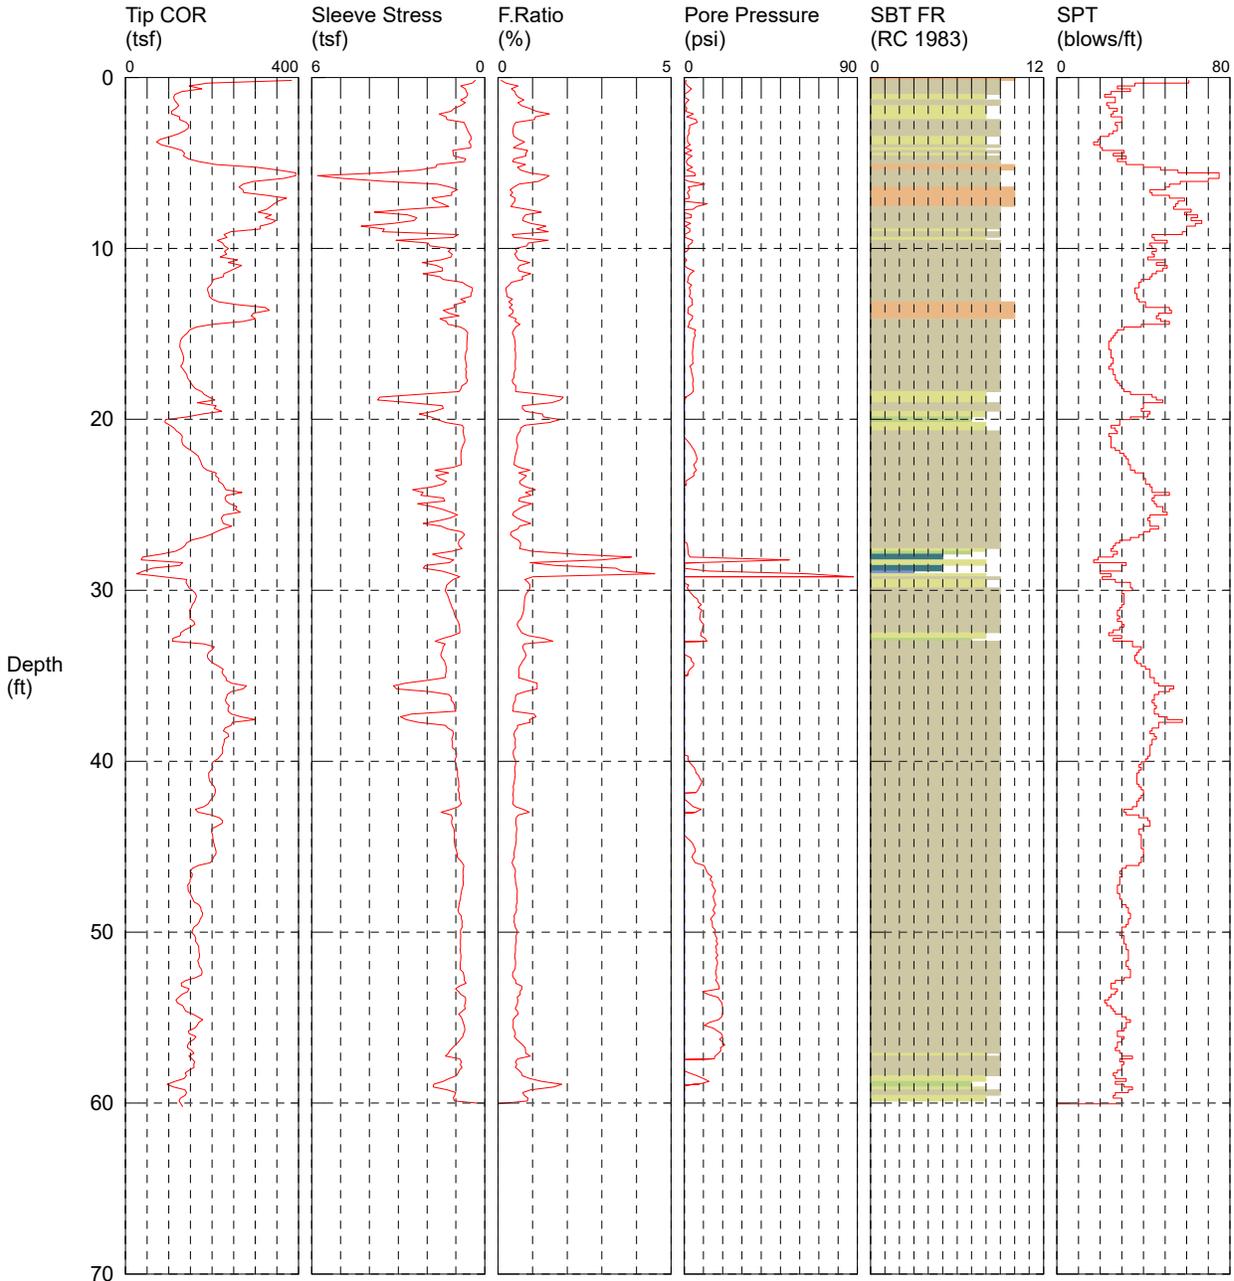
OPERATOR: Forinash
 CONE ID: DDG1351
 TEST DATE: 2/24/2023 9:46:02 AM
 Coring: 0ft
 Backfill: 20% Bentonite Slurry + Bentonite Chip
 Surface Patch: None

TOTAL DEPTH: 60.203 ft

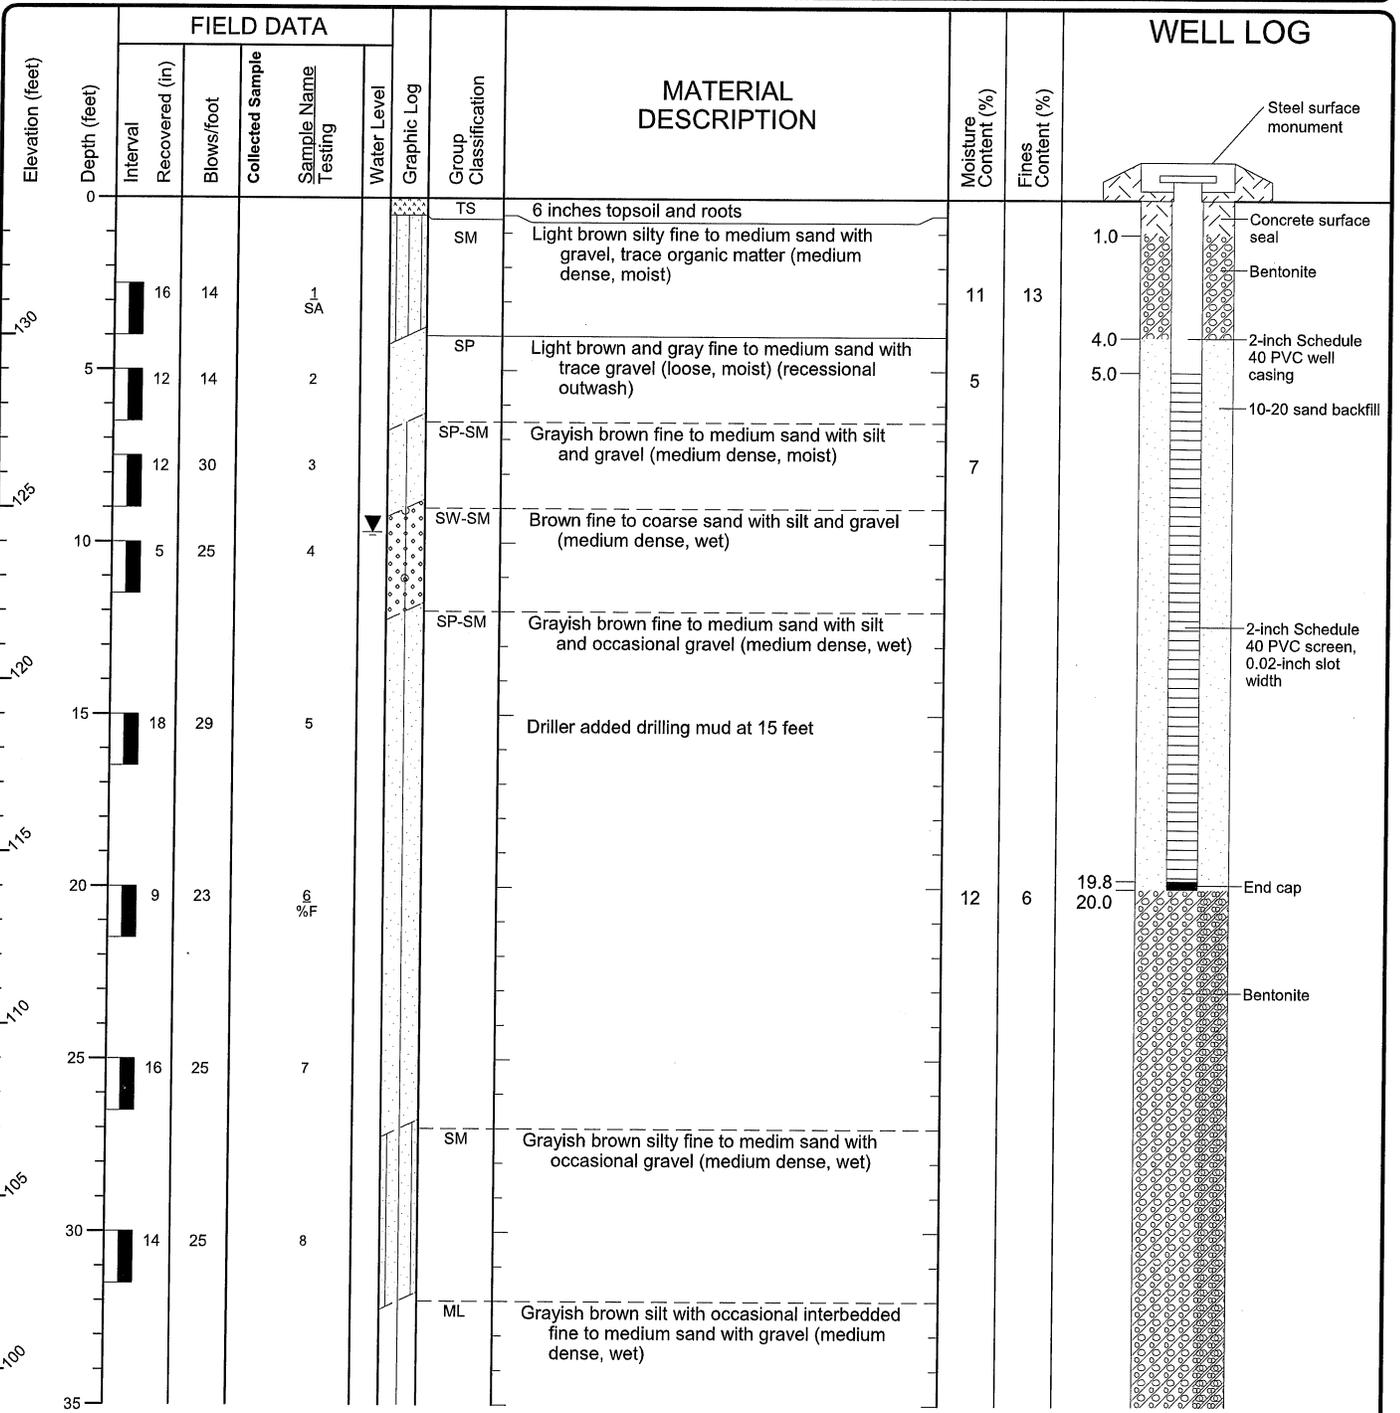
Log of Boring B-3

Start Drilled 6/14/2012	End 6/14/2012	Total Depth (ft) 51.5	Logged By SMJ	Checked By BPD	Driller Geologic Drill Explorations, Inc.	Drilling Method Hollow-stem Auger
Hammer Data Autohammer 140 (lbs) / 30 (in) Drop	Drilling Equipment Diedrich D-50 Track Rig		DOE Well I.D.: BHJ197 A 2 (in) well was installed on to a depth of 20 (ft).			
Surface Elevation (ft) Vertical Datum 134 NAVD88	Top of Casing Elevation (ft)		Groundwater Date Measured 6/25/2012			
Easting (X) Northing (Y)	Horizontal Datum		Depth to Water (ft) 9.7		Elevation (ft) 124.3	
Notes: Elevation estimated from base survey map

Notes: See Figure A-1 for explanation of symbols.
Elevation estimated from base survey map

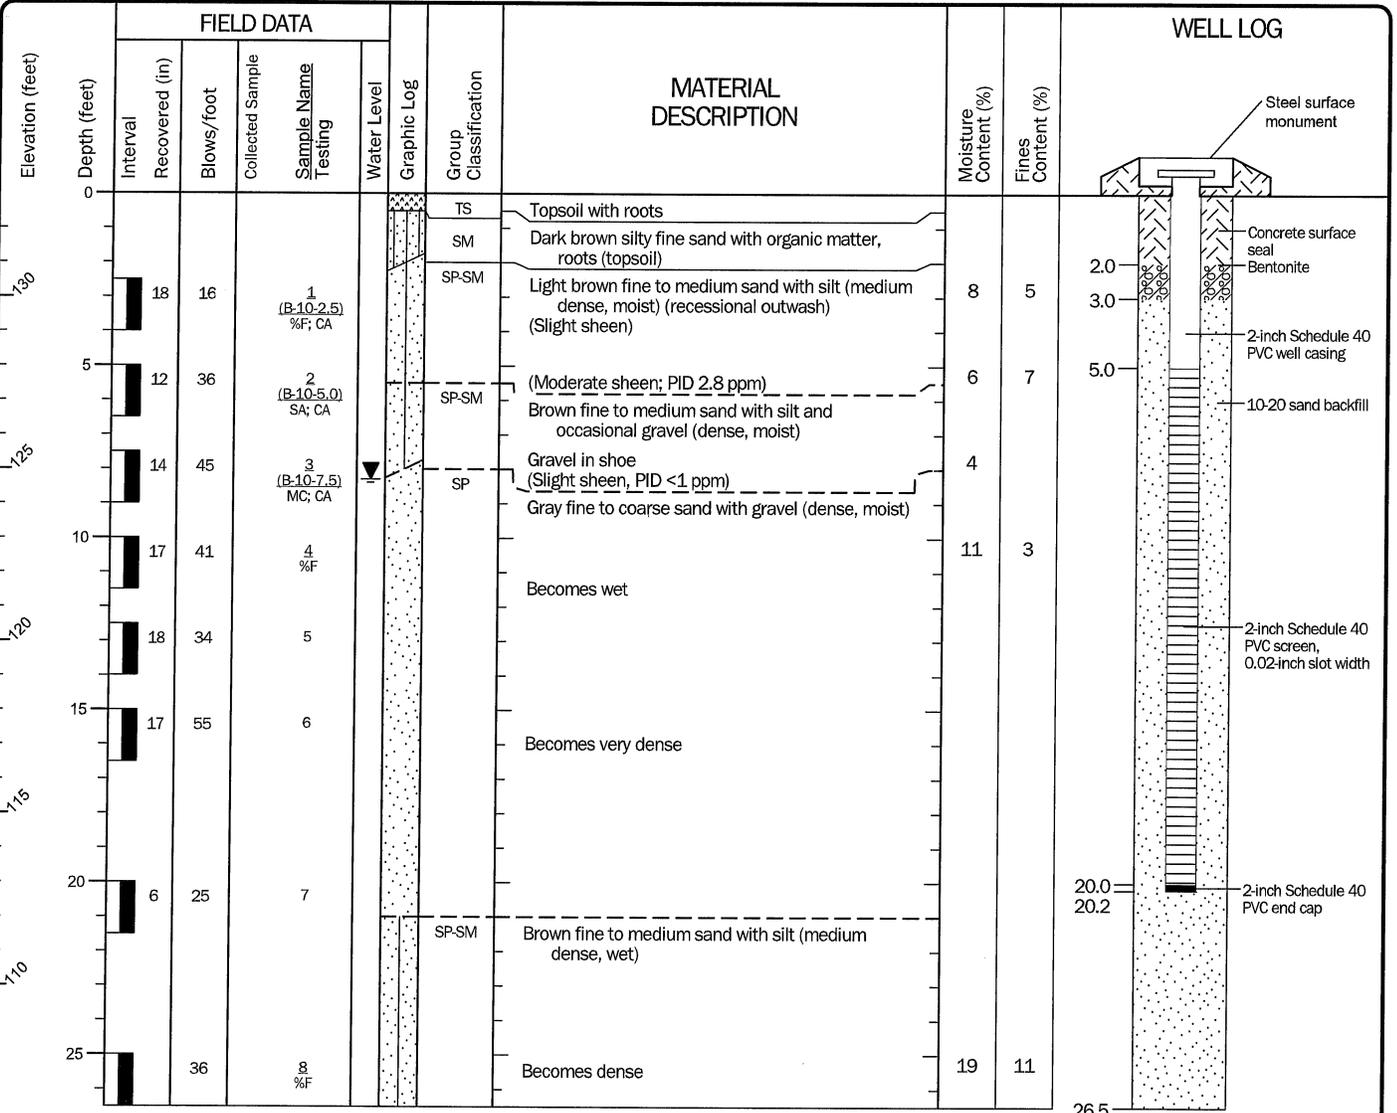
Log of Boring B-10

Drilled	Start 3/8/2017	End 3/8/2017	Total Depth (ft)	26.5	Logged By Checked By	NS KMS	Driller	Holocene Drilling, Inc.	Drilling Method	Hollow-stem Auger
Hammer Data	Autohammer 140 (lbs) / 30 (in) Drop		Drilling Equipment		Diedrich D50 Track-mounted			DOE Well I.D.: BJY260 A 2 (in) well was installed on 3/8/2017 to a depth of 20 (ft).		
Surface Elevation (ft)		133 Vertical Datum NAVD88		Top of Casing Elevation (ft)		133		Groundwater Date Measured		
Easting (X) Northing (Y)		1319707 424320		Horizontal Datum		WA State Plane North NAD83 (feet)		Depth to Water (ft)		Elevation (ft)
								4/13/2017		8.3 124.7
Notes: Environmental field screening was completed on each soil sample. Sheen and head space vapor were not observed unless otherwise noted.

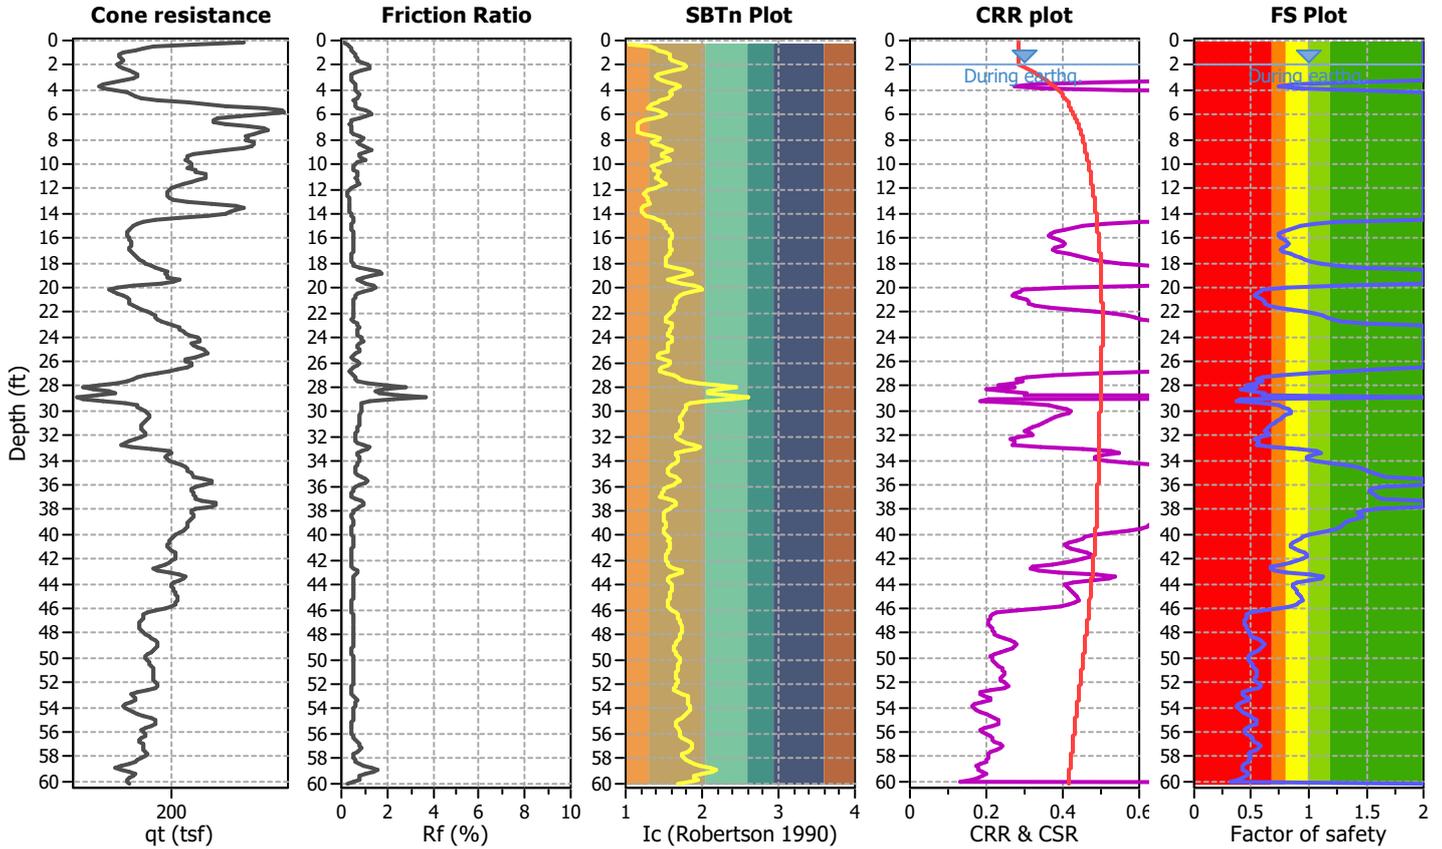
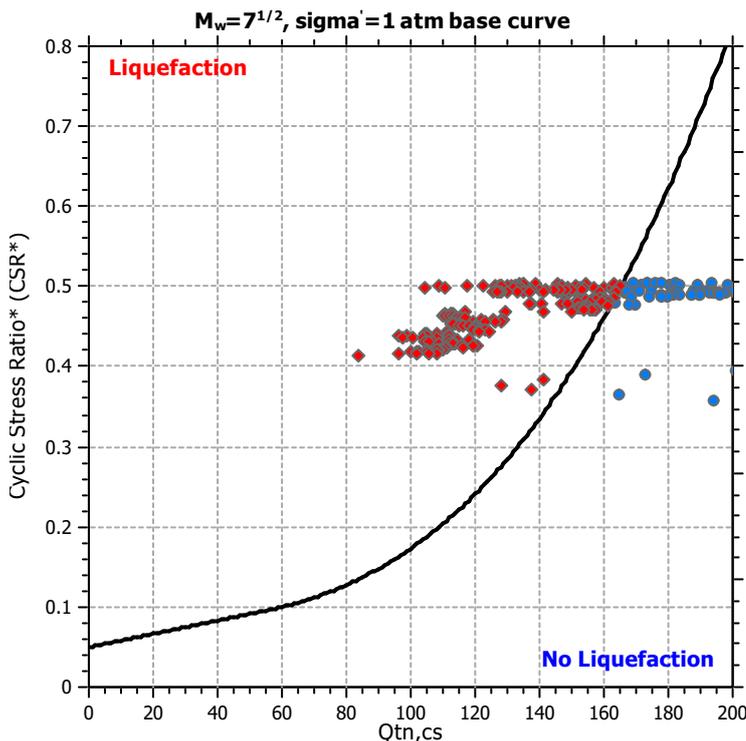
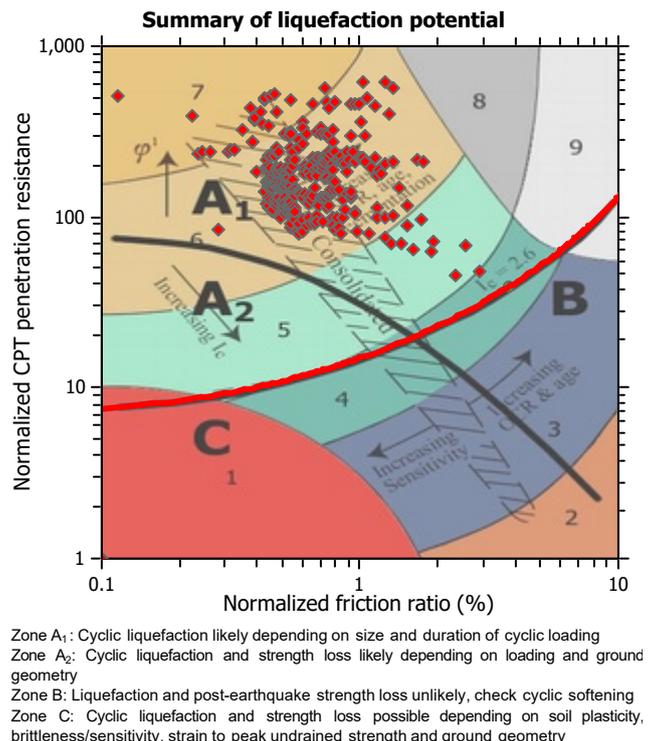
Input parameters and analysis data

Analysis method:	NCEER (1998)	G.W.T. (in-situ):	7.00 ft	Use fill:	No	Clay like behavior applied:	Sands only
Fines correction method:	NCEER (1998)	G.W.T. (earthq.):	2.00 ft	Fill height:	N/A	Limit depth applied:	No
Points to test:	Based on Ic value	Average results interval:	3	Fill weight:	N/A	Limit depth:	N/A
Earthquake magnitude M_w :	7.03	Ic cut-off value:	2.60	Trans. detect. applied:	No	MSF method:	Method based
Peak ground acceleration:	0.52	Unit weight calculation:	Based on SBT	K_o applied:	Yes

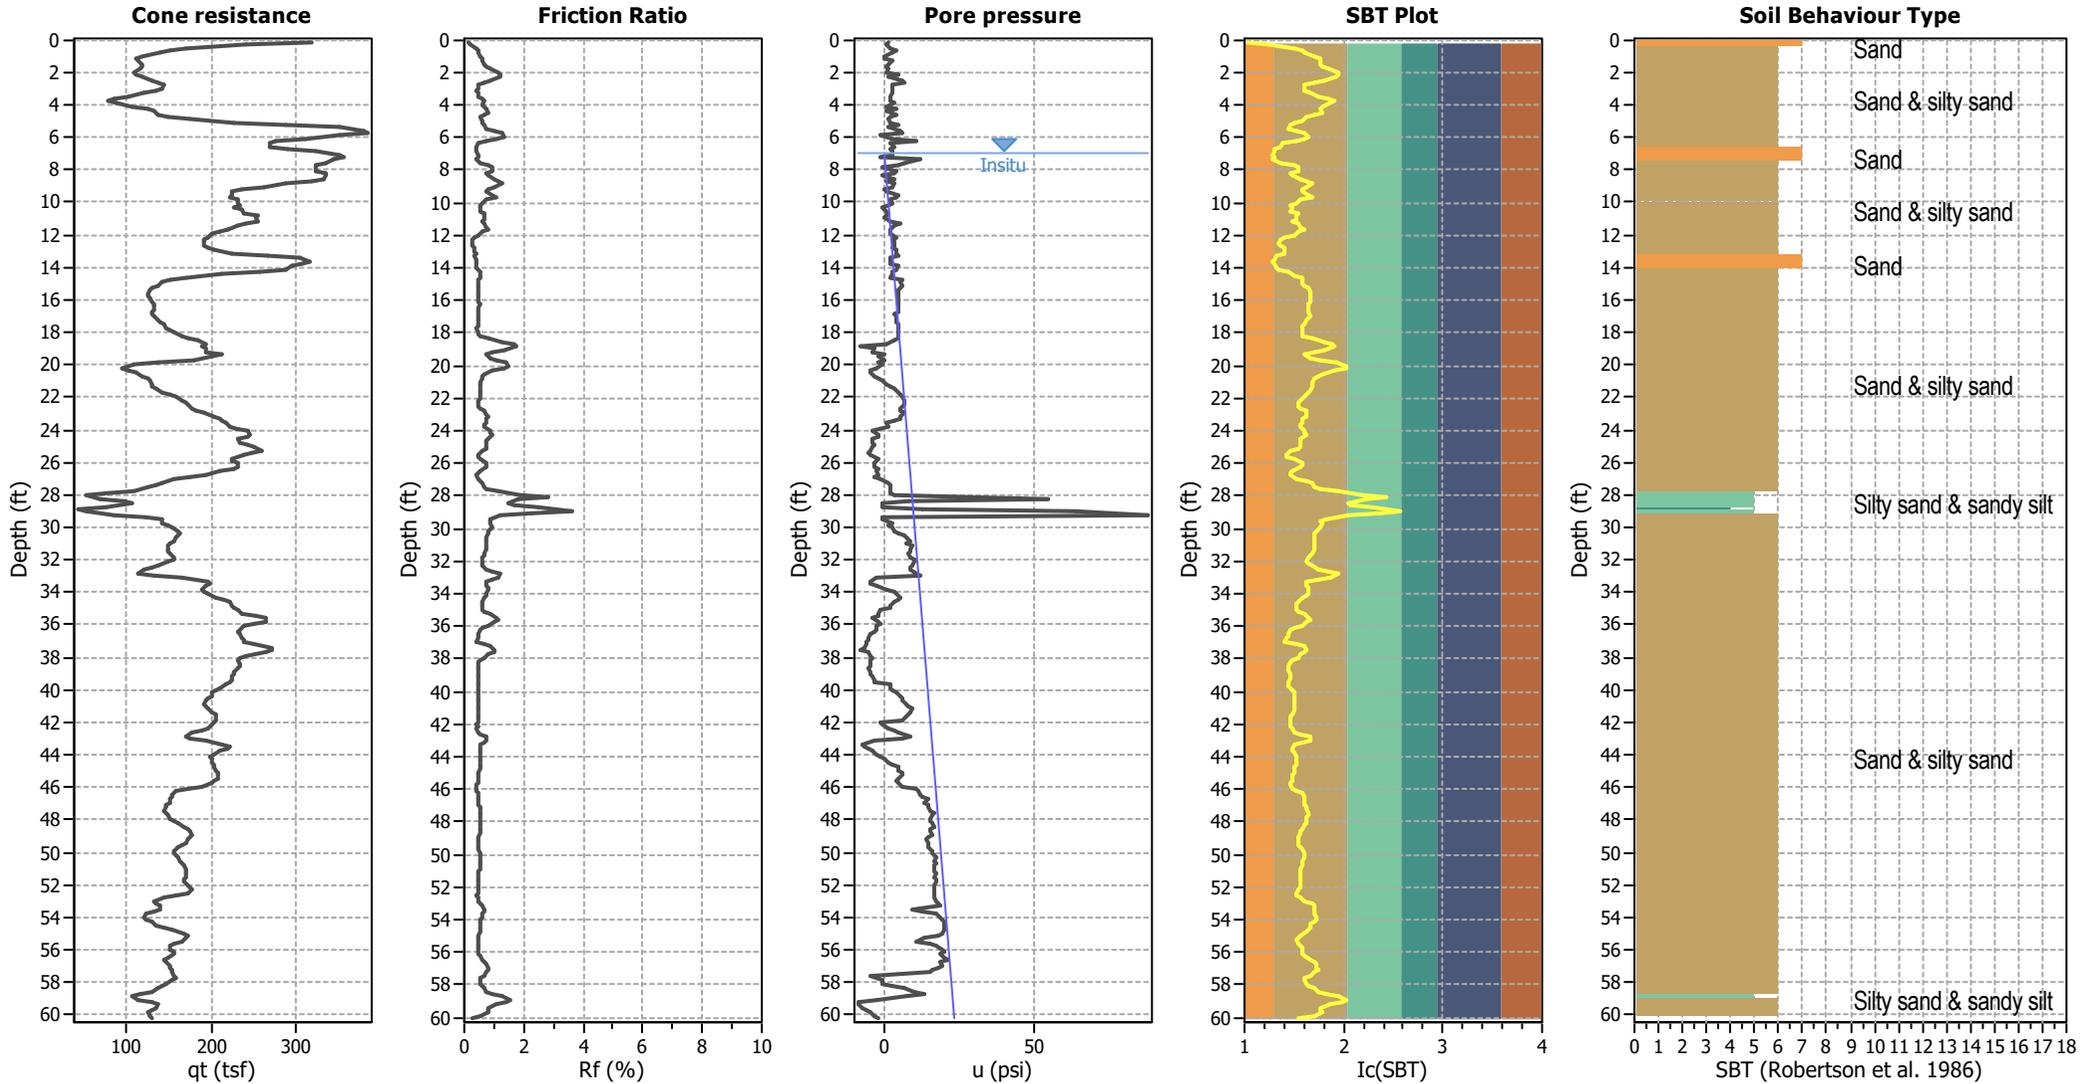
CPT basic interpretation plots

Input parameters and analysis data

Analysis method:	NCEER (1998)	Depth to water table (erthq.):	2.00 ft	Fill weight:	N/A
Fines correction method:	NCEER (1998)	Average results interval:	3	Transition detect. applied:	No
Points to test:	Based on Ic value	Ic cut-off value:	2.60	K_0 applied:	Yes
Earthquake magnitude M_w :	7.03	Unit weight calculation:	Based on SBT	Clay like behavior applied:	Sands only
Peak ground acceleration:	0.52	Use fill:	No	Limit depth applied:	No
Depth to water table (insitu):	7.00 ft	Fill height:	N/A	Limit depth:	N/A

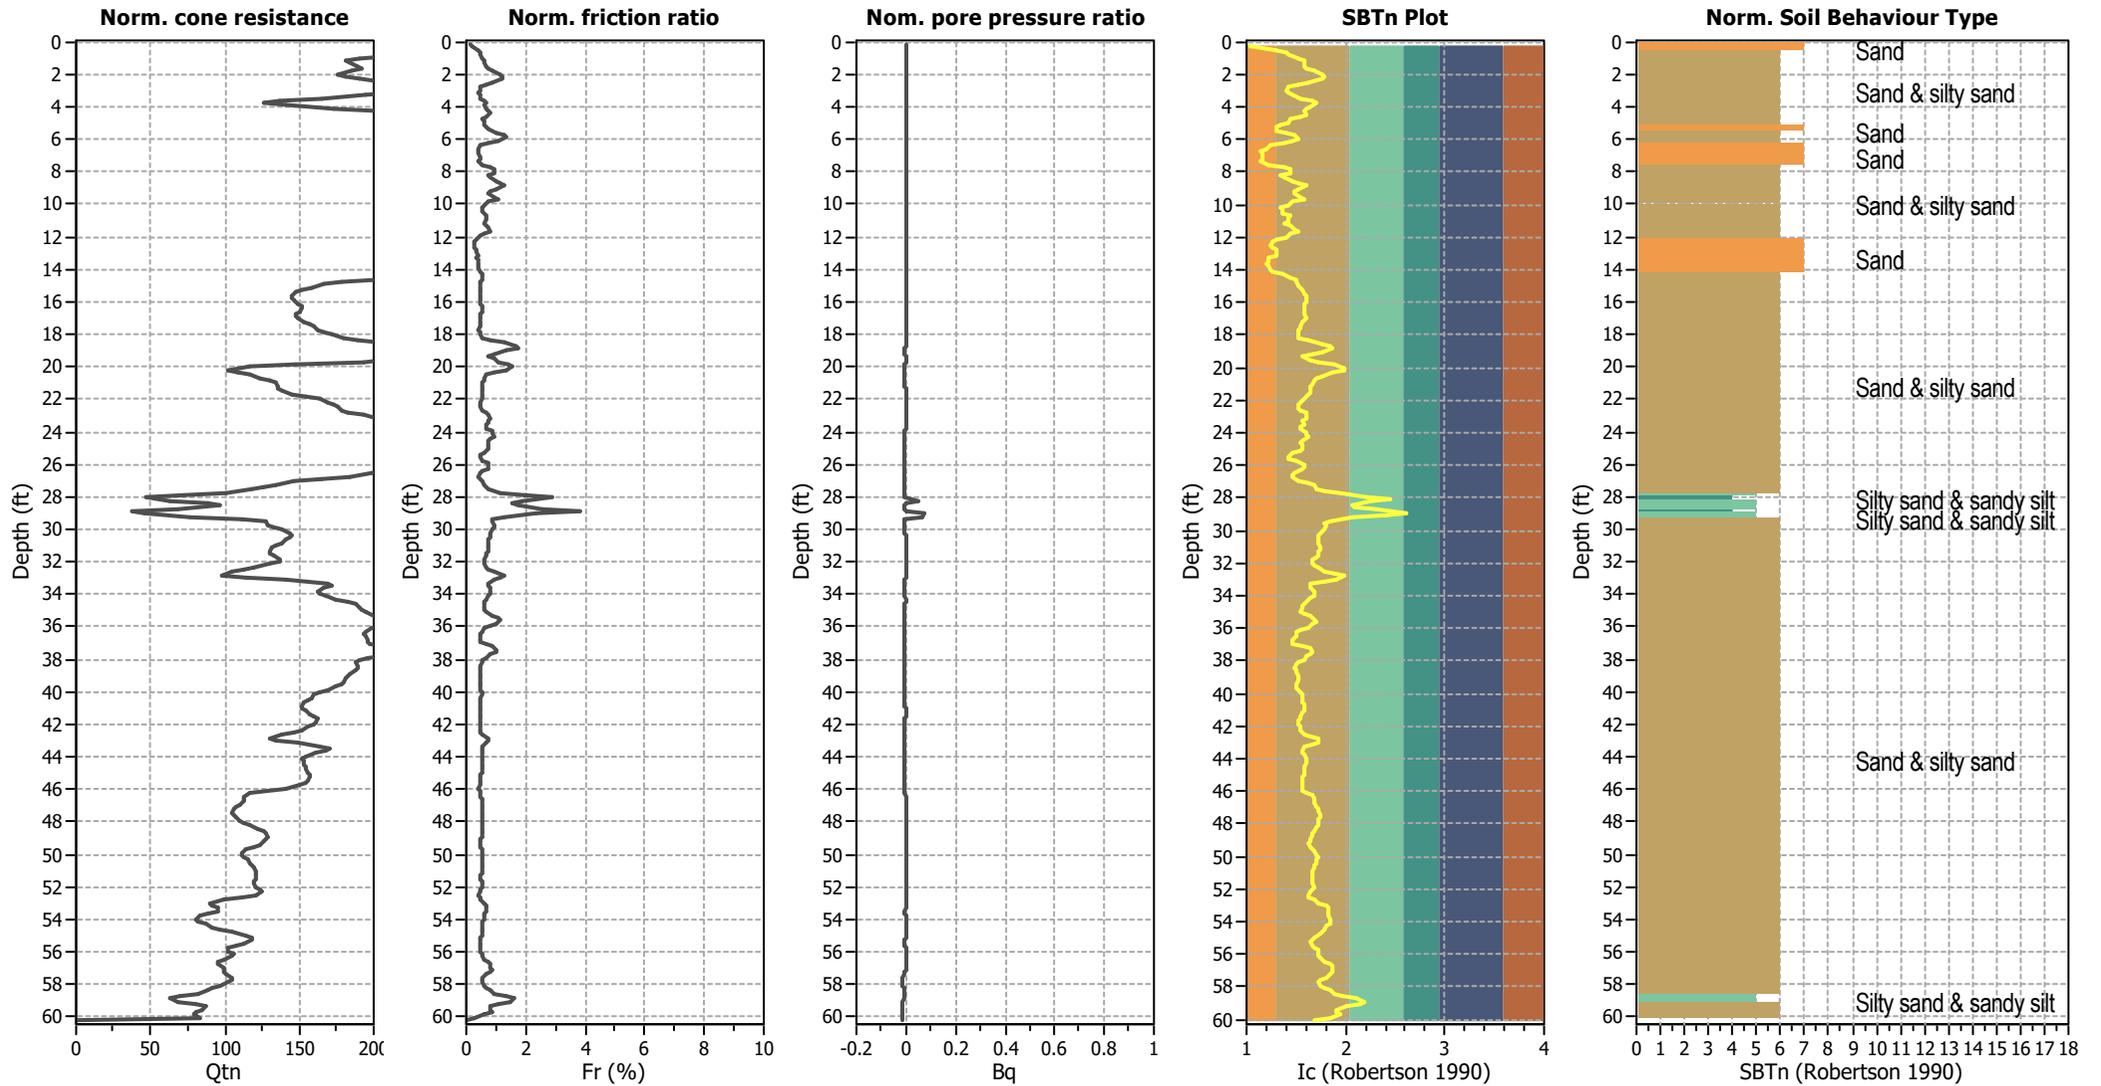
CPT basic interpretation plots (normalized)

Input parameters and analysis data

Analysis method:	NCEER (1998)	Depth to water table (erthq.):	2.00 ft	Fill weight:	N/A
Fines correction method:	NCEER (1998)	Average results interval:	3	Transition detect. applied:	No
Points to test:	Based on Ic value	Ic cut-off value:	2.60	K_0 applied:	Yes
Earthquake magnitude M_w :	7.03	Unit weight calculation:	Based on SBT	Clay like behavior applied:	Sands only
Peak ground acceleration:	0.52	Use fill:	No	Limit depth applied:	No
Depth to water table (insitu):	7.00 ft	Fill height:	N/A	Limit depth:	N/A

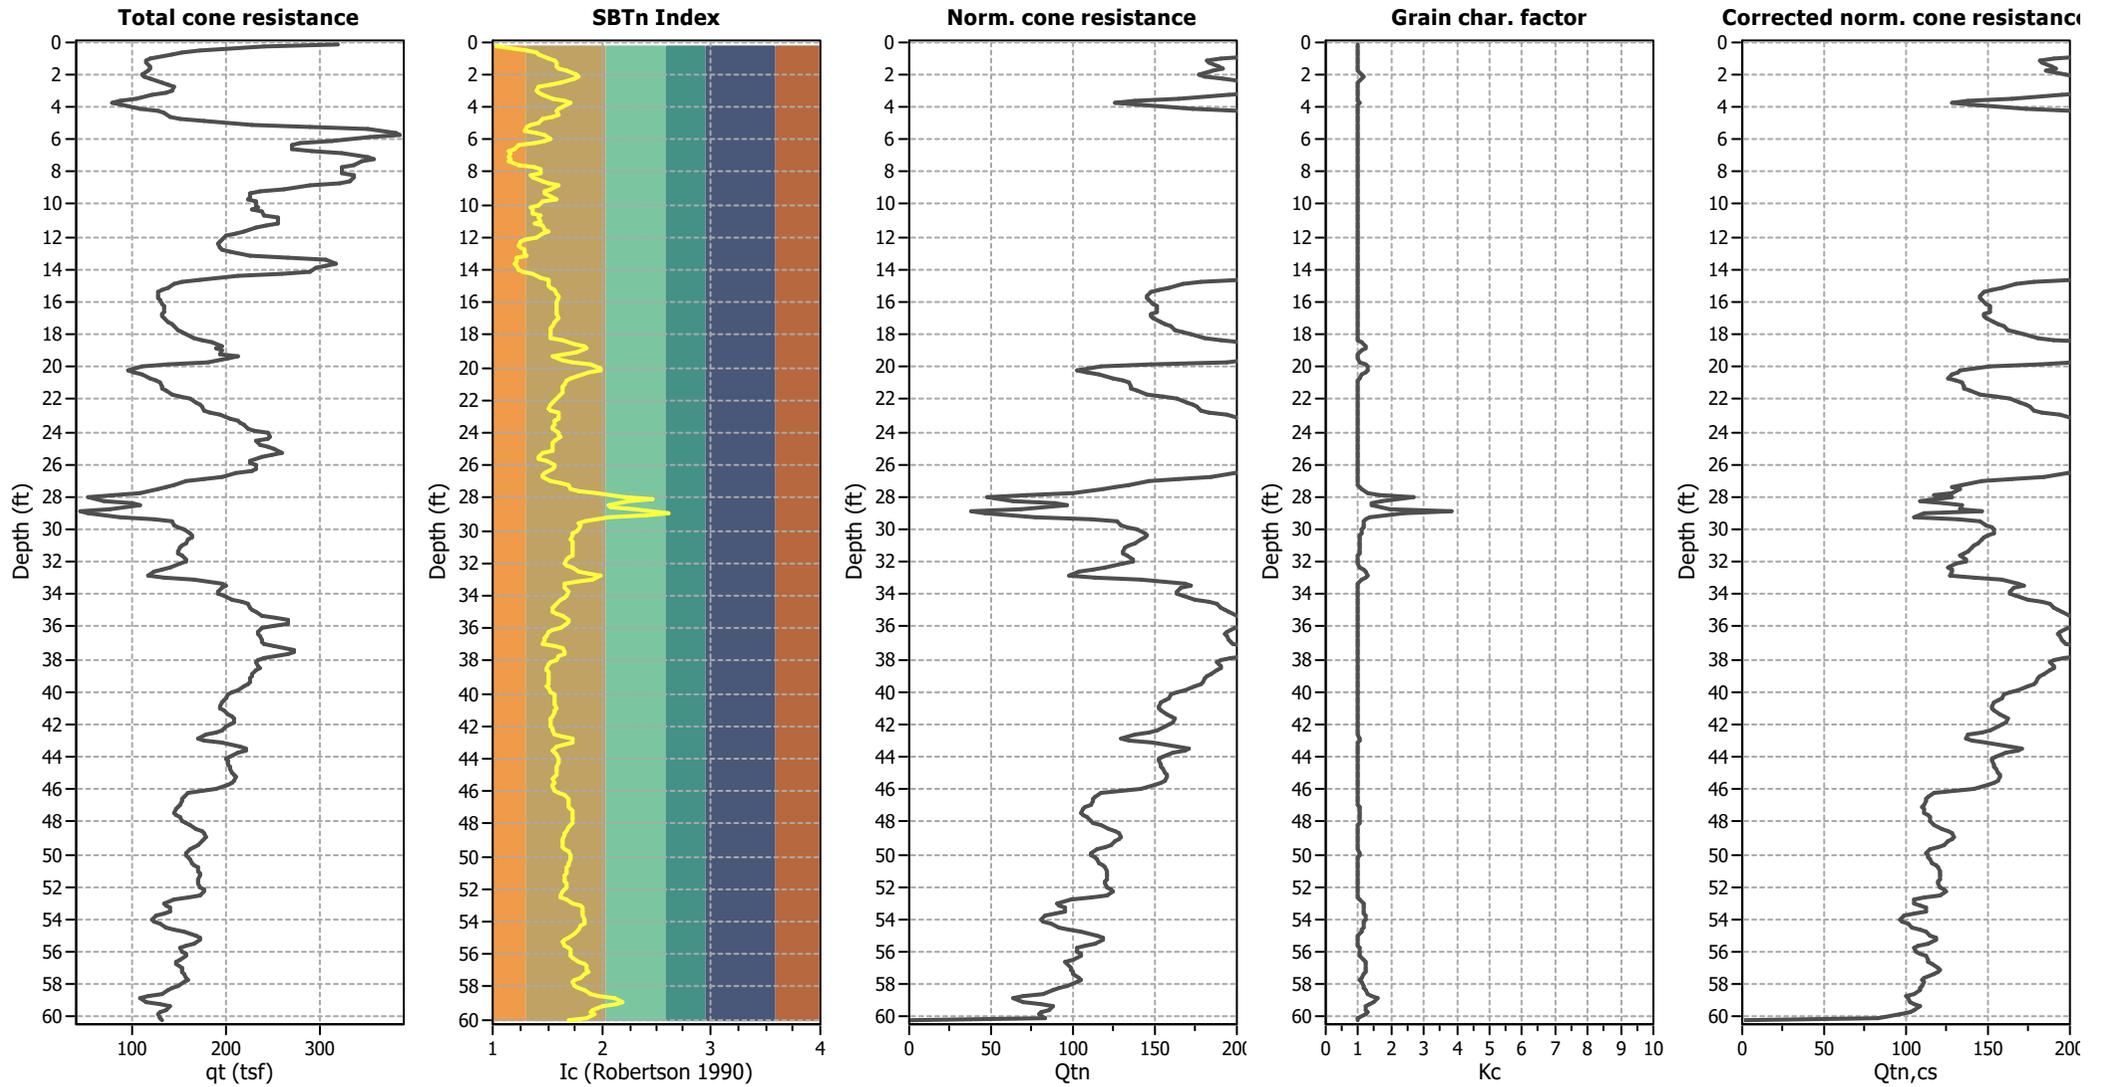
Liquefaction analysis overall plots (intermediate results)

Input parameters and analysis data

Analysis method:	NCEER (1998)	Depth to water table (erthq.):	2.00 ft	Fill weight:	N/A
Fines correction method:	NCEER (1998)	Average results interval:	3	Transition detect. applied:	No
Points to test:	Based on Ic value	Ic cut-off value:	2.60	K_0 applied:	Yes
Earthquake magnitude M_w :	7.03	Unit weight calculation:	Based on SBT	Clay like behavior applied:	Sands only
Peak ground acceleration:	0.52	Use fill:	No	Limit depth applied:	No
Depth to water table (insitu):	7.00 ft	Fill height:	N/A	Limit depth:	N/A

Liquefaction Settlement: The site is mantled by a generally dense and non-liquefiable crust on the order of 15 feet thick. As such, liquefaction-indicated settlements observed at the surface will initiate from potentially liquefiable layers present below the non-liquefiable crust. Research and case histories have shown that the expression of liquefaction-induced settlement at the ground surface is a function of the depth of the liquefiable layers, with deeper liquefiable layers contributing less to ground surface settlement than similar thickness shallow liquefiable layers (Cetin et al., 2009). Cetin proposed use of a “depth weighting factor” (DF_i) that reduces the impact of deep liquefiable layers on the estimated surface settlement. This factor is included in the CLiq program and was used in our settlement analysis.

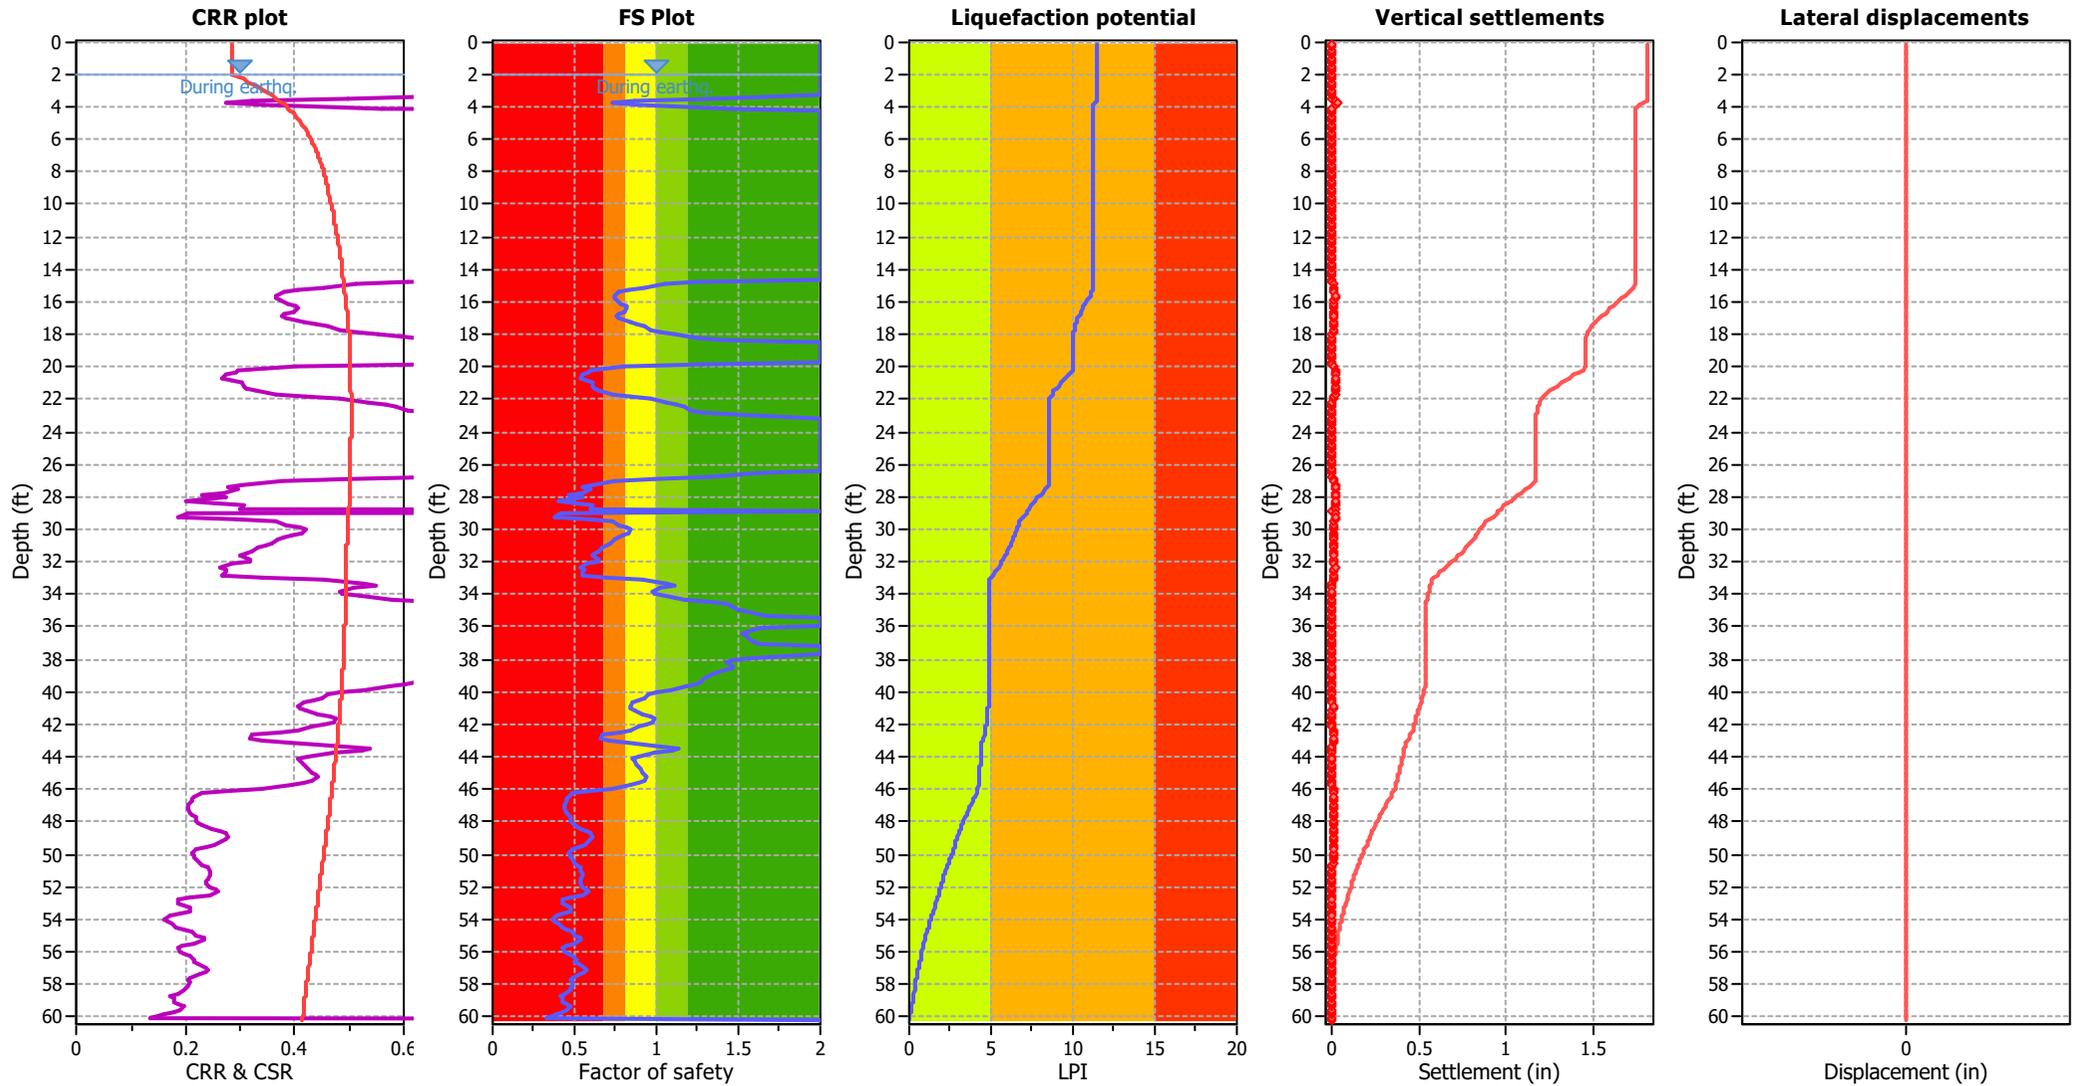
Liquefaction analysis overall plots

Input parameters and analysis data

Analysis method:	NCEER (1998)	Depth to water table (earthq.):	2.00 ft	Fill weight:	N/A
Fines correction method:	NCEER (1998)	Average results interval:	3	Transition detect. applied:	No
Points to test:	Based on Ic value	Ic cut-off value:	2.60	K_0 applied:	Yes
Earthquake magnitude M_w :	7.03	Unit weight calculation:	Based on SBT	Clay like behavior applied:	Sands only
Peak ground acceleration:	0.52	Use fill:	No	Limit depth applied:	No
Depth to water table (insitu):	7.00 ft	Fill height:	N/A	Limit depth:	N/A
