WETLAND AND FISH AND WILDLIFE HABITAT ASSESSMENT AND CONCEPTUAL BUFFER AVERAGING PLAN

ARLINGTON APARTMENTS

JULY 2024
REVISED JUNE 2025

21117 59TH AVENUE NORTHEAST
ARLINGTON, WASHINGTON 98223

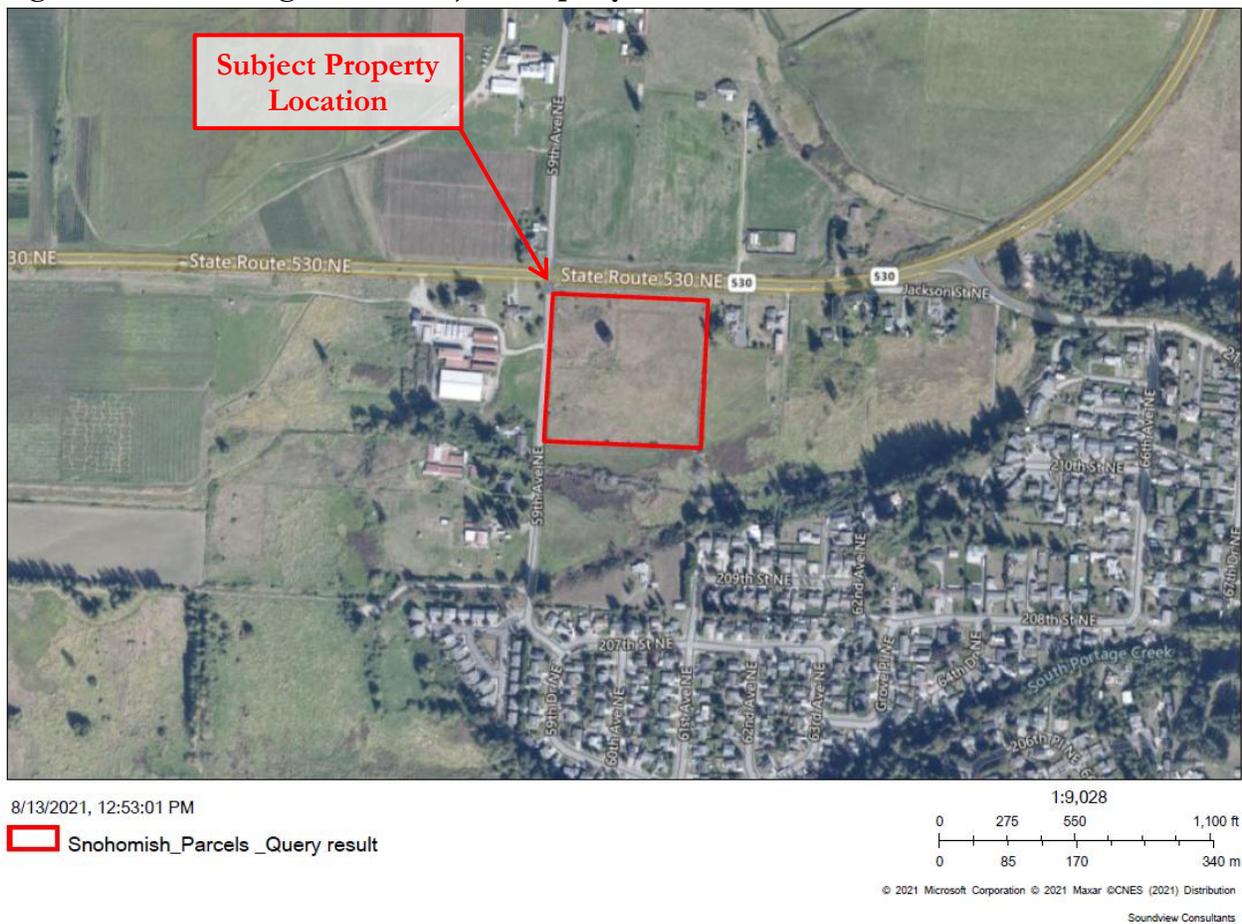
Figure 2. Aerial Image of the Subject Property.

The subject property is located in the City of Arlington in a mixed-use rural/ residential setting and consists entirely of undeveloped unmaintained pastureland (Figure 2). The subject property abuts Highway 530 to the north; a single-family home and open lawns to the east; an undeveloped riparian area to the south, and 59th Avenue Northeast to the west with single-family residences. Topography onsite is relatively flat, generally sloping north to south, with elevations ranging from approximately 60 feet above mean sea level (amsl) to approximately 65 feet amsl. A Snohomish County contours map is provided in Appendix B1. The study area is within the Stillaguamish River Watershed (Water Resources Inventory Area 5).

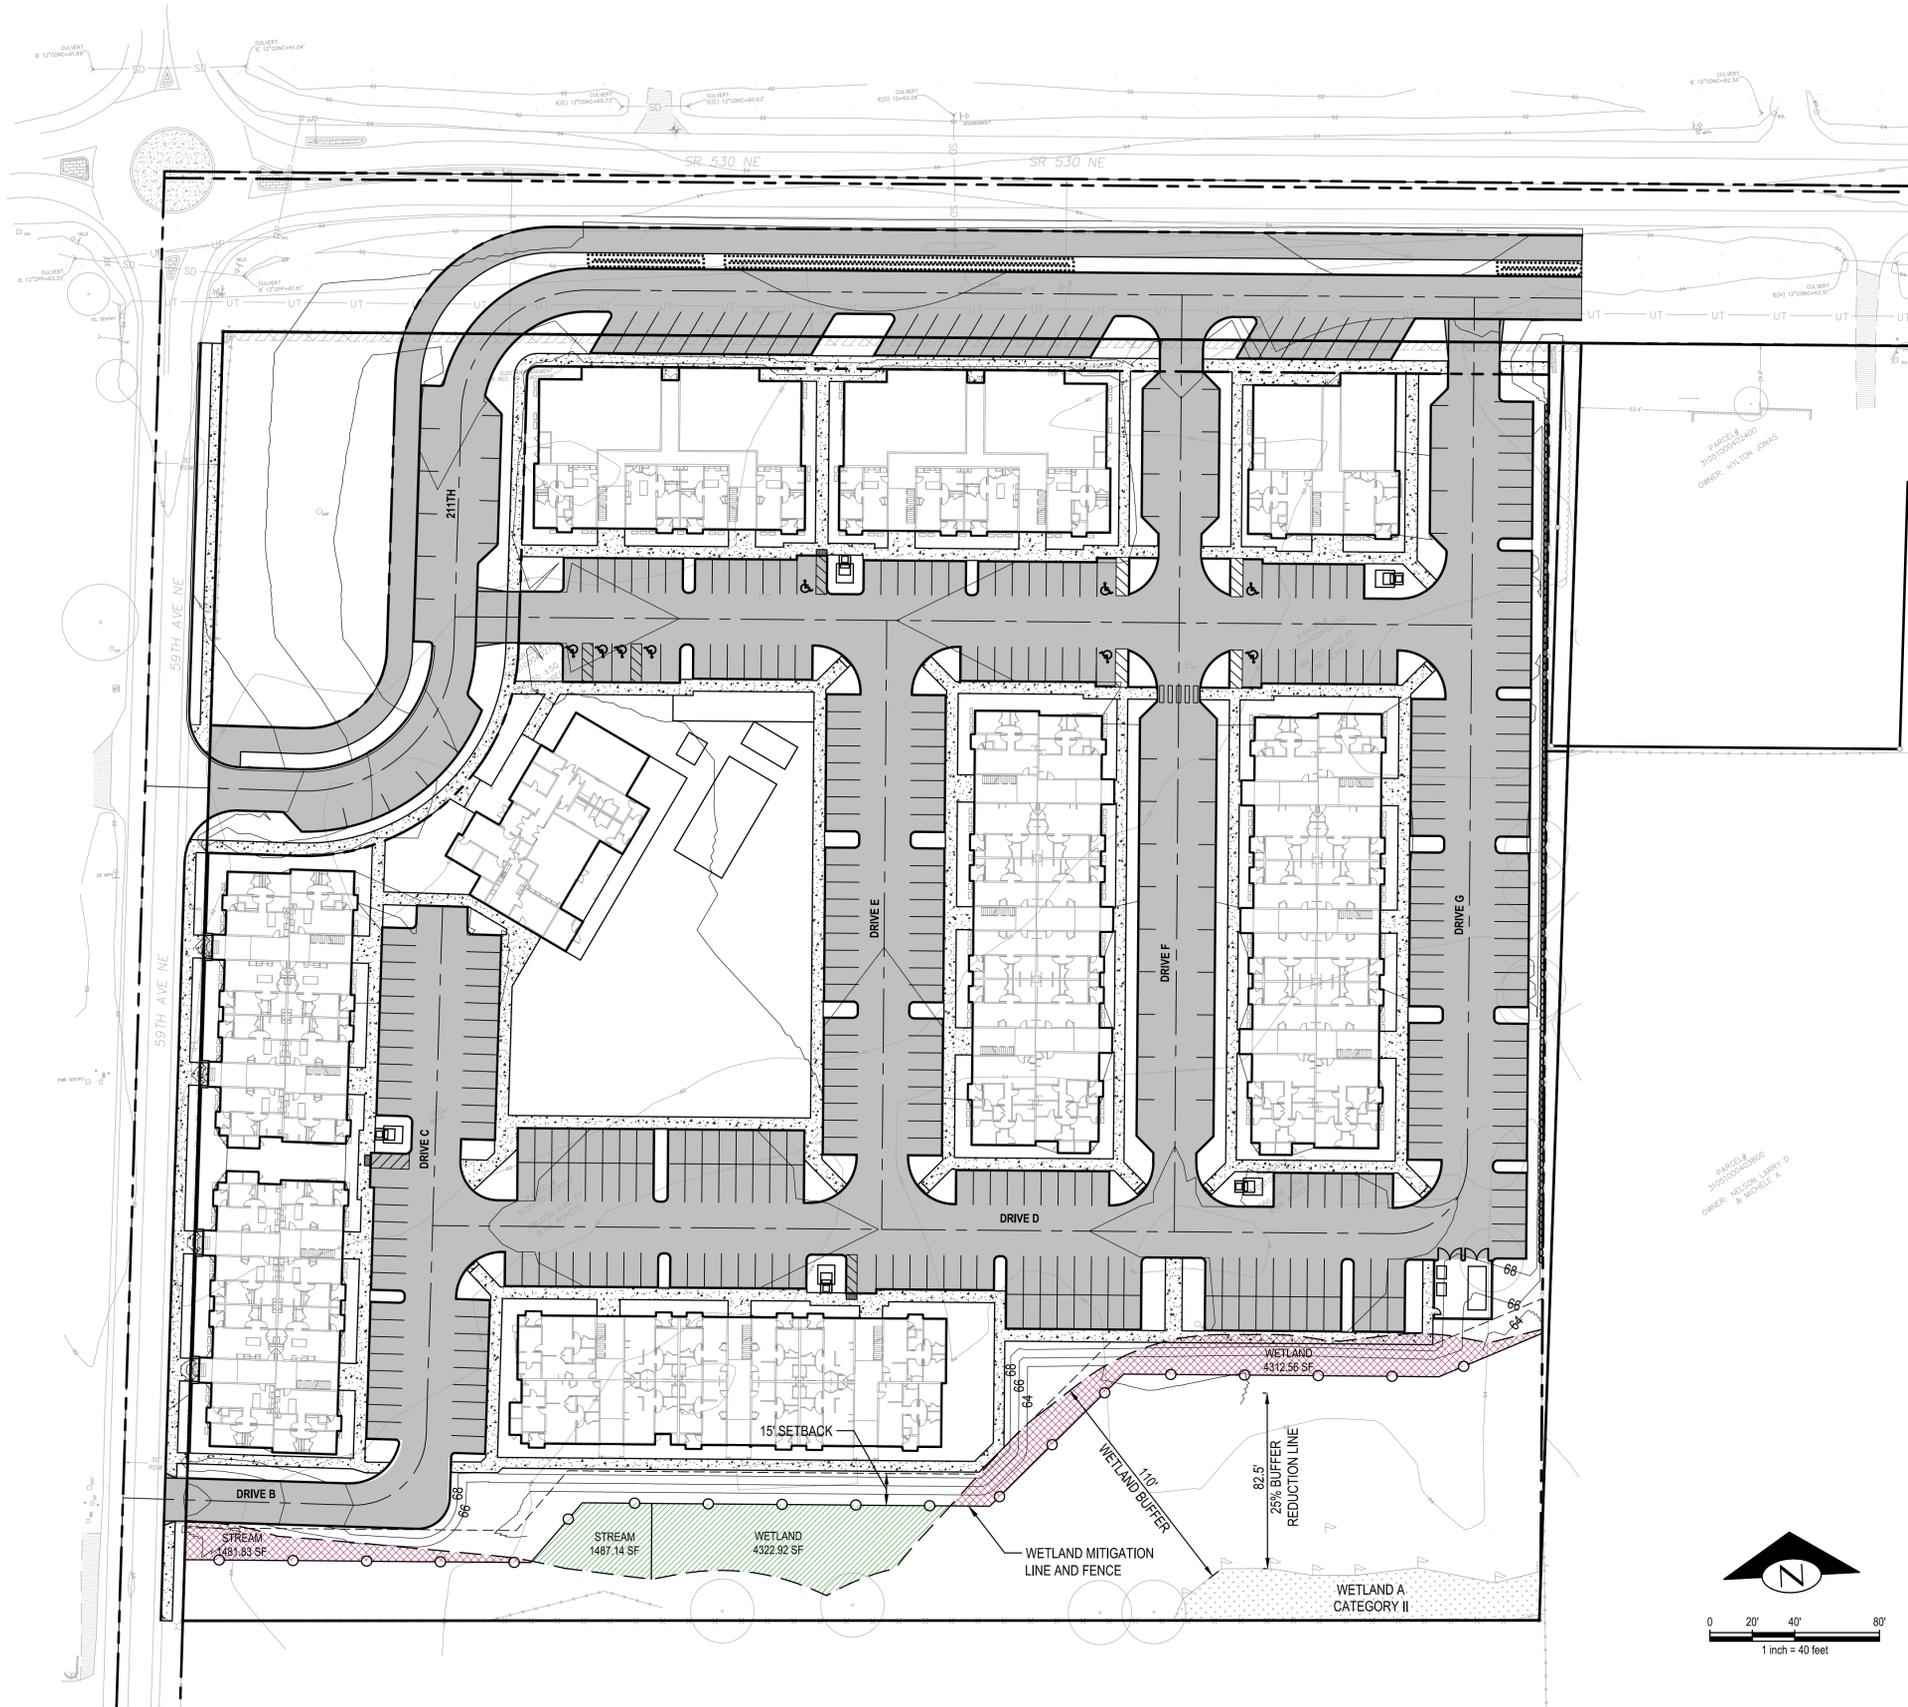
Appendix B — Conceptual Buffer Averaging Plan

BUFFER MITIGATION TABLE		
STREAM REDUCTION AREA	1,481.82 SF	
STREAM ADDITION AREA	1,487.14 SF	
NET 5.32 SF ADDITIONAL STREAM BUFFER		
WETLAND REDUCTION AREA	4,312.56 SF	
WETLAND ADDITION AREA	4,322.92 SF	
NET 10.36 SF ADDITIONAL WETLAND BUFFER

The onsite averaged wetland and stream buffer areas that are currently degraded due to mowing and the encroachment of non-native invasive species, will be fully enhanced through installing native trees and shrubs and controlling non-native invasive species throughout the onsite wetland and stream buffer areas for a period of 5 years. Throughout both the wetland and stream buffer enhancement areas, non-native invasive species and other degradations (trash, debris, etc.) will be removed, and the entire onsite buffer area will be densely planted with an assortment of native trees and shrubs. The wetland and stream buffer enhancement areas are depicted in Appendix B.

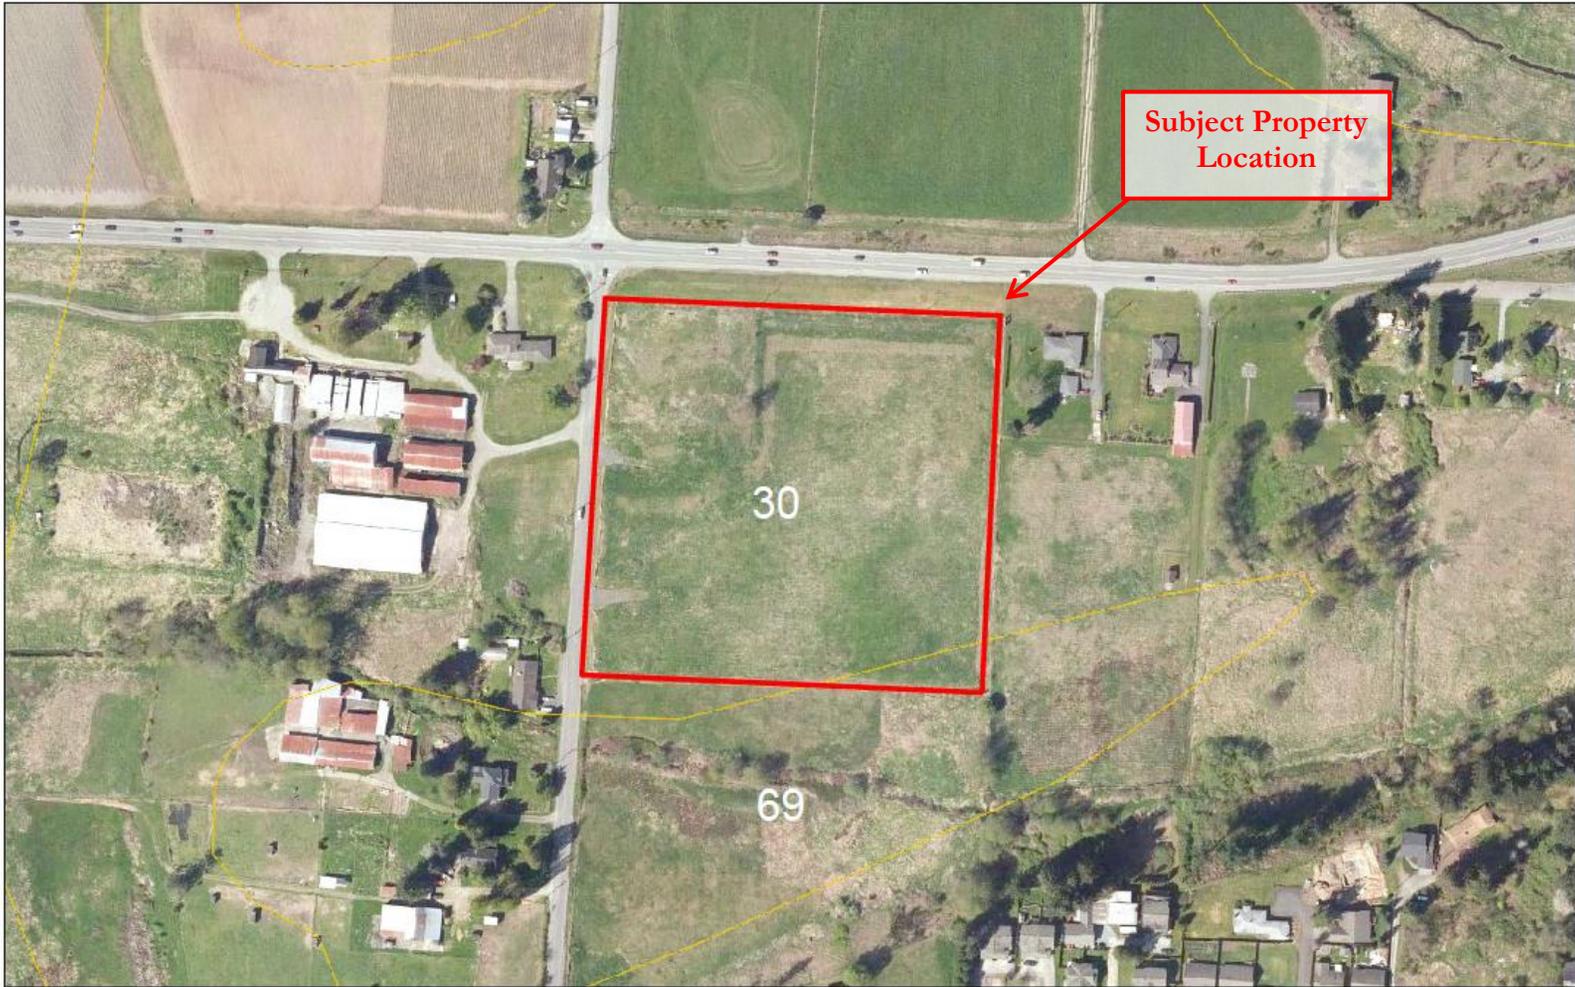
Appendix B2 – NRCS Soil Survey Map

The NRCS soil survey identifies two soil series on the subject property: Lynnwood loamy sand, 0 to 3 percent slopes (30), and Terric Medisaprists, nearly level slopes (69). An NRCS soil survey map is provided in Appendix B2. A description of the soil profiles is below.

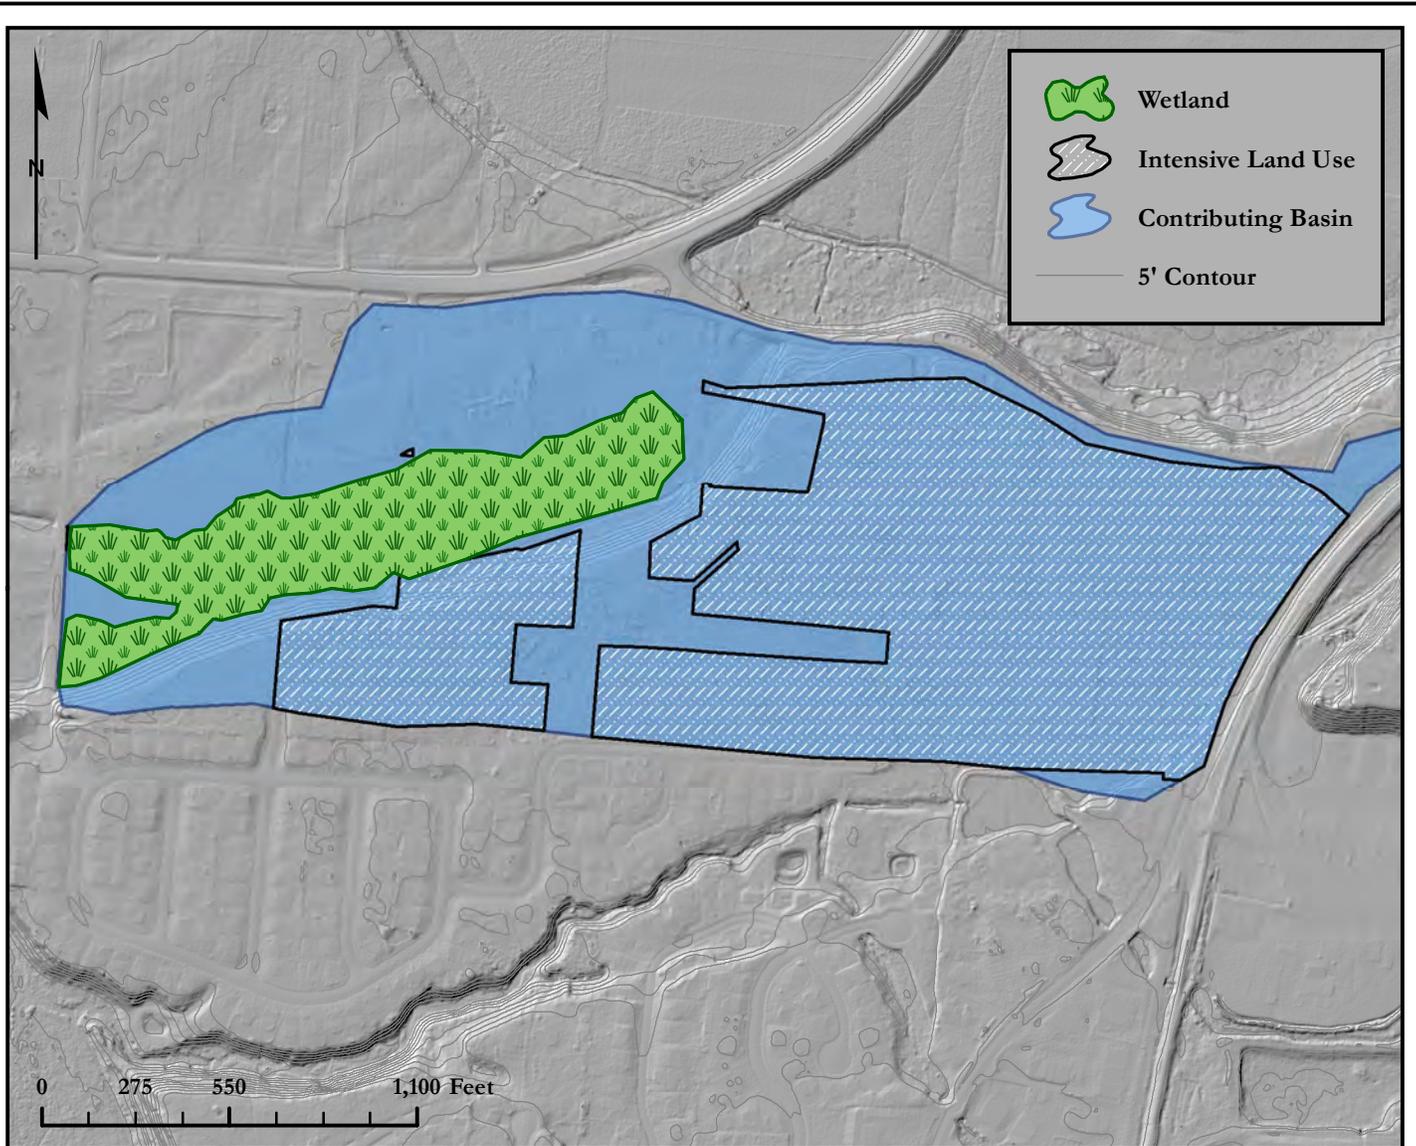
CONTRIBUTING BASIN MAP

D.4		
D.4.3		
	Area of Contributing Basin (SF)	3,895,571
	Area of Wetland A (SF)	551,709
	Percent of Wetland A within Contributing Basin	14.162%
D.5.0		
D.5.3		
	Area of Contributing Basin	3,895,571
	Area of Intensive Human Land Uses	2,278,537
	Percent of Intensive Human Land Use within Contributing Basin	58%

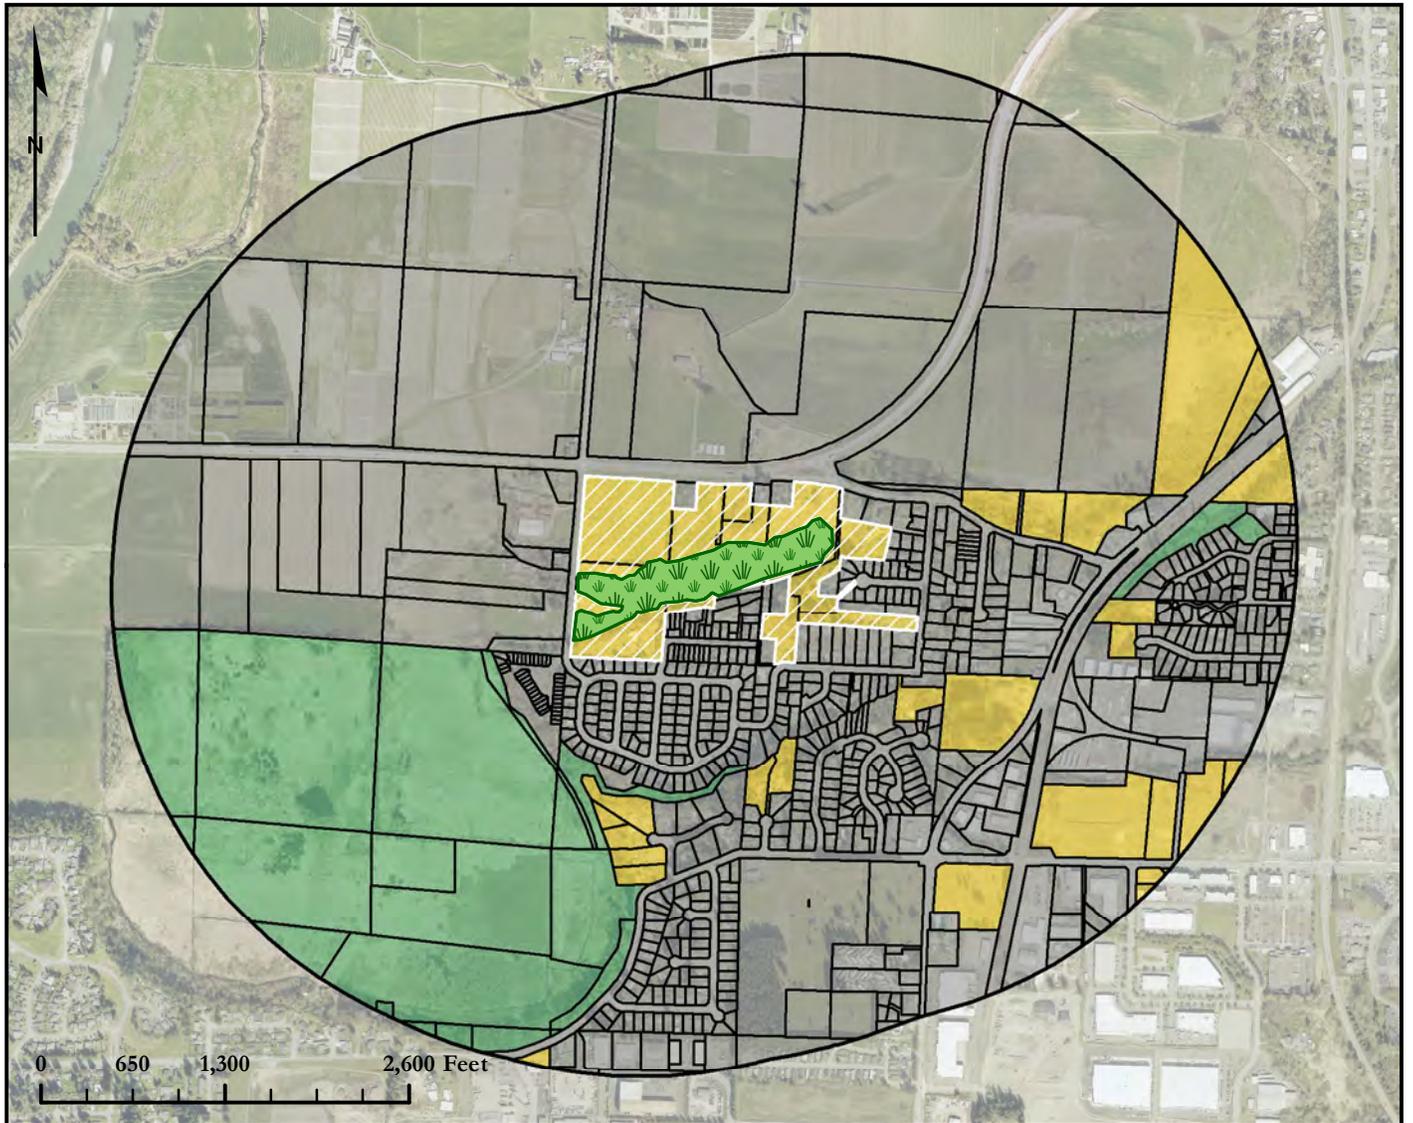
HABITAT MAP

H.2.0 Wetland A		
H.2.1		
	Abutting Undisturbed Habitat	0.00%
	Abutting Moderate & Low Intensity Land Uses	3.08%
	Accessible Habitat	1.54%
H.2.2		
	Undisturbed Habitat	16.26%
	Moderate & Low Intensity Land Uses	9.94%
	Undisturbed Habitat in 1 KM Polygon	21.23%
H.2.3		
	High Intensity Land Use in 1 KM Polygon	73.80%

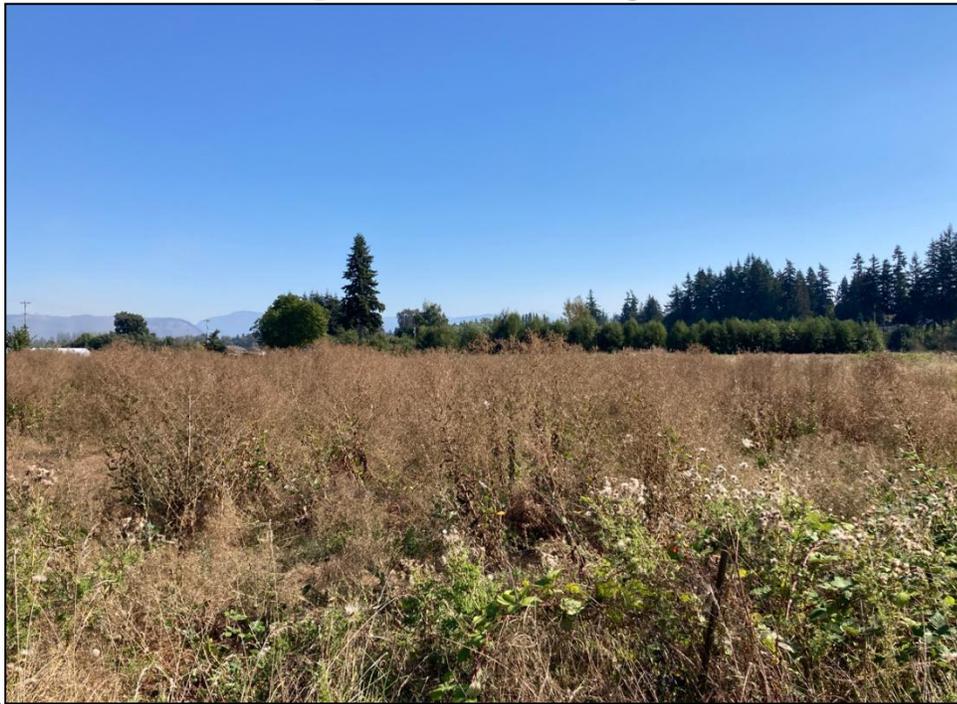
General upland conditions, facing northeast

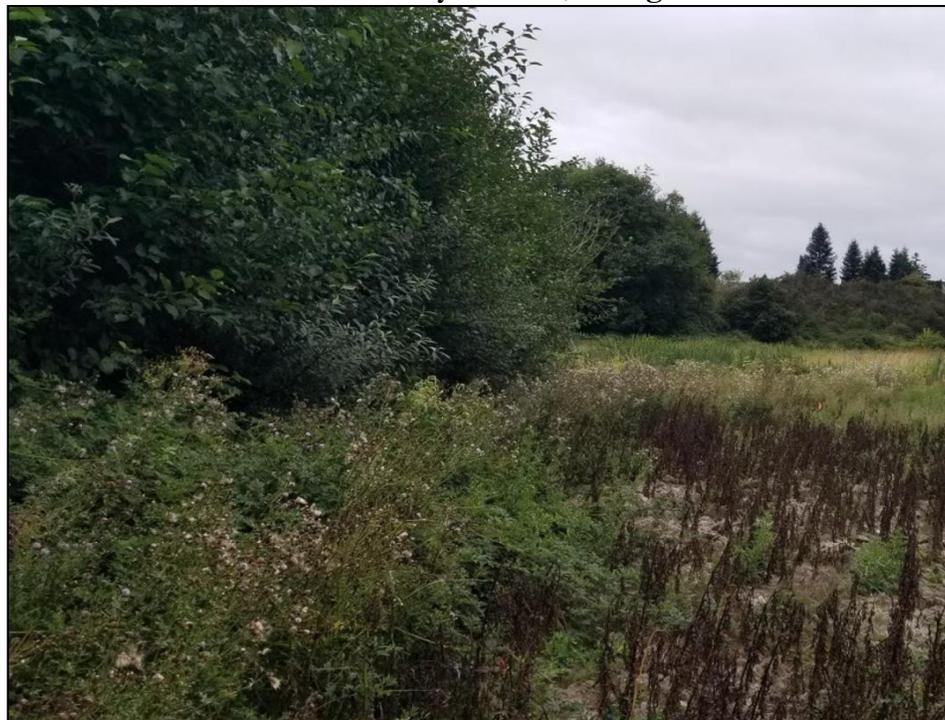
Western boundary of ditch, facing south.

One ditch was identified on the eastern property boundary, flowing north to south. The ditch appears to be artificially and intentionally created out of upland conditions for the purpose of stormwater conveyance. Review of historical aeriels and historic USGS topographic maps dating back to 1911 of this parcel indicate no evidence of a relic stream channel. The ditch is linear, approximately 2 – 3 feet wide, with vertical banks. The banks are lined with red alder, creeping buttercup, field horsetail, and non-native invasive reed canarygrass. No defined bed and bank are present, therefore the ditch does not meet the stream criteria under WAC 222-16-030. Furthermore, per AMC 20.93.100, streams “do not include irrigation ditches, canals, stormwater runoff devices or other entirely artificial watercourses unless they are used to convey any stream naturally occurring prior to construction”. After an additional site investigation in January of 2025, SVC observed that there is an upland area located between the terminus of the ditch and Wetland A that precludes hydrology within the ditch from having an above ground surface water connection to Wetland A and Stream 1. Additionally, during the January 2025 site investigation by SVC under normal precipitation conditions, SVC did not observe and seasonal ponding within the onsite portion of Wetland A. Thus, the onsite portion of Wetland A is all seasonally saturated and there is not above ground surface water connection from the onsite ditch and Wetland A. As such, the ditch is not anticipated to be regulated as a stream, and no buffer is required.

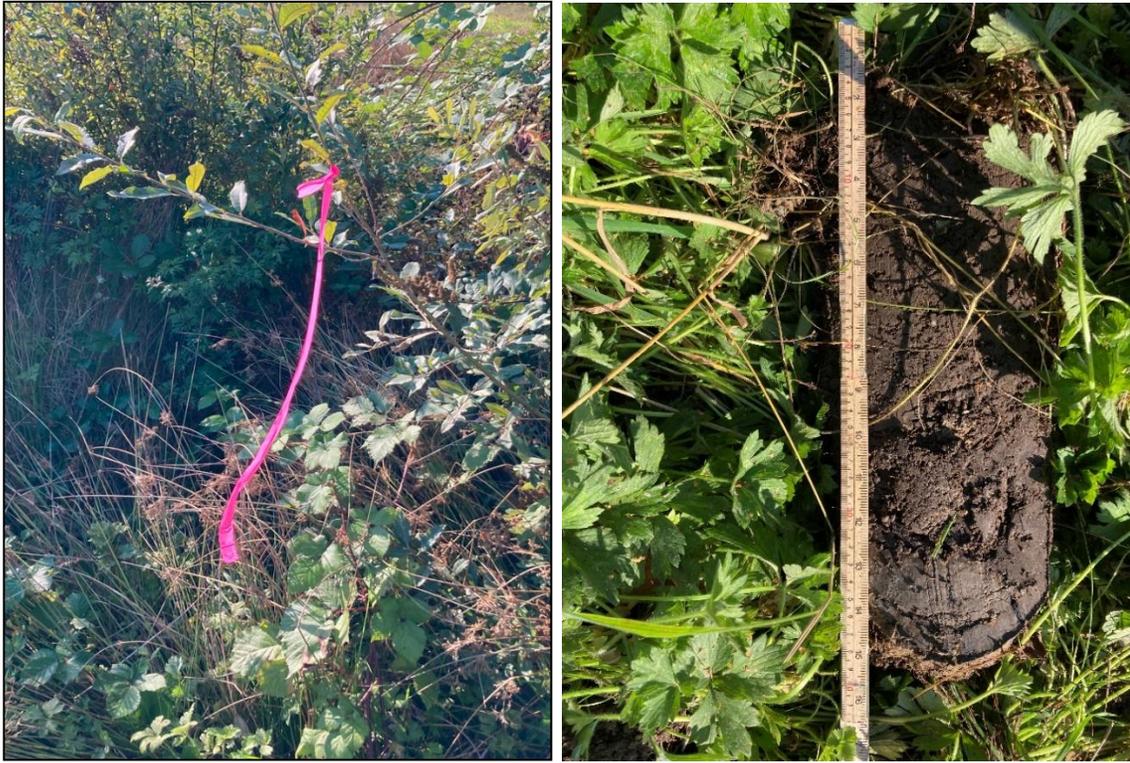
General wetland conditions (left) and soil profile (right) at DP-1.

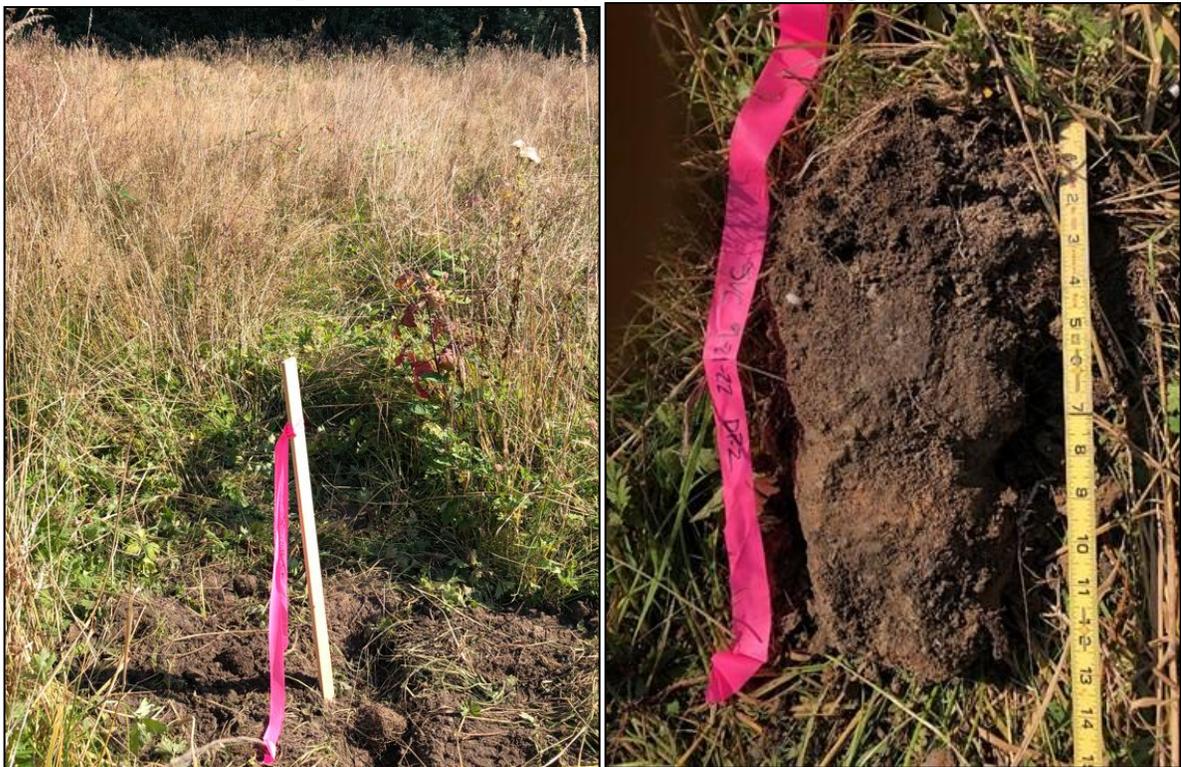
General upland conditions (left) and soil profile (right) at DP-2.

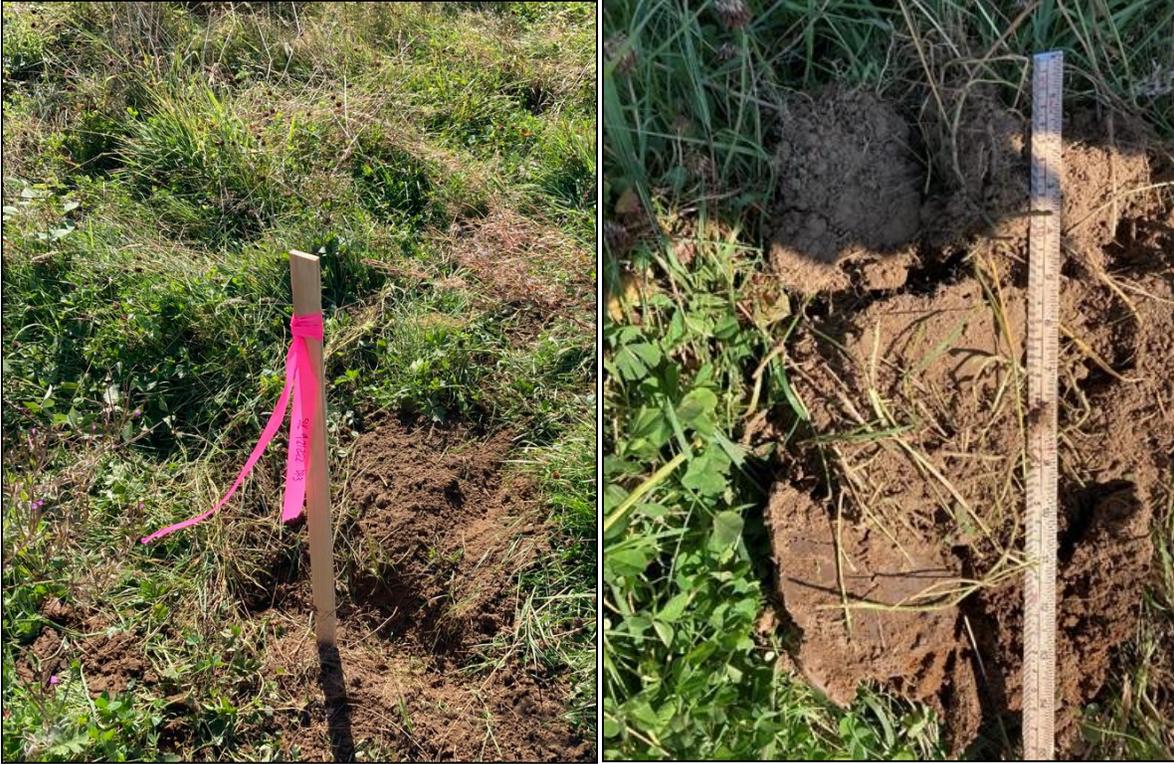
General upland conditions (left) and soil profile (right) at DP-3.
