City of Arlington / MJS Investors

# **Lindsay Subarea Plan**

## Volume II - Appendices

**DRAFT September 2025**

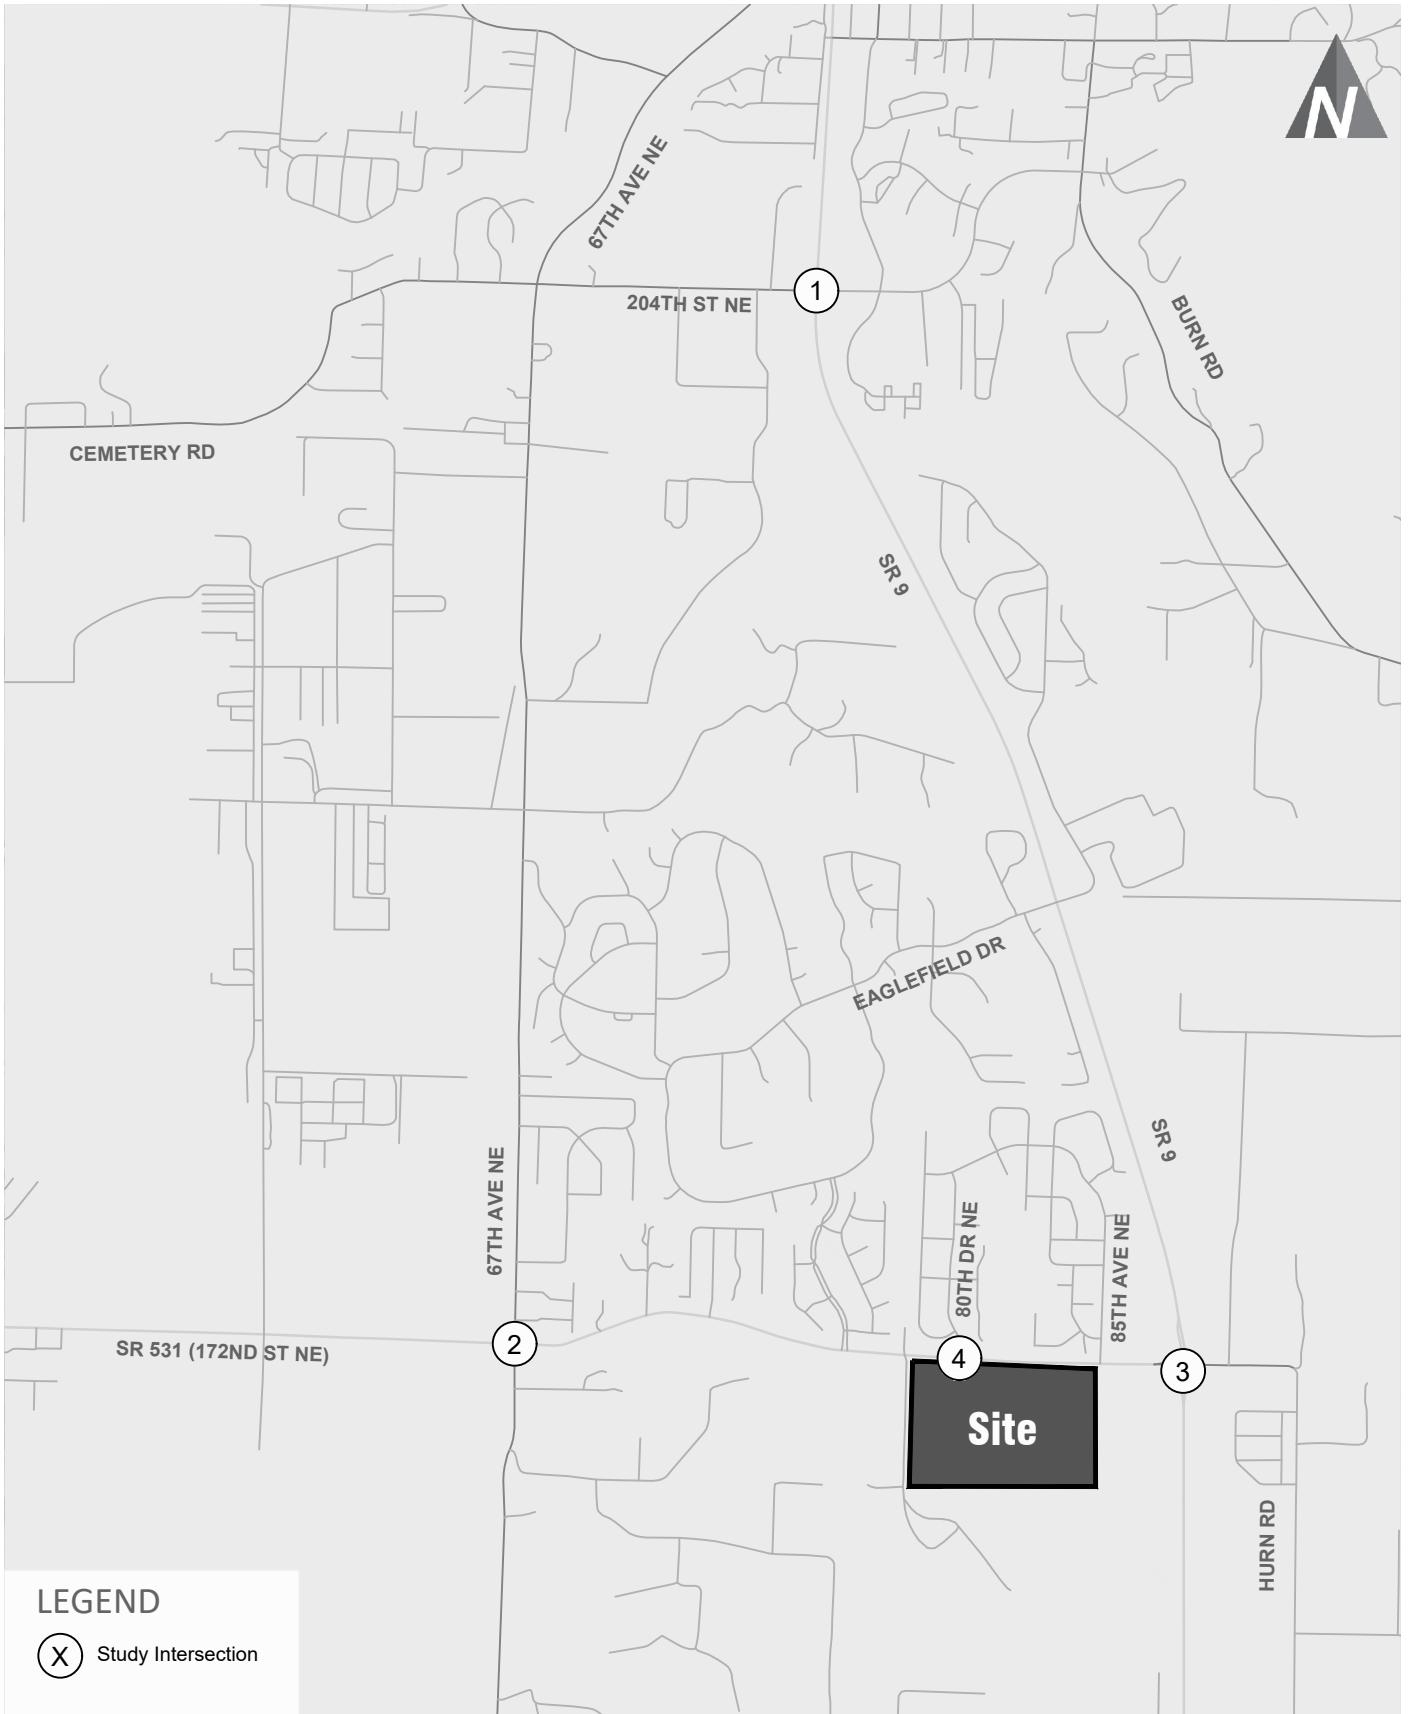
# Project Site Vicinity and Study Intersections

The analysis includes a review of existing conditions in the vicinity of the project site, including the street network, non-motorized facilities, transit service, existing and future (2029) without-project peak hour traffic volumes, traffic operations, and traffic safety. Future (2029) with-project conditions are evaluated by adding site-generated traffic to future (2029) without-project volumes and were then compared to future (2029) without-project conditions to identify the relative impacts the proposed project has on the surrounding transportation system.

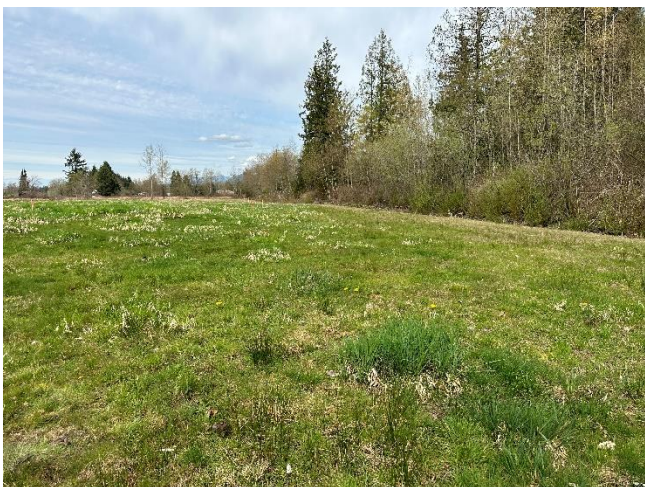
Wetland A is approximately 22,500 square feet (0.52 acre) in size and is located on the southern portion of the subject property. Hydrology for Wetland A is provided by a seasonally-high water table, direct precipitation and surface runoff from adjacent uplands. Wetland vegetation is dominated by velvet grass, common rush (*Juncus effusus*), birdsfoot trefoil (*Lotus corniculatus*), and non-native invasive reed canarygrass. The buffer surrounding Wetland A consists of fields that are degraded by previous grading and non-native invasive reed canary grass. Hydric soil indicators A11 (Depleted below dark surface) and F3 (Depleted Matrix) were observed. Wetland boundaries were determined by a transition of topography and wetland hydrology. Wetland A is a Palustrine Emergent and Seasonally Saturated wetland (PEMB). Table 3 provides a summary of Wetland A.

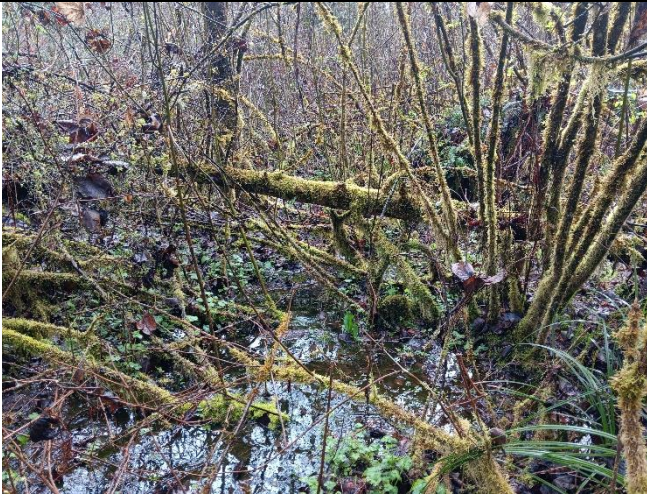
on age (*Tolmiea menziesii*), water parsley (*Oenanthe sarmentosa*), creeping buttercup, water horsetail (*Equisetum fluviatile*), and slough sedge (*Carex obnupta*). Hydric soil indicators A11 (Depleted below dark surface) and F3 (Depleted Matrix) were observed. Wetland boundaries were determined by a transition to wetland hydrology and hydrophytic vegetation. Wetland B is a Palustrine Forested, Scrub-Shrub, Seasonally Saturated, Seasonally Flooded, and Permanently Flooded wetland (PFO/SSBCH). Table 4 provides a summary of Wetland B.

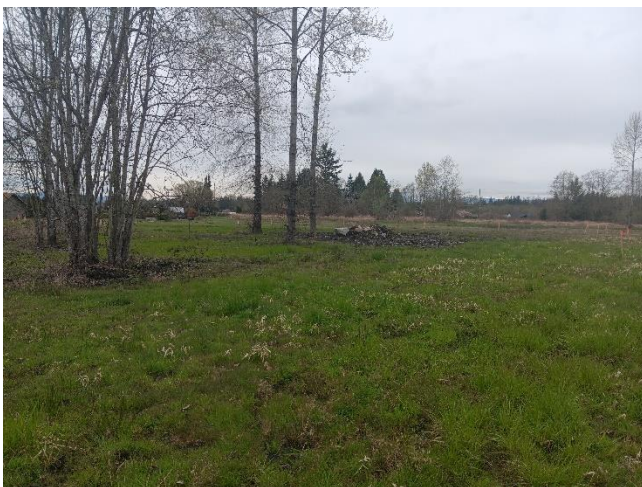
Wetland C is approximately 30,080 square feet (0.69 acre) in size and is located on the southwest edge of the site. Hydrology for Wetland C is provided by a seasonally-high water table, direct precipitation, surface runoff from adjacent uplands, and flow from a ditch that runs south to north through the wetland. Wetland vegetation is dominated by common rush, and non-native invasive reed canarygrass. The buffer surrounding Wetland C consists of fields that are degraded by non-native invasive reed canarygrass and Kentucky bluegrass (*Poa pratensis*). Hydric soil indicators A11 (Depleted below dark surface) and F3 (Depleted Matrix) were observed. Wetland C is a Palustrine Emergent, Seasonally Saturated, and Seasonally Flooded wetland (PEMBC). Table 5 provides a summary of Wetland C.

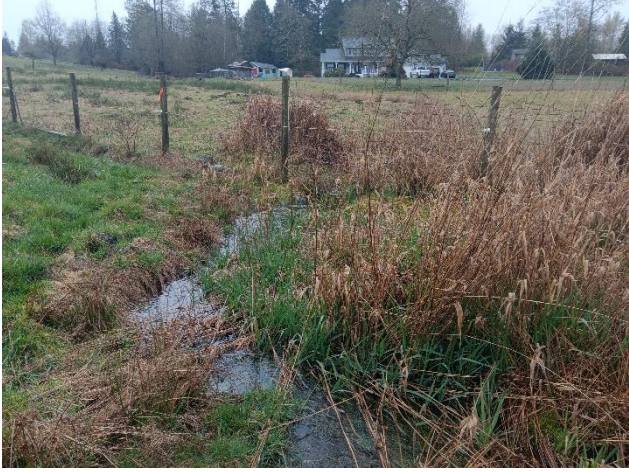
| STREAM INFORMATION SUMMARY | | |
|---|---|---|
| <b>Riparian/Buffer Condition</b> | The onsite stream channel is degraded, consisting of a shallow channel that is heavily vegetated with reed canary grass. The onsite buffer is degraded by seasonally mowed fields. | |

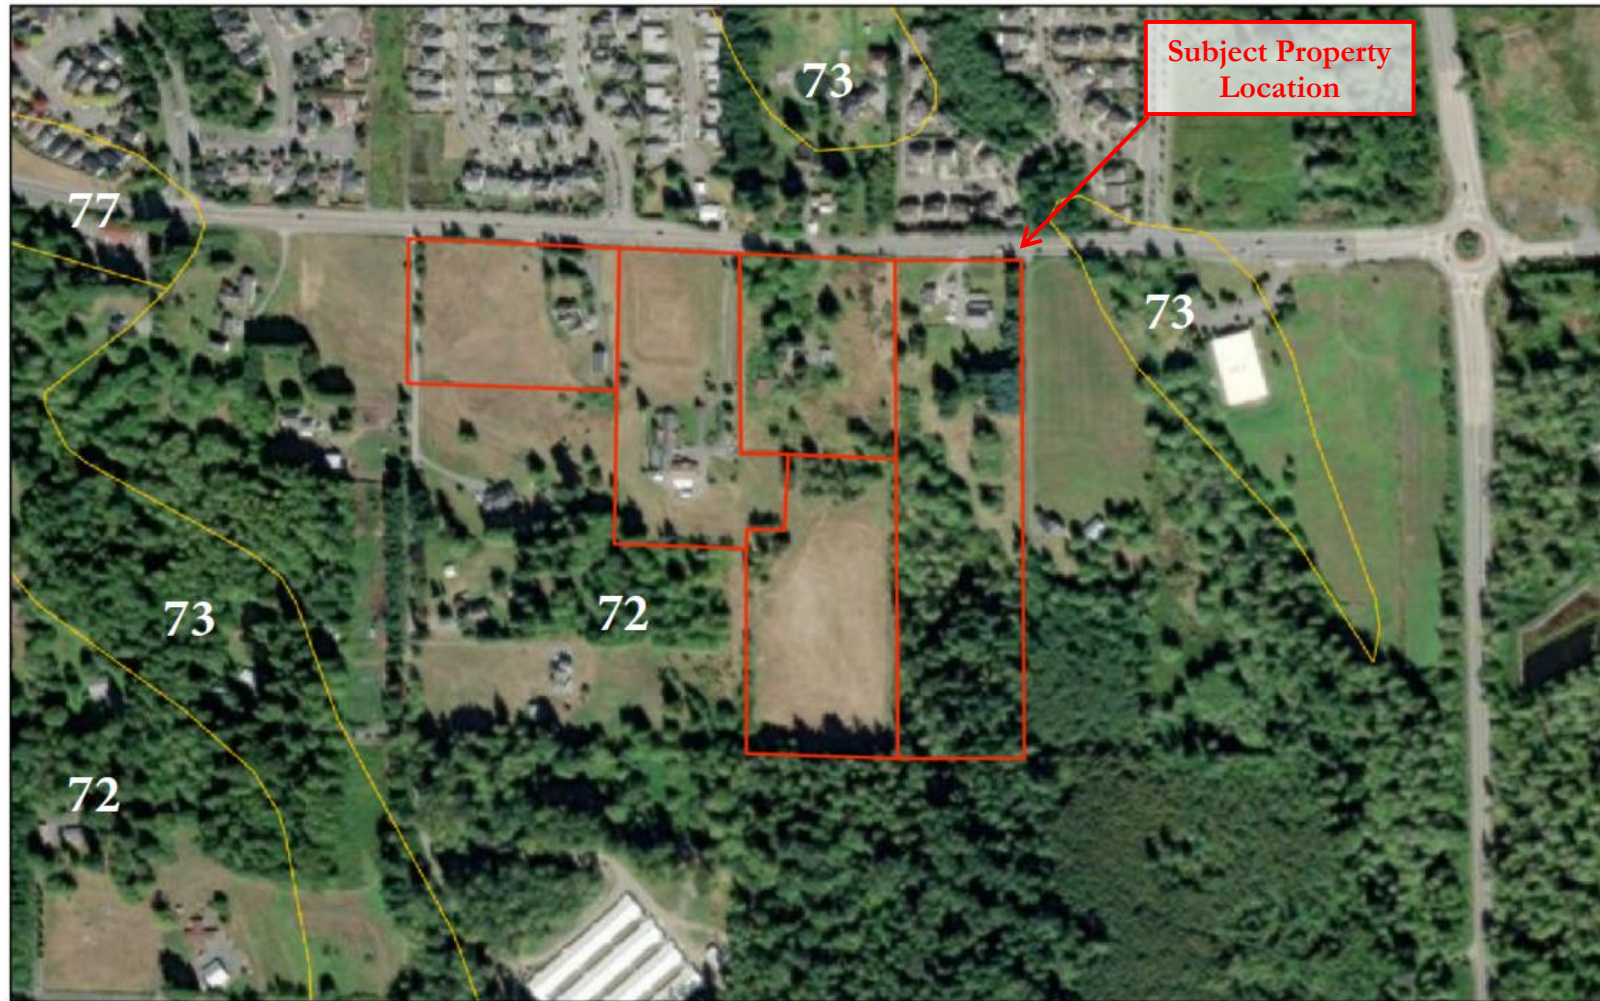
## Appendix B2 – NRCS Soil Survey Map

The NRCS soil survey identifies one soil series on the site: Tokul gravelly medial loam, 0 to 8 percent slopes. A NRCS soil survey map is provided in Appendix B2. A description of the soil profile is below.

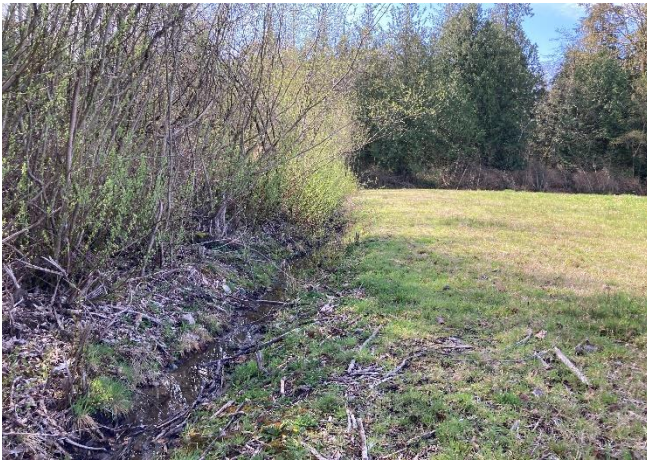
Ditch conditions in the southeast portion of the site on 04/02/24 (facing south).

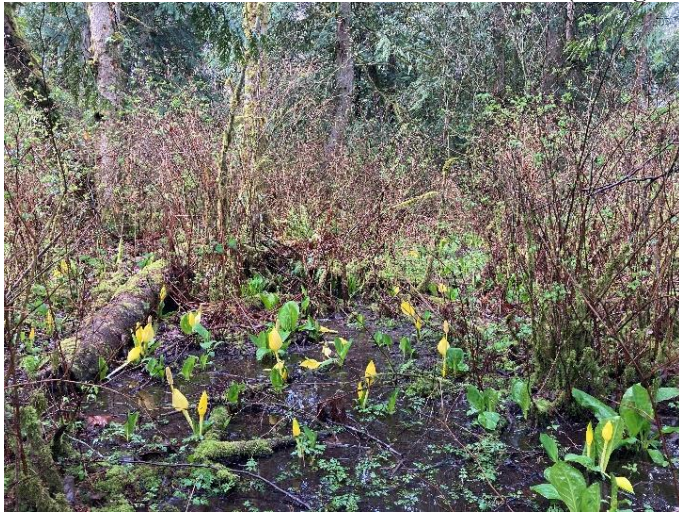
General site conditions in Wetland B on 04/02/24 (facing south).

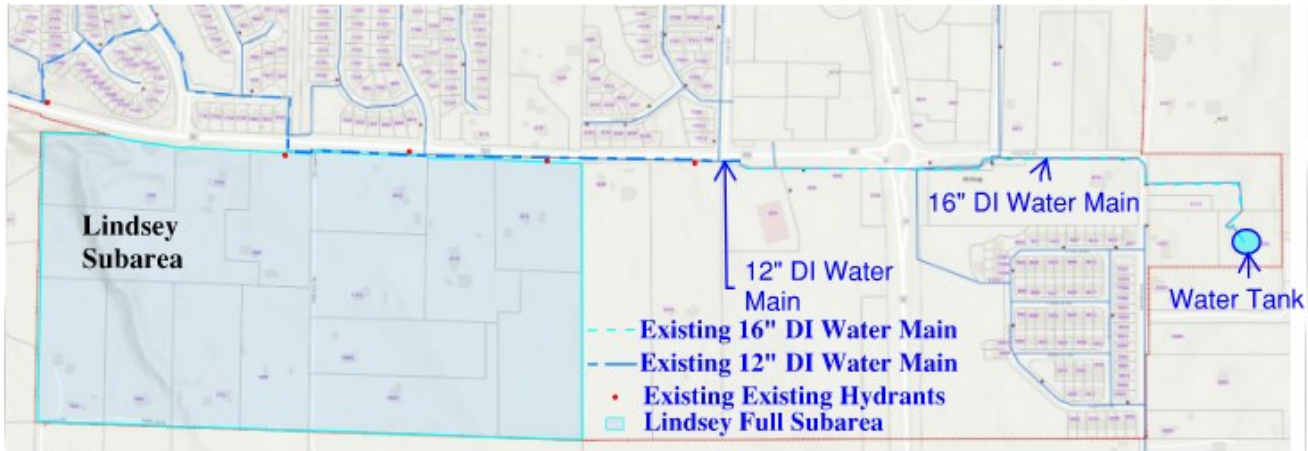
## Exhibit 2. Offsite water system

Pressures at the hydrants along 172<sup>nd</sup> St NE along the Lindsay Subarea have been listed between 55 psi in the hydrant at the east end of the Subarea and as high as 101 psi at the hydrant at the NW corner of the site. This is currently adequate capacity for fighting fires. The difference in pressure may be attributed to the 100-foot difference in hydrant elevations.
