City of Arlington | **Lindsay Subarea**

# Planned Action Final Environmental Impact Statement Volume II - Appendices

## LINDSAY ANNEXATION

# WETLAND AND FISH AND WILDLIFE HABITAT ASSESSMENT REPORT

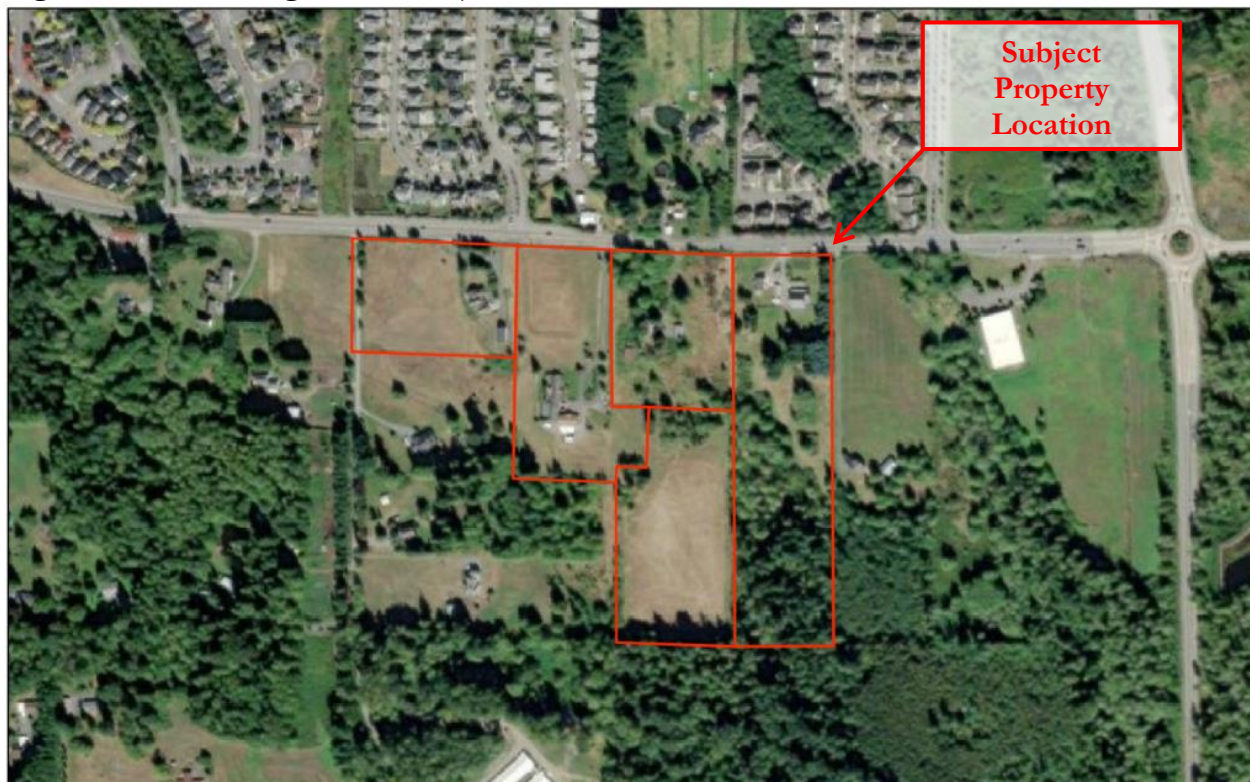
**Figure 2. Aerial Image of the Subject Area**

The subject property is located within a rural residential setting within the City of Arlington and is partially developed with four single-family residences, associated infrastructure, gravel driveways, and garages. Much of the site consists of open fields, lawn, and small pockets of deciduous trees and shrubs, with a larger forested area located on the southeast area of the subject property. The subject property abuts 172<sup>nd</sup> Street Northeast to the north, a single-family residence and undeveloped land to the east, undeveloped forested land and chicken farm facilities to the south, and single-family residences on large lots to the west. Topography on the site generally slopes from southeast to northwest with elevations ranging from approximately 408 feet above mean sea level (amsl) to 360 feet amsl (Appendix B1). The subject property is within the Snohomish River Watershed (Water Resources Inventory Area 7).

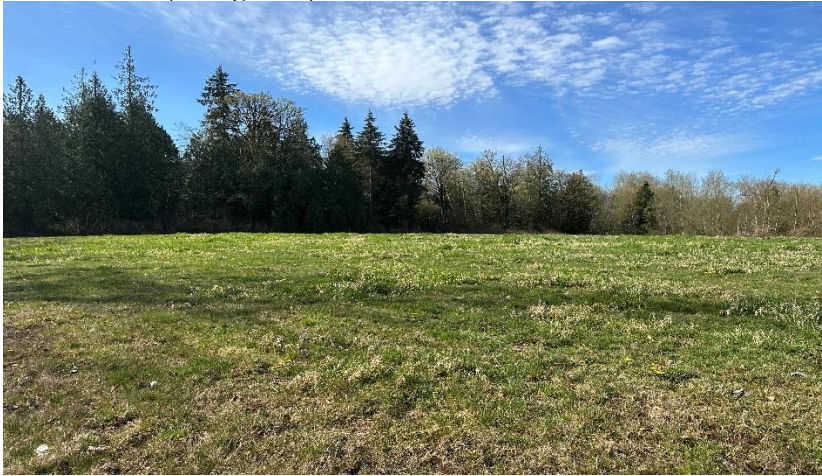
General site conditions in the southeast portion of the site on 04/02/2024 (facing west).

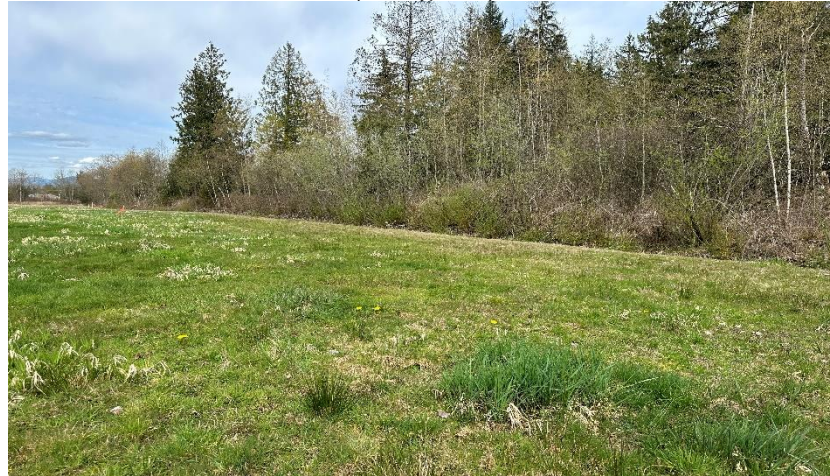
General site conditions in the southeast portion of the site around Wetland A on 04/02/2024 (facing east).

Wetland A is approximately 22,500 square feet (0.52 acre) in size and is located on the southern portion of the subject property. Hydrology for Wetland A is provided by a seasonally-high water table, direct precipitation and surface runoff from adjacent uplands. Wetland vegetation is dominated by velvet grass, common rush (*Juncus effusus*), birdsfoot trefoil (*Lotus corniculatus*), and non-native invasive reed canarygrass. The buffer surrounding Wetland A consists of fields that are degraded by previous grading and non-native invasive reed canary grass. Hydric soil indicators A11 (Depleted below dark surface) and F3 (Depleted Matrix) were observed. Wetland boundaries were determined by a transition of topography and wetland hydrology. Wetland A is a Palustrine Emergent and Seasonally Saturated wetland (PEMB). Table 3 provides a summary of Wetland A.

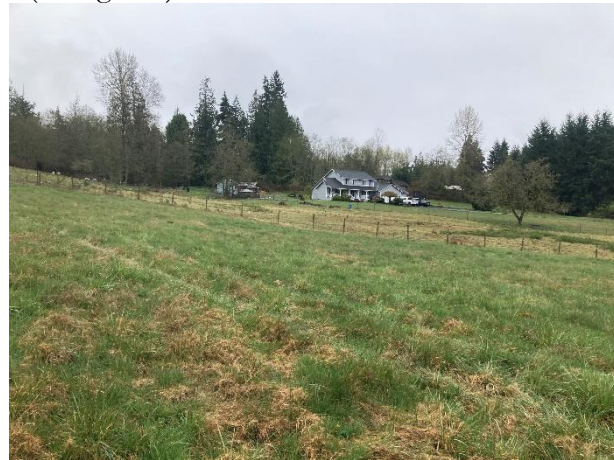
General site conditions in the north portion of the site on 04/02/24 (facing east).

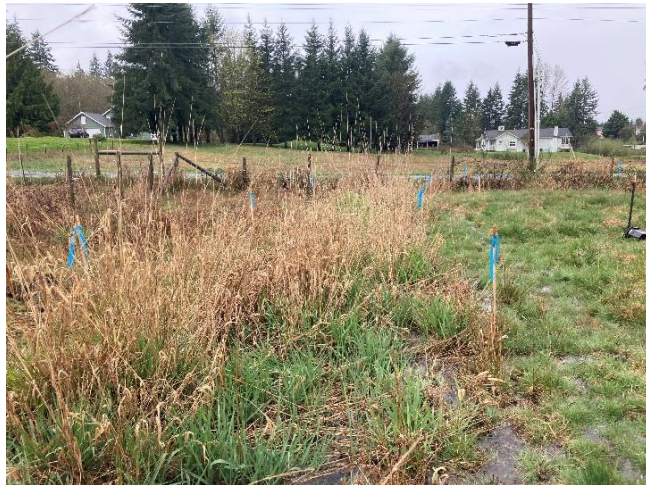
General site conditions around Stream Z on 04/03/24 (facing west).

The actual consistently defined stream channel of Stream Z appears to begin at the downstream end of a culvert system on parcel 31052600102000. During the reconnaissance investigation in December of 2022, SVC staff had access to parcel 31052600102000, as the Applicant was assessing feasibility on parcel 31052600102000. During the reconnaissance investigation SVC staff observed no defined channel to the south of the southern culvert, while a defined channel was observed immediately north of the culvert system on parcel 31052600102000.

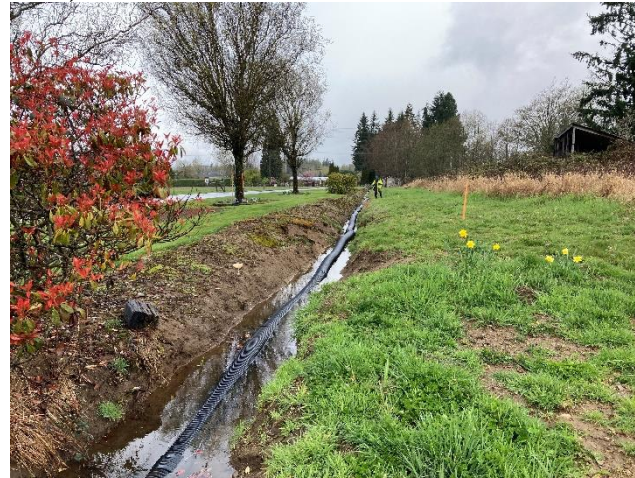
General site conditions in north ditch of the site on 04/02/24 (facing south).

A second series of manmade, artificially constructed drainage ditches were observed on the northern area of the subject property. The ditches flow from south to north. The ditches on the northern half of the site are conveyed offsite to the north into a roadside stormwater ditch. The identified ditches are approximately 2 to 4 feet wide and feature linear, vertical-cut channels indicative of manmade conditions, and lack a defined bed or bank. The linear nature of the channels, steep vertical banks, and berms built up along the sides of the some of the ditches, indicate that these were constructed to manage surface runoff.

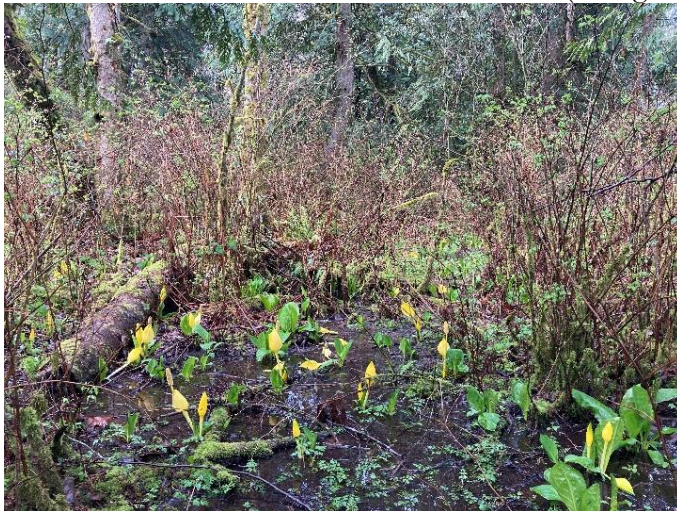
General site conditions in Wetland B on 04/02/24 (facing south).

on age (*Tolmiea menziesii*), water parsley (*Oenanthe sarmentosa*), creeping buttercup, water horsetail (*Equisetum fluviatile*), and slough sedge (*Carex obnupta*). Hydric soil indicators A11 (Depleted below dark surface) and F3 (Depleted Matrix) were observed. Wetland boundaries were determined by a transition to wetland hydrology and hydrophytic vegetation. Wetland B is a Palustrine Forested, Scrub-Shrub, Seasonally Saturated, Seasonally Flooded, and Permanently Flooded wetland (PFO/SSBCH). Table 4 provides a summary of Wetland B.

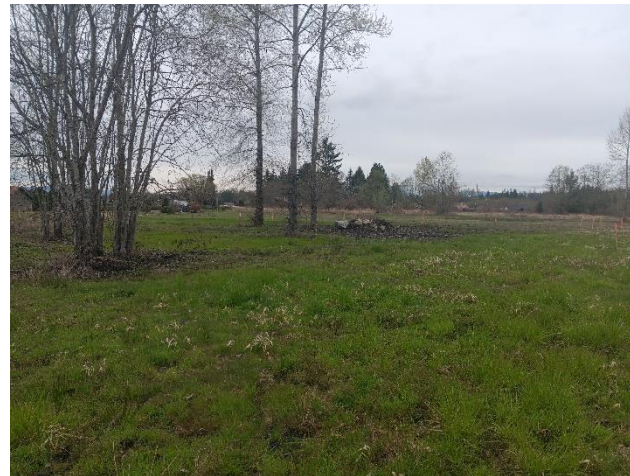
General site conditions around Wetland C on 04/02/24 (facing south).

Wetland C is approximately 30,080 square feet (0.69 acre) in size and is located on the southwest edge of the site. Hydrology for Wetland C is provided by a seasonally-high water table, direct precipitation, surface runoff from adjacent uplands, and flow from a ditch that runs south to north through the wetland. Wetland vegetation is dominated by common rush, and non-native invasive reed canarygrass. The buffer surrounding Wetland C consists of fields that are degraded by non-native invasive reed canarygrass and Kentucky bluegrass (*Poa pratensis*). Hydric soil indicators A11 (Depleted below dark surface) and F3 (Depleted Matrix) were observed. Wetland C is a Palustrine Emergent, Seasonally Saturated, and Seasonally Flooded wetland (PEMBC). Table 5 provides a summary of Wetland C.
