# Geotechnical Engineering Report

## Proposed 67<sup>th</sup> Avenue Development

### Arlington, WA

June 7, 2021  
Project No. 21-0553

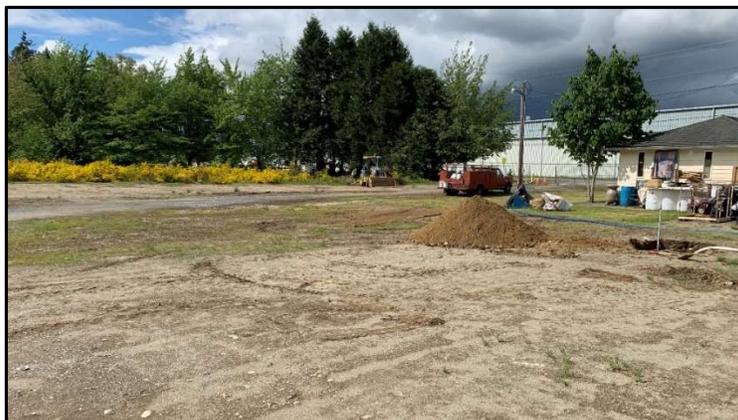
**Image 1:** Existing surface conditions at the subject property. View of the subject property looking south. Exploration of TP-3 in progress. (Image taken on May 19, 2021.)

The flag-shaped subject property is mostly undeveloped and contains two parcels (Parcel Nos. 31052300200500 and 00738500103100) totaling approximately 2.5 acres. Both parcels combined occupy approximately 285 feet of frontage along the eastern side of 67<sup>th</sup> Avenue NE in Arlington, WA. There is also an approximate 30-foot-wide road that provides access from 188<sup>th</sup> Street NE from between residential properties located at 6800 and 6804 188<sup>th</sup> Street NE. There is a single-family residence in the central section of the west side of parcel 31052300200500. In general, the topography across the subject property is relatively flat with an approximate elevation of 148 feet above mean sea level. A large majority of the site is stripped of groundcover and consists of gravelly sand material. The southern and eastern margins are covered with weeds, blackberry brambles, scotch broom, alders and conifers. No signs of surface water were observed on the proposed development at the time of our site visit in mid-May.

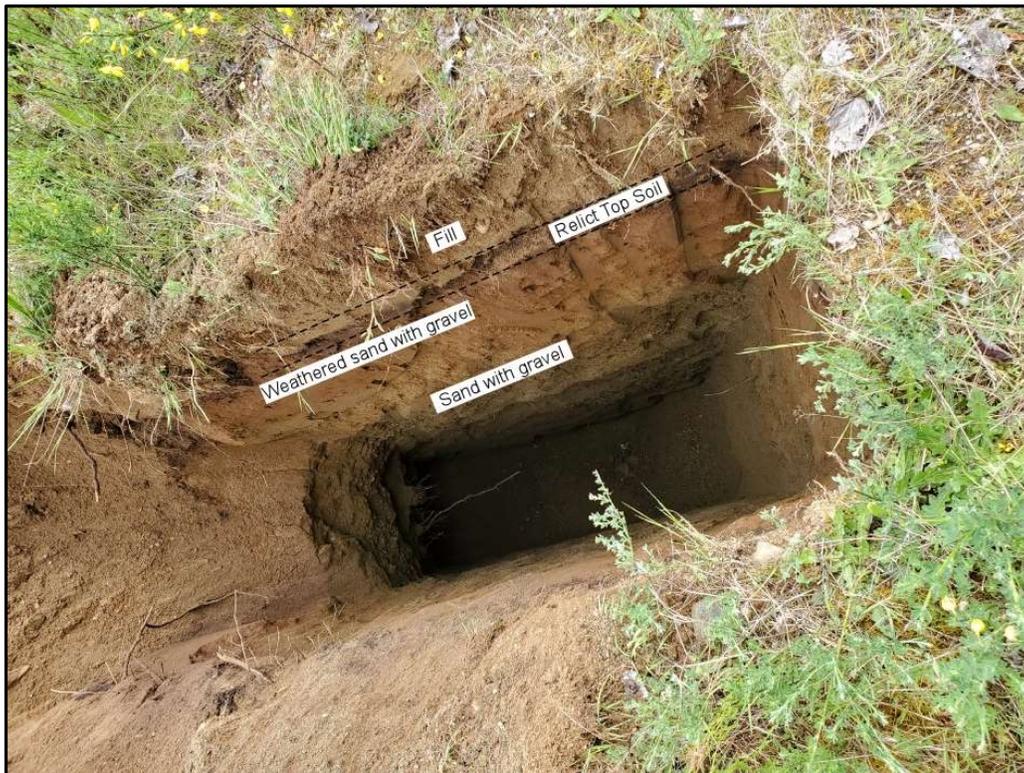
**Image 2:** Subsurface soil conditions within TP-3, in which fill overlies a relict topsoil and sand with gravels (Image taken on May 19, 2021.)

All seven test pits encountered similar subsurface conditions. In general, explorations consisted of 1 to 2 feet of medium dense, slightly silty, gravelly sand with some rootlets (undocumented fill) at the surface. Underlying the fill was a thin bed that varies in thickness and consists of dark brown medium dense, silty sand with trace gravels and rootlets interpreted to be relict topsoil. At approximately 1.5 to 2.5 feet BGS, a dense sand with varying amounts of gravel (unweathered recessional outwash) was encountered. The upper 1 to 2 feet of this lower unit was weathered. The unweathered recessional outwash commonly contained deposits of cobbles and was encountered to the maximum explored depth of the test pits.

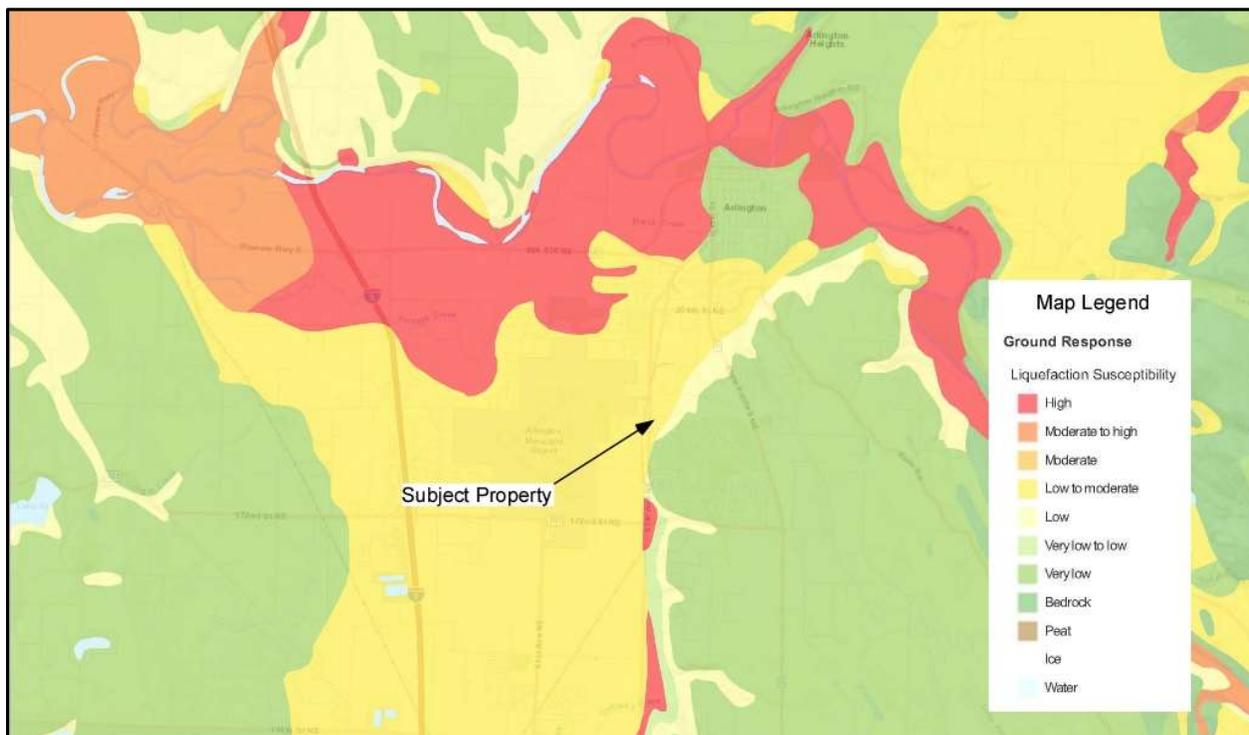
**Image 3:** Map showing liquefaction hazard susceptibility. Yellow depicts “low to moderate” susceptibility in the vicinity of subject property. Data source: Washington Geologic Information Portal.

Based on our subsurface explorations, the site is underlain by native medium dense, gravelly, sandy soils. GeoTest did not encounter the regional groundwater table during our explorations and a review of local well log data suggest it is typically encountered at approximately 50 feet BGS in the vicinity of the site. Due to these factors, it is GeoTest’s opinion that the potential for liquefaction underlying the subject property is low. Thus, it is also our opinion that no mitigations are required to address liquefaction for the proposed development.

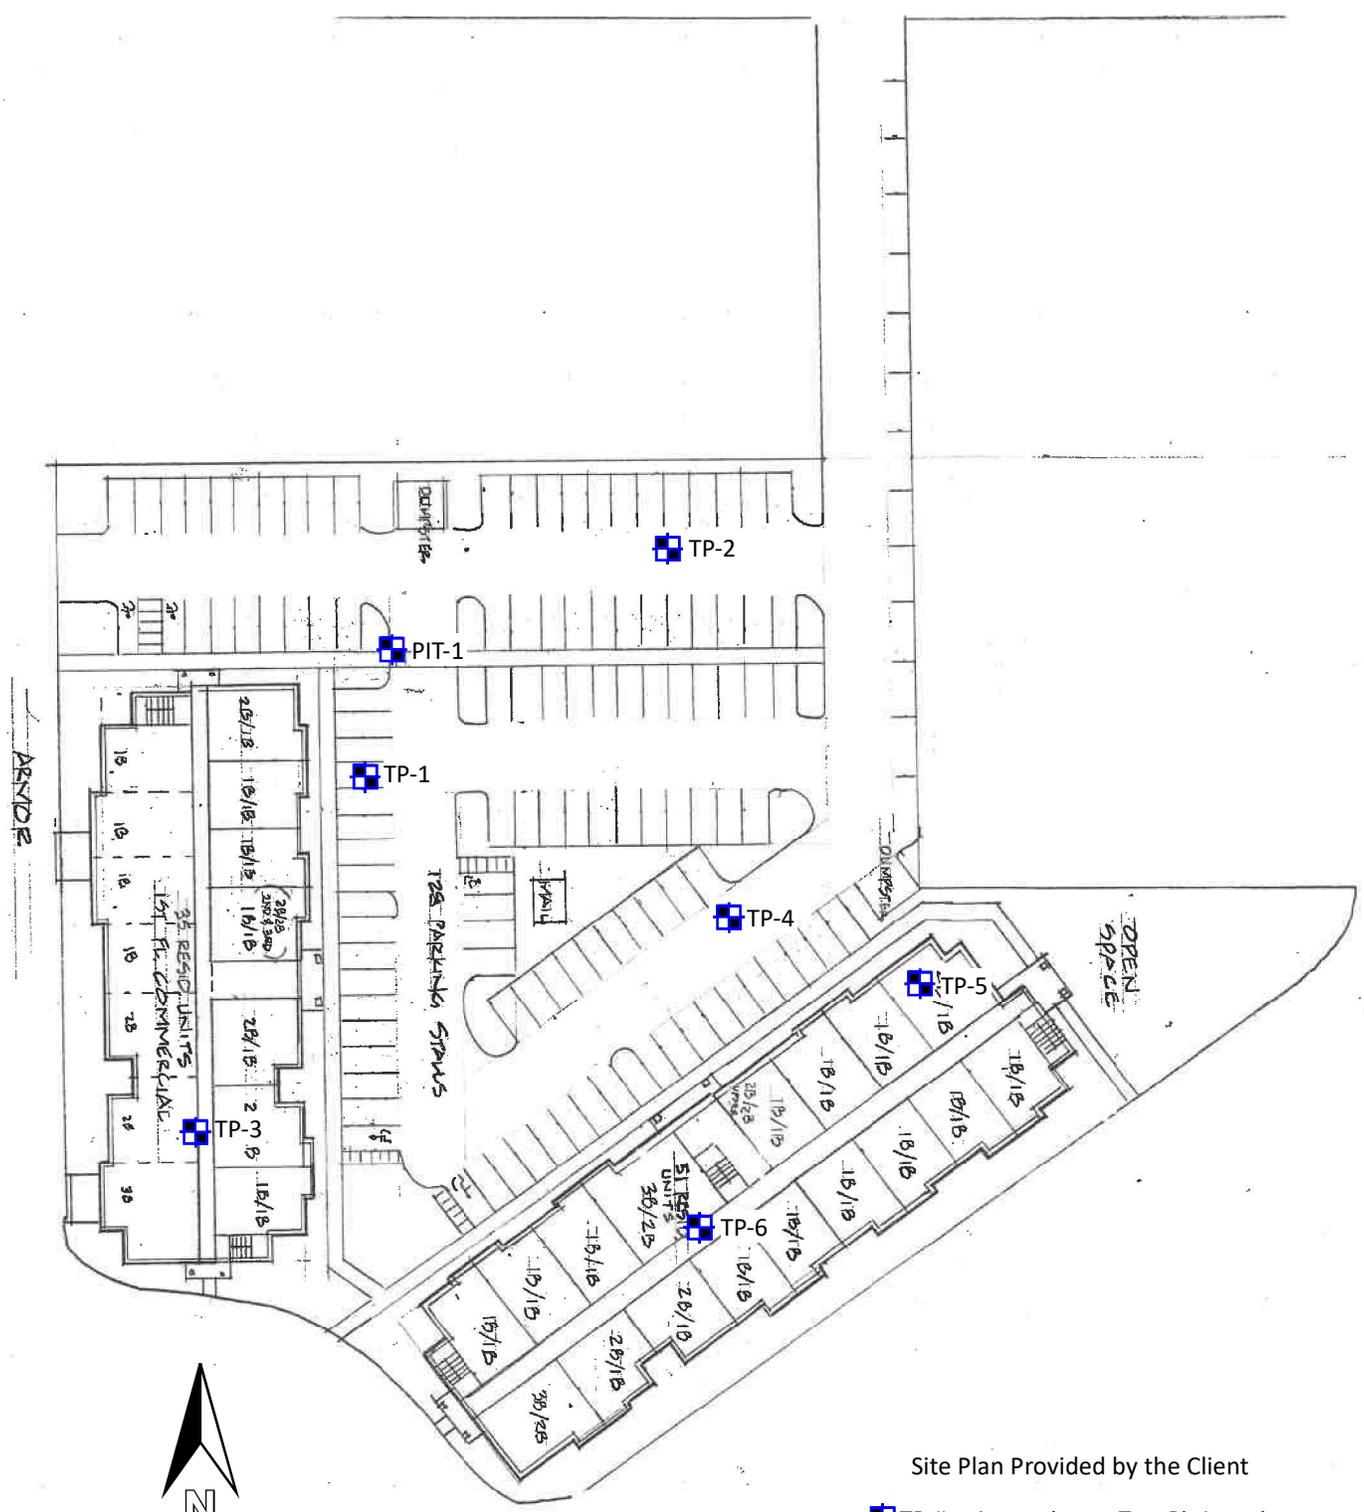
Date: 5-27-21	By: BWS	Scale: NTS	Project 21-0553
<b>SITE AND EXPLORATION PLAN</b> <b>67TH AVENUE DEVELOPMENT</b> <b>18705 &amp; 18625 67TH AVENUE NE</b> <b>ARLINGTON, WA 98223</b>			Figure <b>2</b>

Site Plan Provided by the Client

TP-# = Approximate Test Pit Location

Subsurface conditions were explored by advancing seven exploratory test pits (TP-1 through TP-6 and PIT-1) on May 19, 2021. The explorations were advanced to an approximate depth of 9 to 11.5 feet below ground surface (BGS) using a backhoe. Approximate locations of these explorations have been plotted on the *Site and Exploration Plan* (Figure 2).

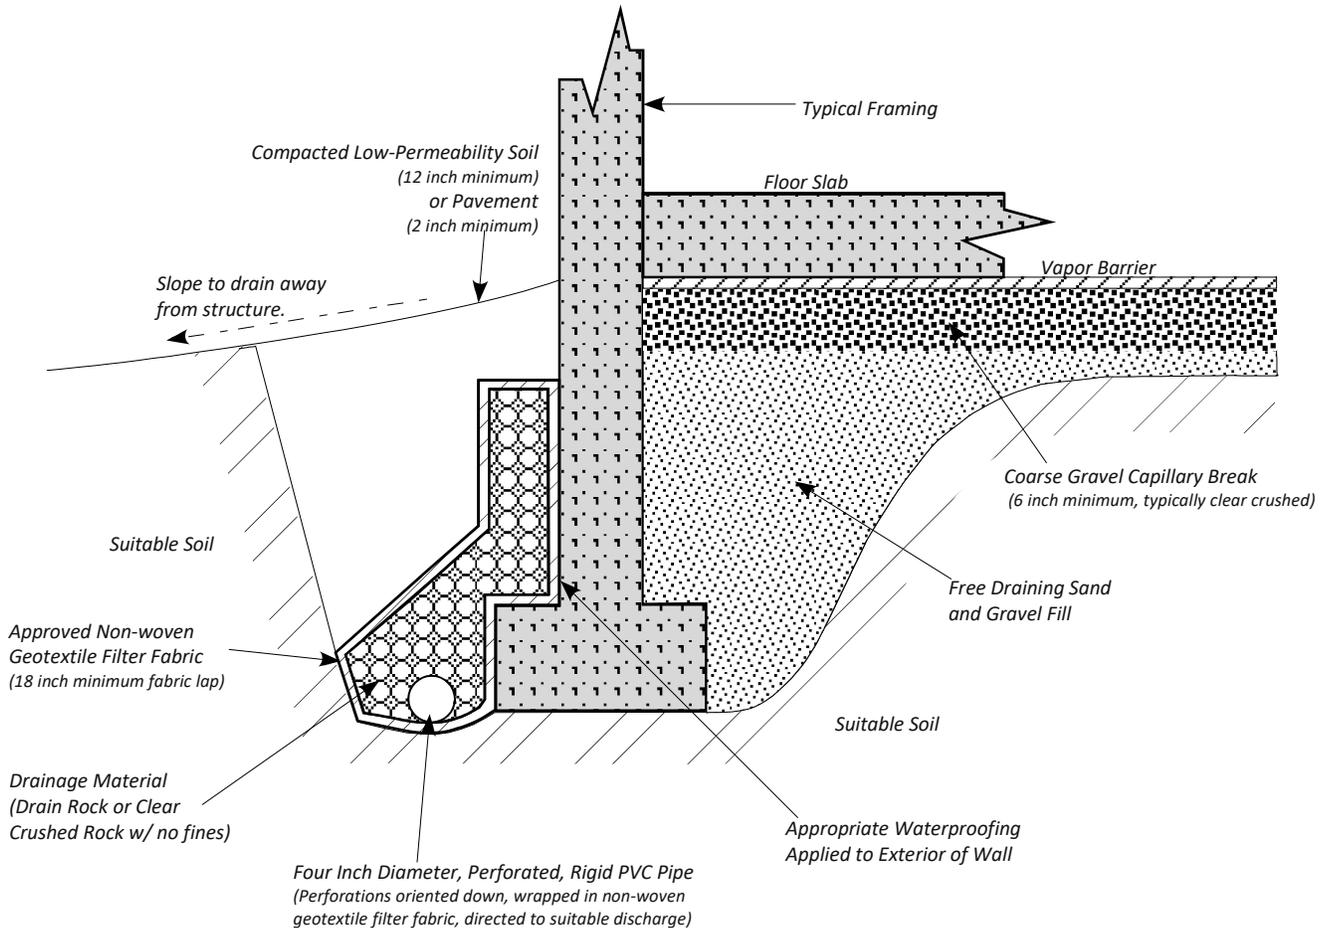
## CONCEPTUAL FOOTINGS WITH INTERIOR SLAB-ON-GRADE

**This figure is not intended to be representative of a design. This figure is intended to present concepts that can be incorporated into a functional foundation drain designed by a Civil Engineer. In all cases, refer to the Civil plan sheet for drain details and elevations.**

To reduce the potential for groundwater and surface water to seep into interior spaces, GeoTest recommends that an exterior footing drain system be constructed around the perimeter of new building foundations as shown in the *Typical Footing Drain Section* (Figure 3) of this report. The

The filtering media may consist of open-graded drain rock wrapped in a nonwoven geotextile fabric such as Mirafi 140N (or equivalent) or wrapped with a graded sand and gravel filter. For foundations supporting retaining walls, drainage backfill should be carried up the back of the wall and be at least 12 inches wide. The drainage backfill should extend from the foundation drain to within approximately 1 foot of the finished grade and consist of open-graded drain rock containing less than 3 percent fines by weight passing the U.S. Standard No. 200 sieve (based on a wet sieve analysis of that portion passing the U.S. Standard No. 4 sieve). The invert of the footing drainpipe should be placed at approximately the same elevation as the bottom of the footing or 12 inches below the adjacent floor slab grade, whichever is deeper, so that water will be contained. This process prevents water from seeping through walls or floor slabs. The drain system should include cleanouts to allow for periodic maintenance and inspection.

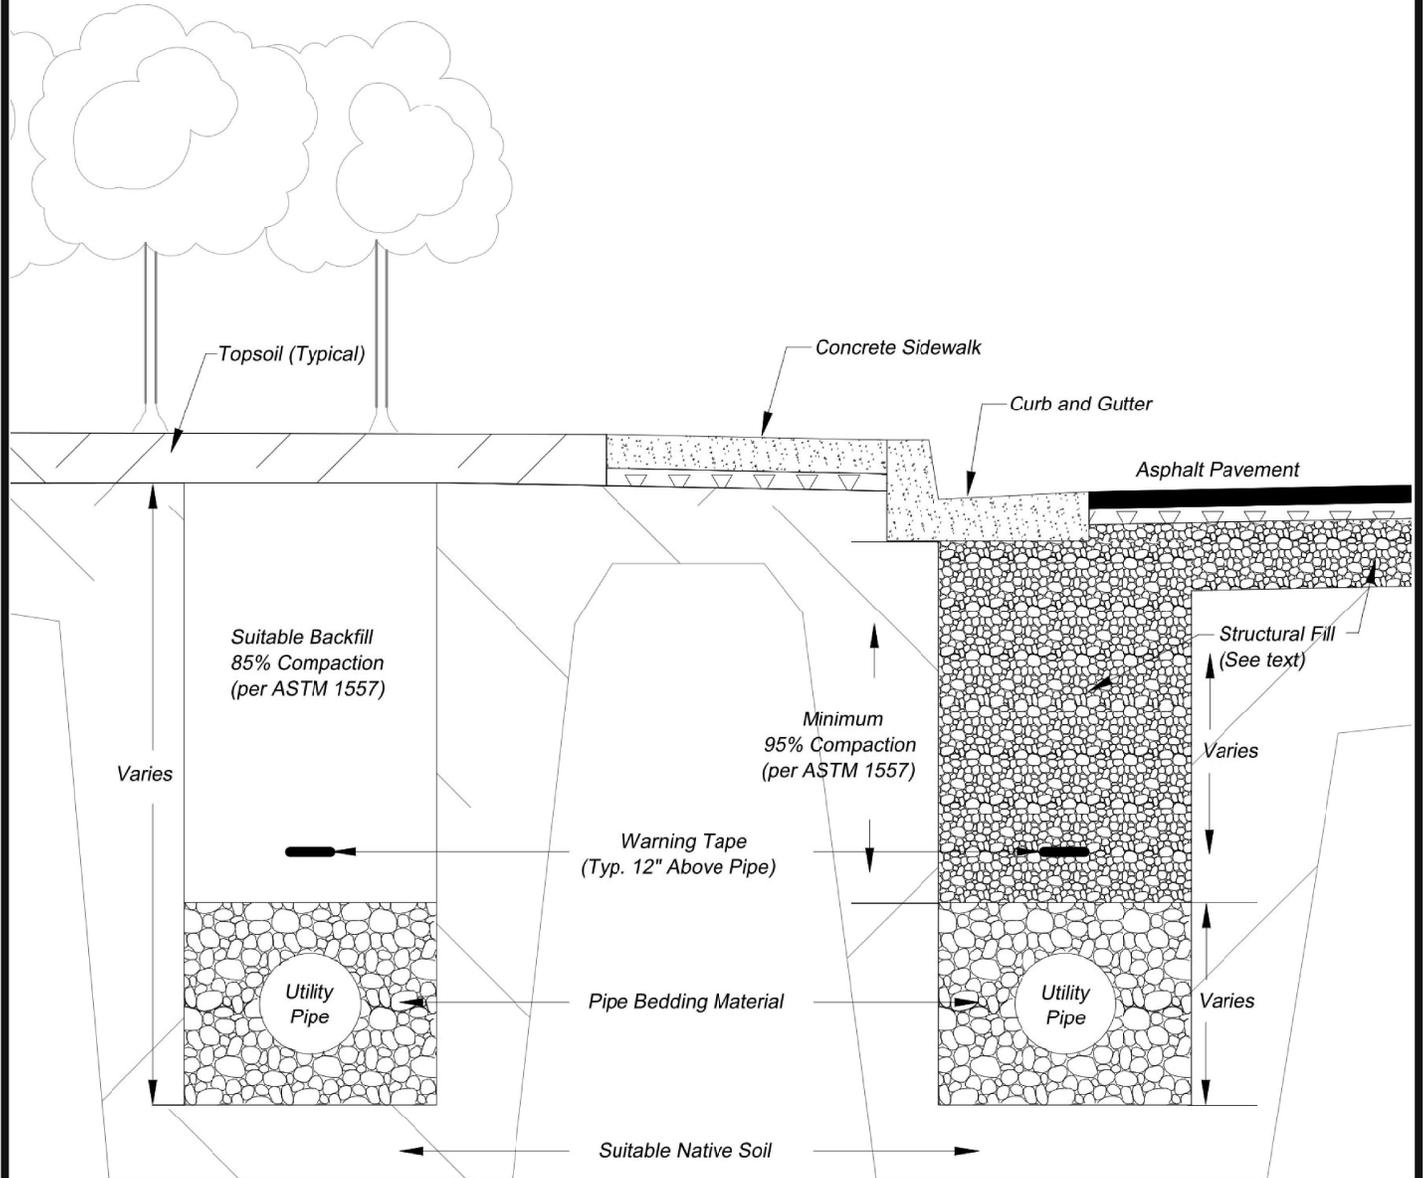
**LANDSCAPING AREAS**

**LOAD BEARING AREAS**

Trench backfill in improved areas (beneath structures, pavements, sidewalks, etc.) should consist of structural fill as defined in the *Fill and Compaction* section of this report. Outside of improved areas, trench backfill may consist of reused native material provided the backfill can be compacted to the project specifications. Trench backfill should be placed and compacted in general accordance with the recommendations presented in the *Fill and Compaction* section of this report and *Typical Utility Trench Section* (Figure 4).

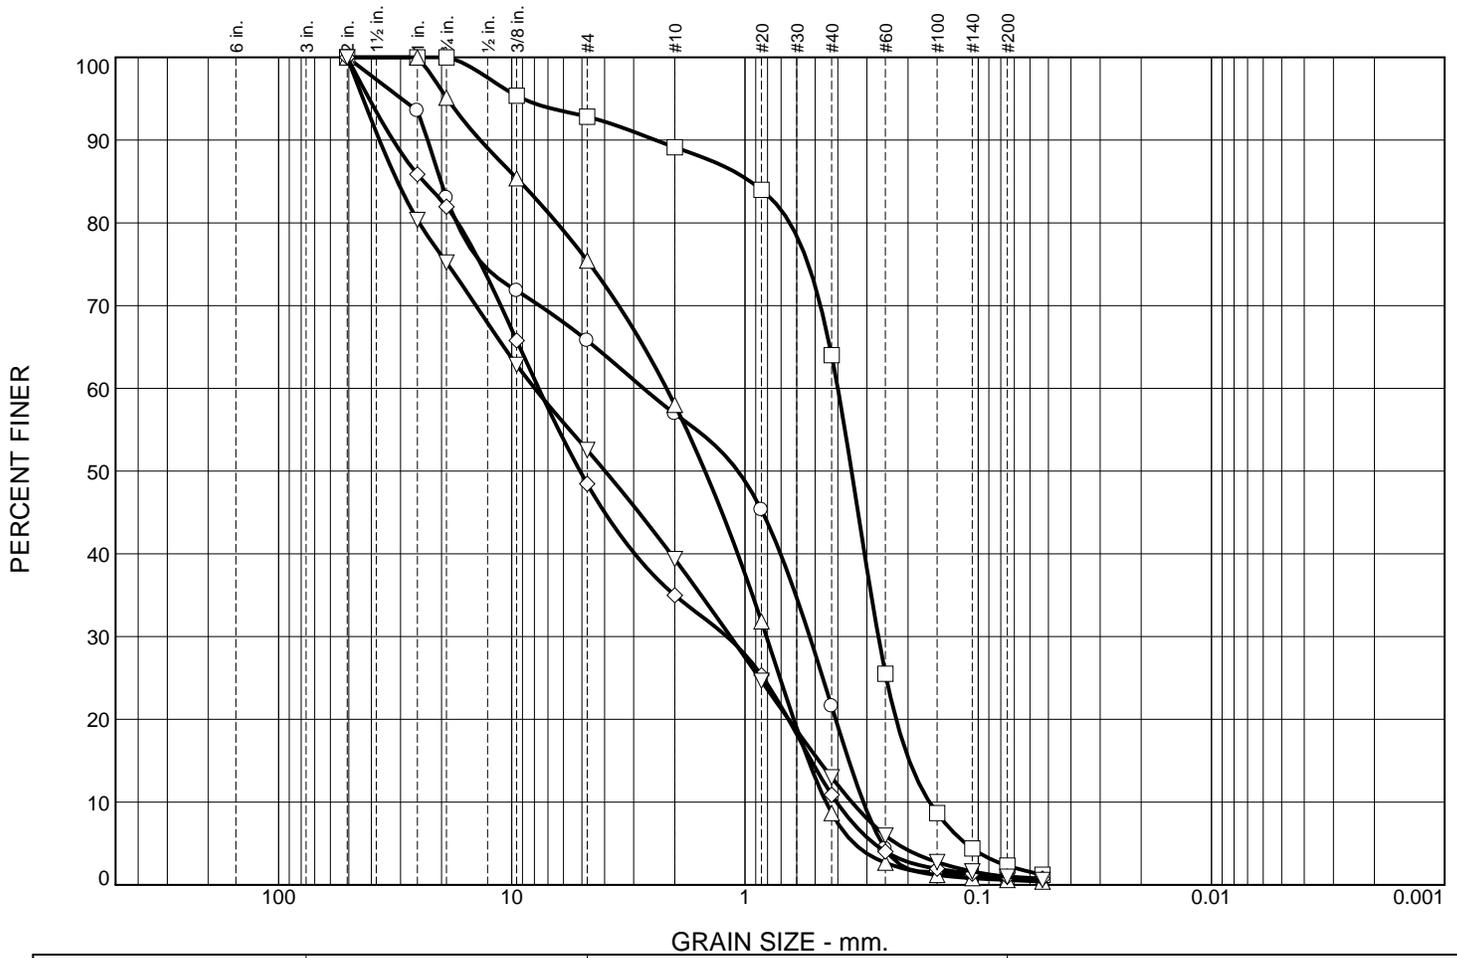
# Grain Size Test Data

% +3"	% Gravel		% Sand			% Fines	
		Coarse	Fine	Coarse	Medium	Fine	Silt	Clay
○	0	17	17	9	35	21	1	
□	0	0	7	4	25	62	2	
△	0	5	20	17	49	8	1	
◇	0	18	34	13	24	10	1	
▽	0	25	22	14	26	12	1

SOIL DATA					
SYMBOL	SOURCE	SAMPLE NO.	DEPTH (ft.)	Material Description	USCS
○	TP-2	19	6.5	poorly graded sand with gravel	SP
□	TP-3	25	4.1	poorly graded sand	SP
△	TP-4	34	5.8	poorly graded sand with gravel	SP
◇	TP-5	42	6.0	poorly graded gravel with sand	GP
▽	TP-6	47	5.8	poorly graded sand with gravel	SP
