Stormwater Management Report

Jensen Park Improvements

Infiltration Feasibility and Limited Geotechnical Report

Regarding: Infiltration Feasibility and Limited Geotechnical Report
Proposed Parking Lot Expansion and Restroom
Jensen Park
7801 Jensen Farm Lane
Arlington, WA 98223
Parcel No. 00875500099900

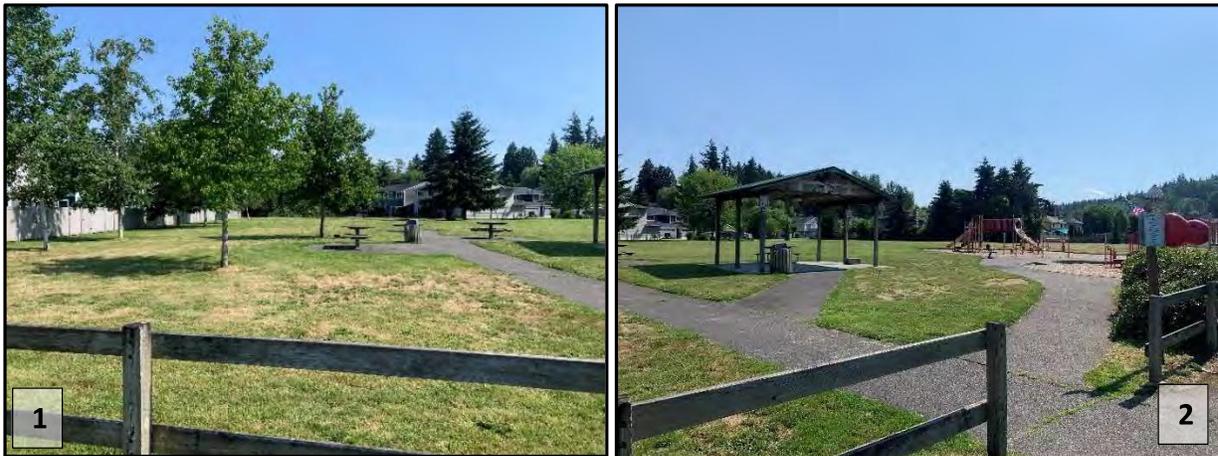
Images 1 and 2: Grassy landscape north of the existing parking lot, facing north (Image 1). Existing playground and gazebo in the central portion of Jensen Park, facing northeast (Image 2). Images 1 and 2 taken on June 23, 2023.

The project area currently contains an open public park and is generally flat with less than 5 feet of elevation change across the site. The park is located on the north side of Jensen Farm Lane in Arlington, just east of Kent Prairie Elementary School. The subject property is surrounded by residential housing, but also borders Portage Creek to the north and Jensen Farm Lane to the south. Empty grass fields with a few sparse deciduous trees make up most of the project area, but the site also contains walking paths, a gazebo, picnic benches, and a playground. A small parking lot sits in the southwestern corner of the park and consists of approximately six parking stalls.

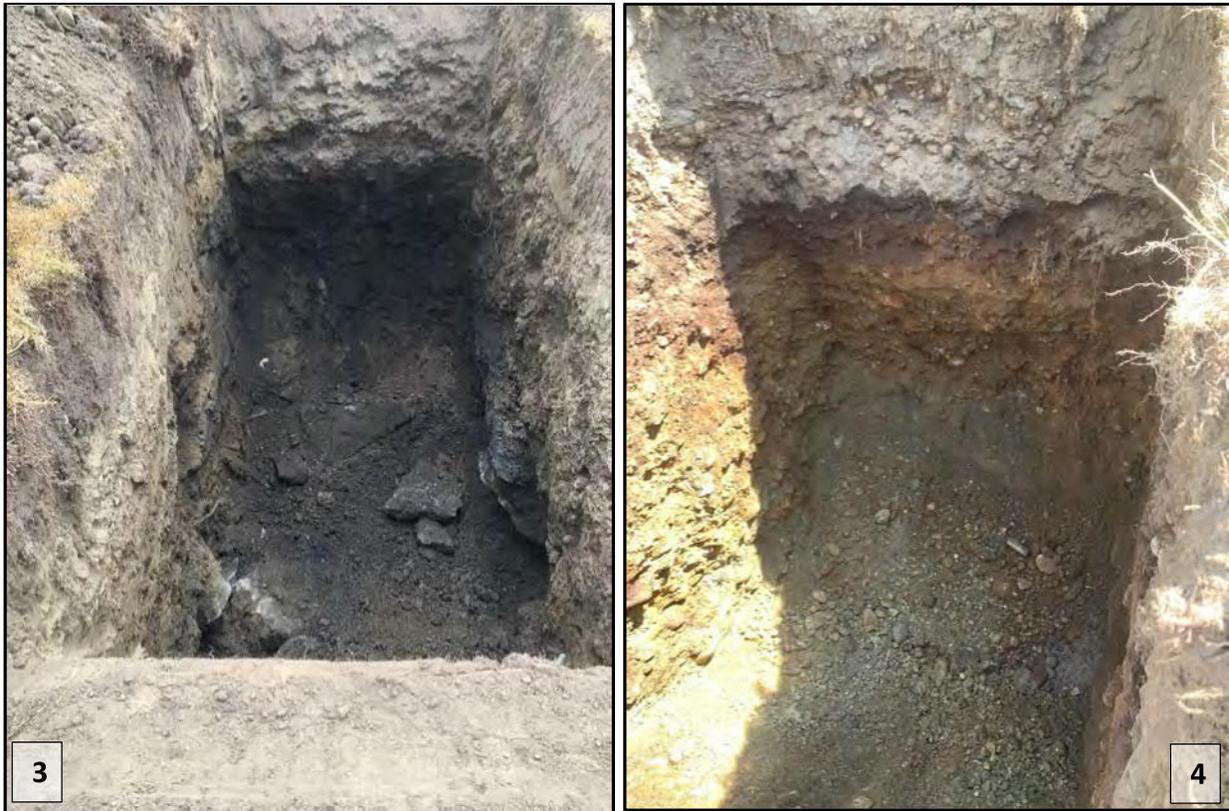
Images 3 and 4: General soil sequence observed in the northwestern area of the park where uncontrolled fill sections were observed (TP-2 – Image 3). Soil sequence in the southern portion of the park near the parking lot, where native sands and gravels were observed (TP-2 – Image 4). Images 3 and 4 taken on July 11, 2023.

The on-site subsurface soils in all three test pits consisted of approximately 1 to 1.5 feet of topsoil, which was medium dense, gray, dry, gravelly, silty sand with scattered organics (grass and roots). At location TP-1, underlying the topsoil was medium dense, brown, moist, gravelly, silty sand with cobbles. At 2.5 feet BGS, a 0.5-foot-thick bed of dense, dark gray, moist, silty, very sandy gravel with cobbles and boulders, GeoTest interpreted these soils to be moderately compacted fill. From 3 to 4.5 feet BGS, a relict topsoil was observed consisting of loose, black, moist, very silty sand with trace gravel and scattered grasses. From 4.5 feet BGS to the end of the exploration at 10 feet BGS, GeoTest observed loose, black, moist, very silty sand with trace gravel with wood and organics, interpreted to be old farm soils.

At the location of TP-2, underlying the topsoil was loose, brown, moist, poorly graded sand with silt and trace gravel with occasional roots interpreted to be reworked uncontrolled fill. From 2.75 feet BGS to 5.5 feet BGS, a medium dense, dark brown, moist, sandy, very silty gravel with garbage and construction debris, which was interpreted to be uncontrolled fill. A 1-foot-thick section of medium stiff, gray, moist, gravelly, very sandy silt, was observed from 5.5 to 6.5 feet BGS. From 6.5 feet BGS to the terminal depth of 8.5 feet BGS, GeoTest observed dense, dark gray, moist, silty, very sandy gravel with abundant amounts of concrete and wood, which was interpreted as uncontrolled fill and construction debris.

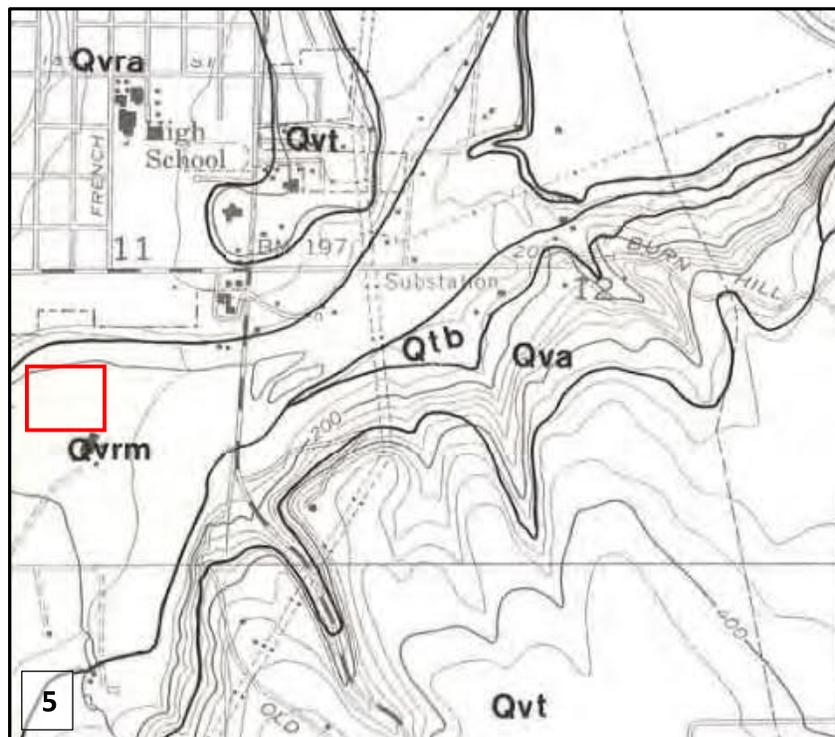
Image 5. Clip from the *Geologic map of the Arlington East 7.5-minute quadrangle, Snohomish County, Washington*, illustrating that the subject property is underlain by mapped Marysville Sand soils (map unit deposits Minard, J.P., 1985). Approximate site vicinity encapsulated by the red polygon.

Geologic information for the project site was obtained from the *Geologic map of the Arlington East quadrangle, Snohomish County, Washington* (Minard, J.P., 1985) and from the *Washington Geologic Information Portal*. According to these publications, geology within the vicinity of the project site consists of Recessional Outwash (Marysville Sand member, map unit Qvrm) and originated in the last Pleistocene. Till (map unit Qvt) is mapped atop the hillside to the southeast of the project area and also originates from Pleistocene glacial periods, also referred to as “Vashon Till.” Recessional Outwash, (Arlington Gravel member map unit Qvra) is mapped to the north of the project area and originated in the late Pleistocene period.

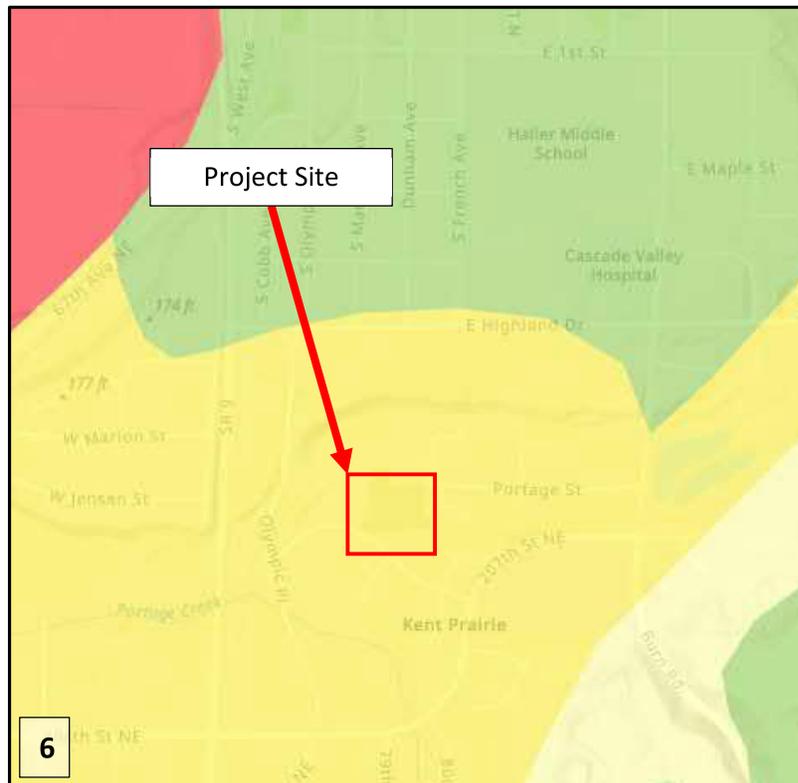
Image 6. Screenshot from the DNR *Geologic Information Portal*, in which the entire project site is considered to possess a **low to moderate** liquefaction susceptibility (shown in yellow).

According to the *Washington Geologic Information Portal* and the *PDS Map Portal*, the subject property is mapped as having a **low to moderate** potential for seismic liquefaction. According to the *Geologic Information Portal* and *United States Geological Survey (USGS)*, the closest known faults are part of the Darrington-Devils Mountain Fault Zone, approximately 10 miles north of the project area. Similarly, there are mapped faults in vicinity of Mukilteo, WA approximately 20 miles southwest of the project area. These mapped faults are part of the Southern Whidbey Island Fault Zone.

Based on our understanding of the local geology, it is GeoTest’s opinion that **the subject property is not a Seismic Hazard**. Outside of compliance with current building codes, GeoTest does not recommend specific mitigations for the planned construction to address potential seismic hazards that exist in the region.

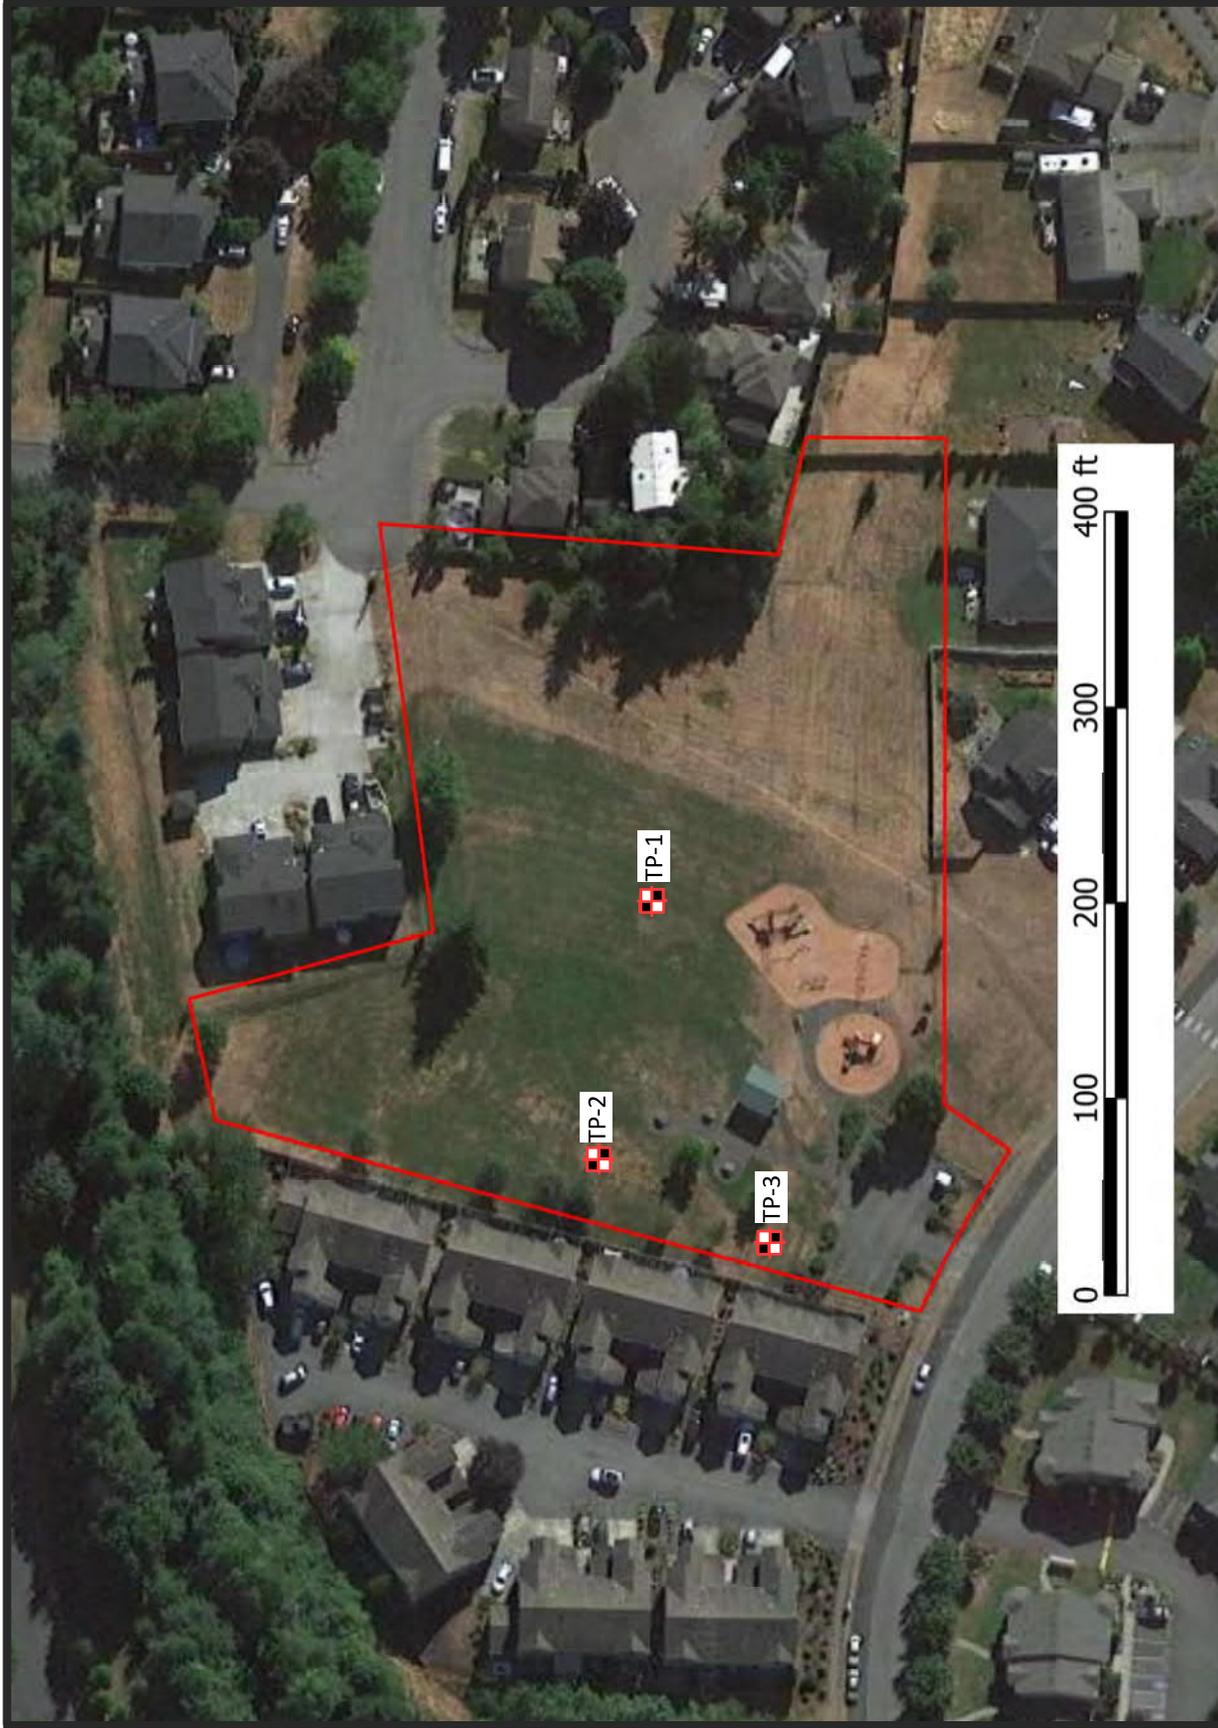
- TP-# = Approximate Test Pit Location**
- Notes:**
- 1) Parcel shapefile sourced from Snohomish County PDS Map Portal
 - 2) Approximate project area outlined in RED
 - 3) Map image created using QGIS 3.22.6.

Subsurface conditions were explored and documented by advancing three test pits (TP-1 through TP-3) on July 11, 2023, under the direction of a Licensed Geologist. Soils were classified in general accordance with the guidelines of the American Society for Testing and Materials (ASTM) D2487 and D2488. Approximate locations of these explorations have been plotted on the *Site and Exploration Plan* (Figure 2). A *Soil Classification System and Key* can be found as Figure 3, detailed test pit logs are presented as Figures 4 and 5, with laboratory results as Figure 6.

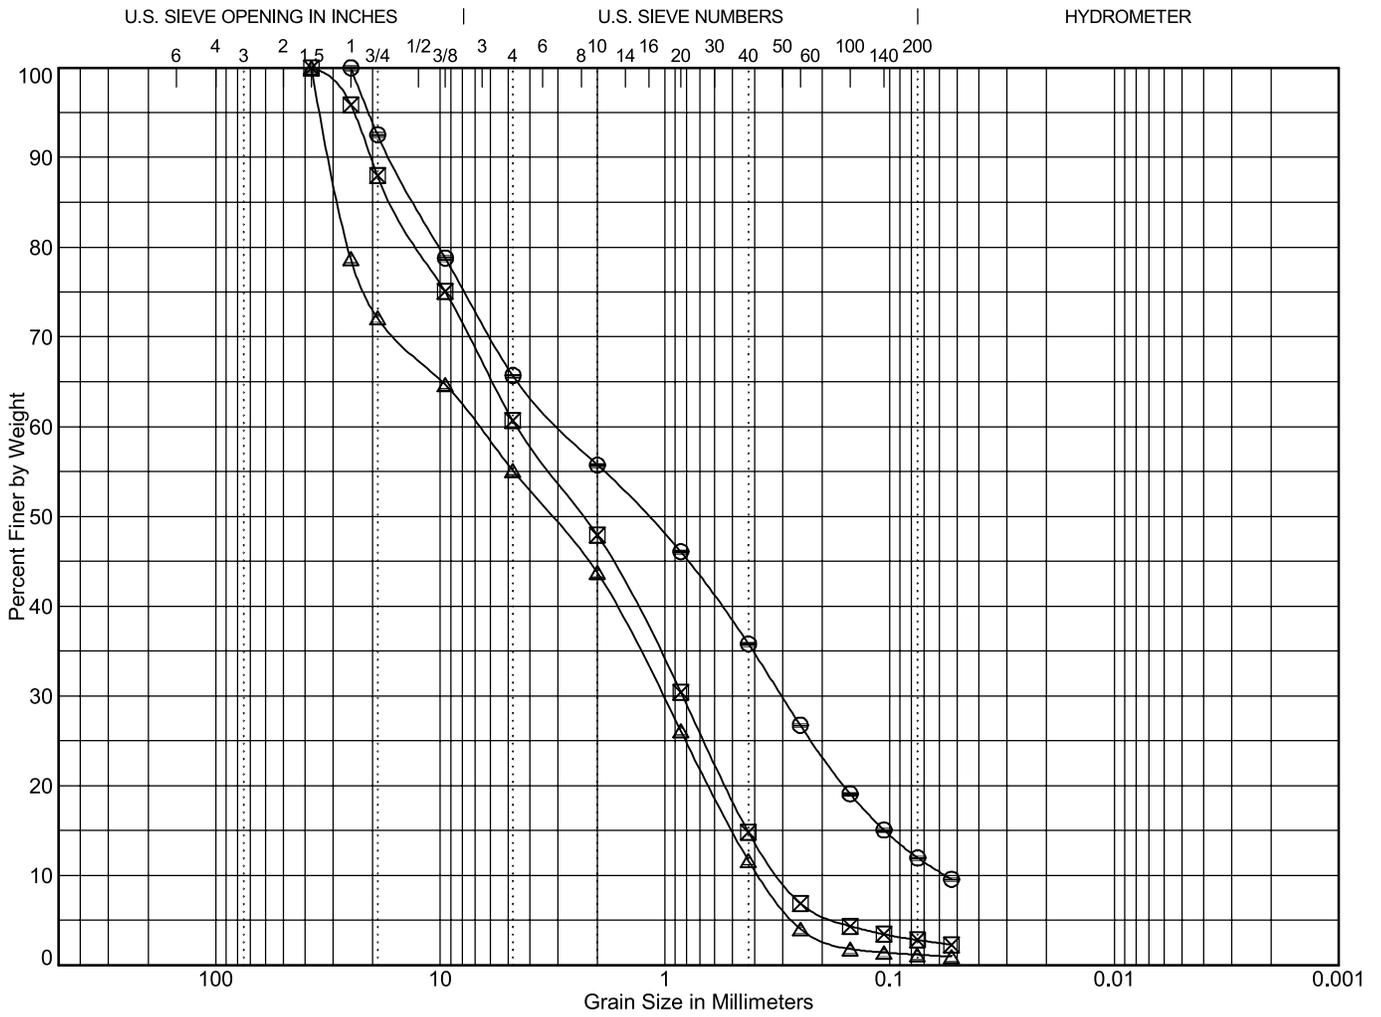
Cobbles	Gravel		Sand			Silt or Clay
	coarse	fine	coarse	medium	fine

Point	Depth	Classification	LL	PL	PI	C _c	C _u
⊖	TP-2 4.0	SILTY, VERY GRAVELLY SAND (SM)				0.56	51.36
⊠	TP-3 4.0	POORLY GRADED SAND with GRAVEL (SP)				0.50	14.72
⊠	TP-3 6.0	POORLY GRADED SAND with GRAVEL (SP)				0.41	17.80

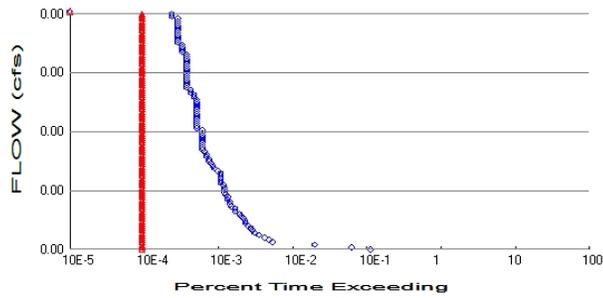
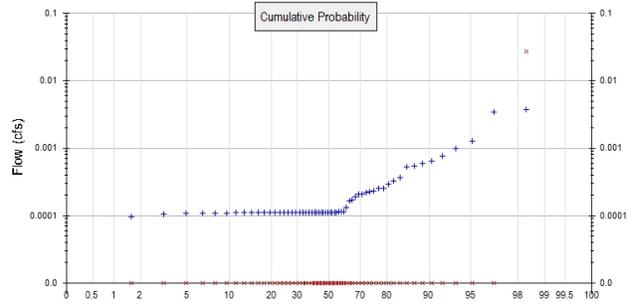
POC 1

Analysis Results

+ Predeveloped x Mitigated

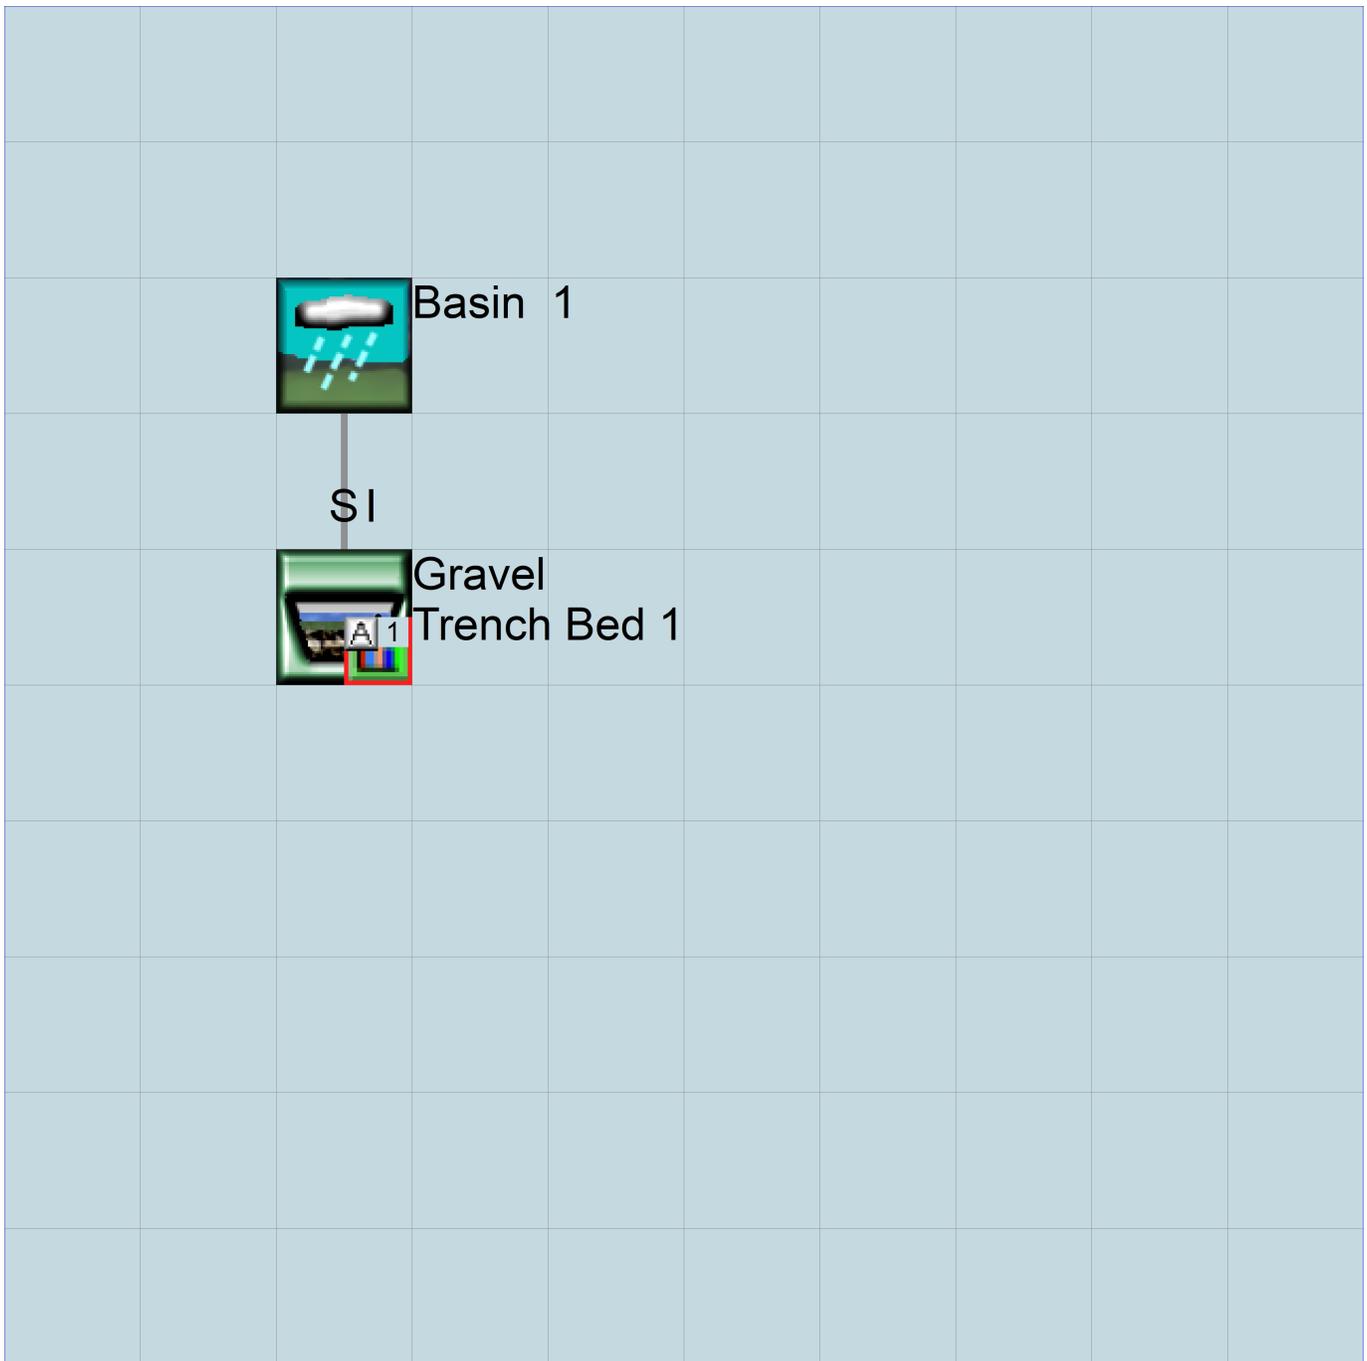
Mitigated Schematic

Basin 1
0.14ac
