**GEOTECHNICAL ENGINEERING STUDY
PROPOSED RESIDENTIAL DEVELOPMENT
LINDSAY ANNEXATION
8014, 8118, 8210, AND 8326 – 172ND STREET NORTHEAST
ARLINGTON, WASHINGTON**

ES-9786

June 28, 2024

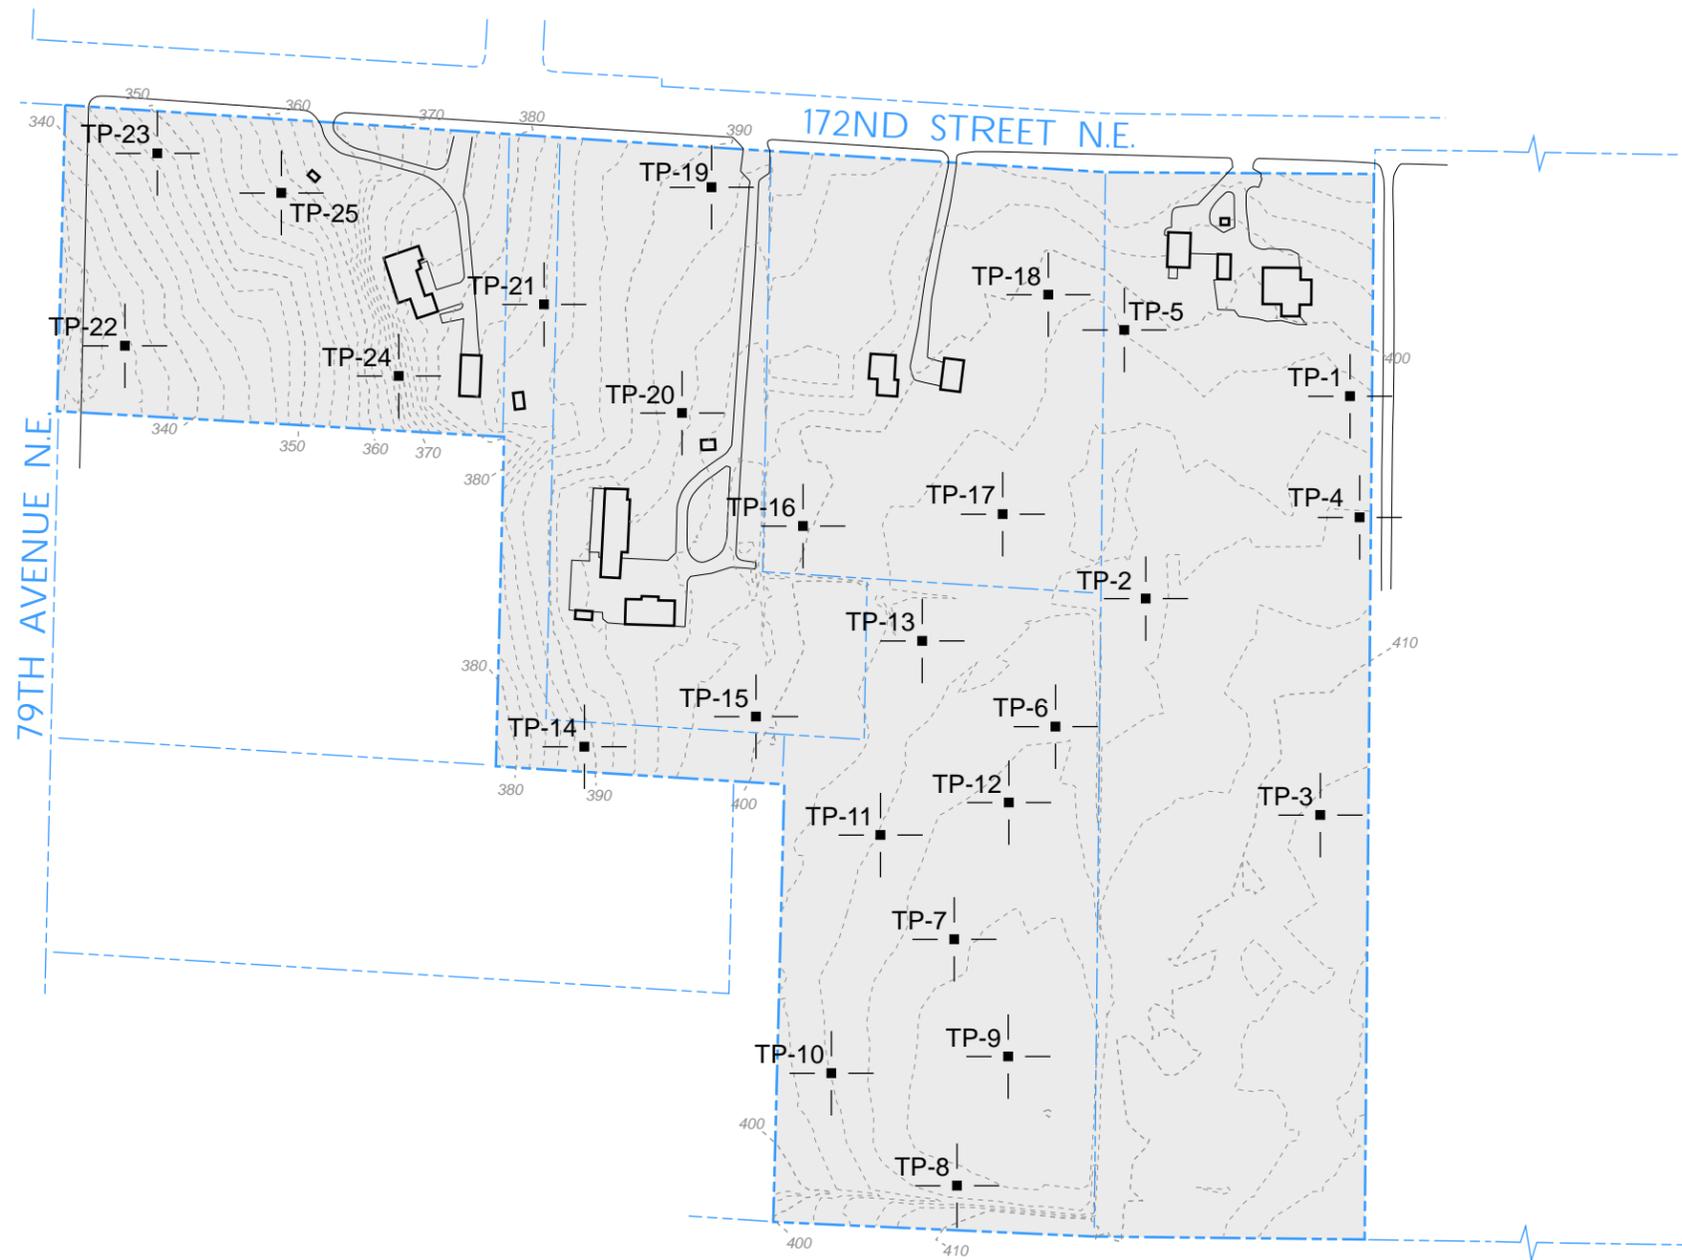
Drawn MRS
Checked AZS
Date 06/12/2024
Proj. No. 9786
Plate 2

- TP-1 | ■ | Approximate Location of ESNW Test Pit, Proj. No. ES-9786, April 2024
- ▭ | Subject Site
- ▭ | Existing Building

The approximate locations of the test pits are depicted on Plate 2 (Test Pit Location Plan). Please refer to the test pit logs provided in Appendix A for a more detailed description of subsurface conditions. Representative soil samples collected at our exploration sites were analyzed in general accordance with Unified Soil Classification System (USCS) and United States Department of Agriculture (USDA) methods and procedures.

Subsurface conditions on site were explored on April 2, 2024, by advancing 25 test pits using a machine and an operator retained by ESNW. The approximate locations of the test pits are illustrated on Plate 2 of this study. The test pit logs are provided in this Appendix. The test pits were advanced to a maximum depth of about 11 feet bgs.

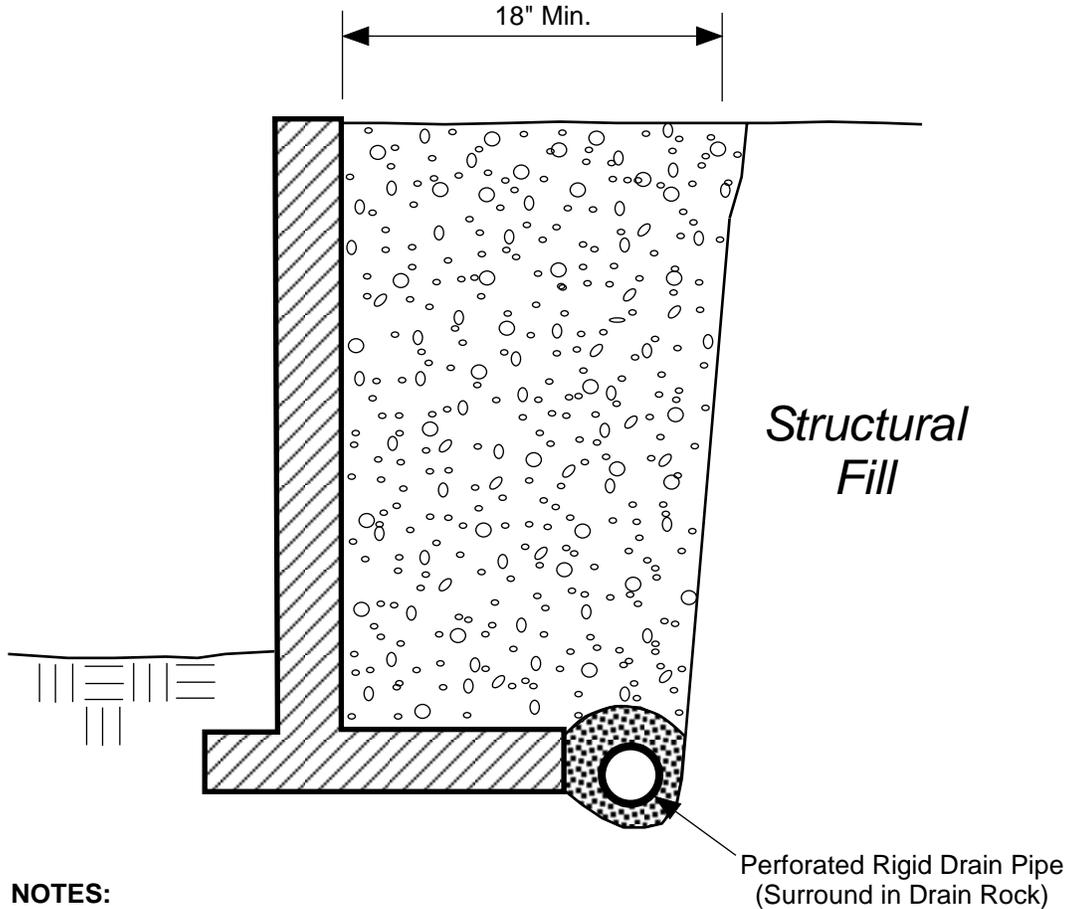
Earth Solutions NW_{LLC} Geotechnical Engineering, Construction Observation/Testing and Environmental Services	
Retaining Wall Drainage Detail Lindsay Annexation Arlington, Washington			
Drawn	MRS	Date	06/13/2024
Proj. No.	9786		
Checked	AZS	Date	June 2024
Plate	3

- Free-draining Backfill should consist of soil having less than 5 percent fines. Percent passing No. 4 sieve should be 25 to 75 percent.
- Sheet Drain may be feasible in lieu of Free-draining Backfill, per ESNW recommendations.
- Drain Pipe should consist of perforated, rigid PVC Pipe surrounded with 1-inch Drain Rock.

Drainage should be provided behind retaining walls such that hydrostatic pressures do not develop. If drainage is not provided, hydrostatic pressures should be included in the wall design. A perforated drainpipe should be placed along the base of the wall and connected to an approved discharge location. A typical retaining wall drainage detail is provided on Plate 3.

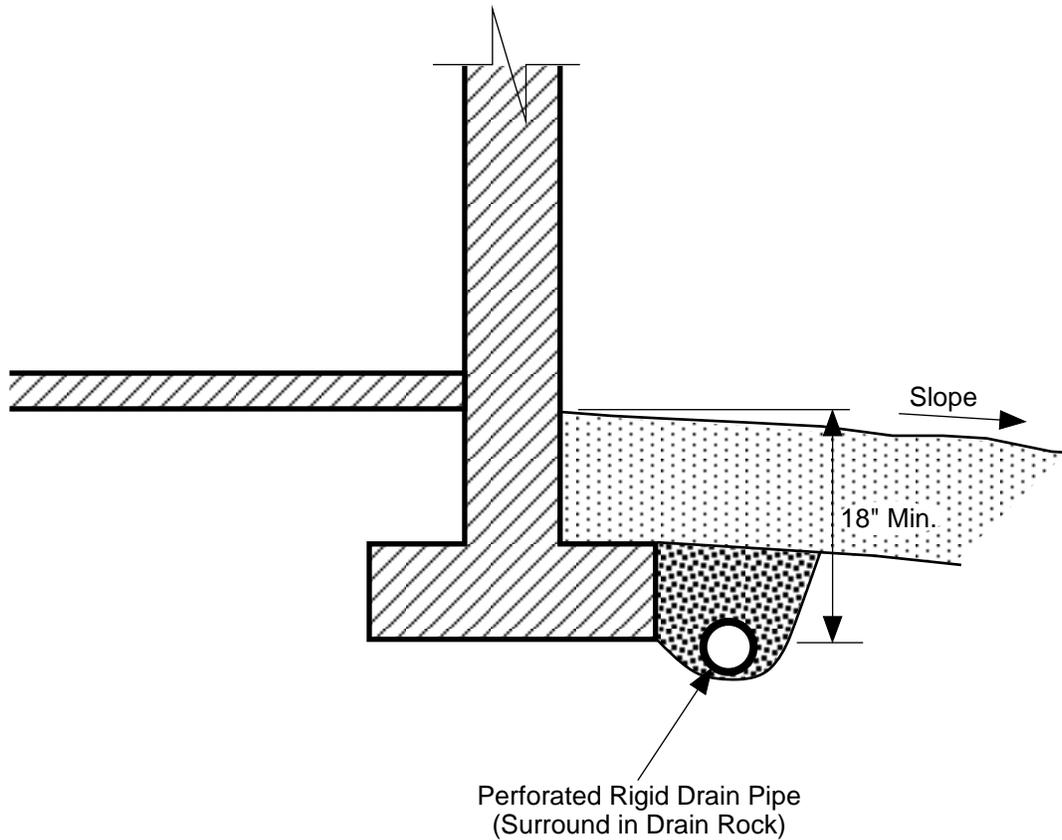
- Do NOT tie roof downspouts to Footing Drain.
- Surface Seal to consist of 12" of less permeable, suitable soil. Slope away from building.
