Technical Memorandum

**Re: Wetland, Fish, and Wildlife Habitat Assessment Technical Memorandum,
Atonement Church – 6905 172nd Street NE, Arlington, WA 98223**

ATONEMENT CHURCH - EXISTING CONDITIONS

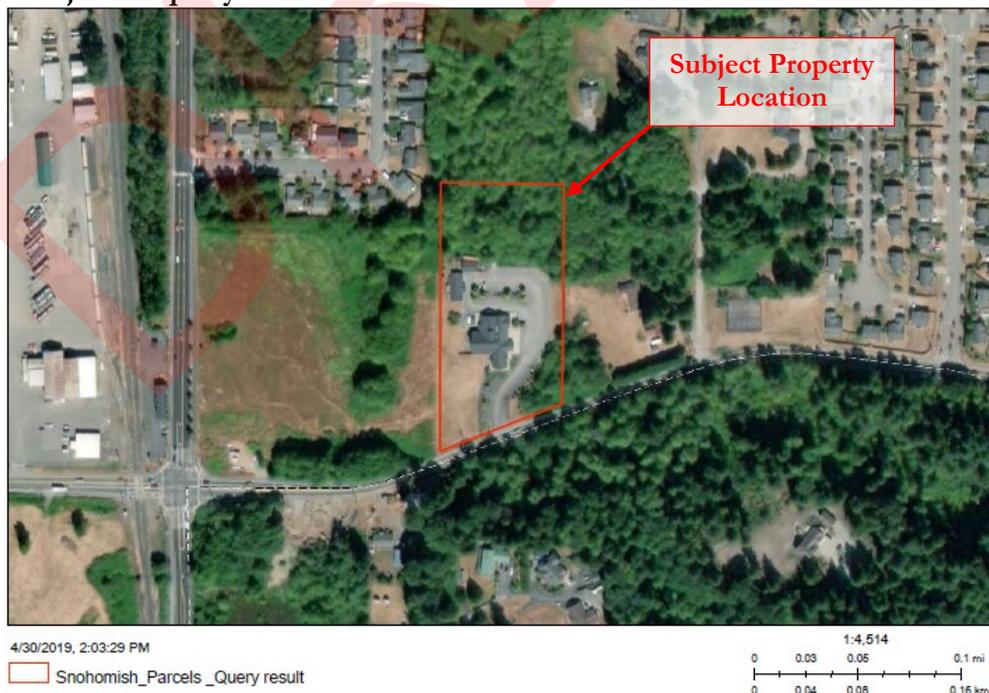
Figure 1. Subject Property Location.

Soundview Consultants LLC (SVC) conducted a wetland and fish and wildlife habitat assessment of an approximately 4.43-acre property located at 6905 172nd Street Northeast, in the City of Arlington, Washington (Figure 1). The property consists of one parcel in the Southwest $\frac{1}{4}$ of Section 23, Township 31 North, Range 05 East, W.M. (Snohomish County Tax Parcel Number 31052300300900). This assessment was conducted to support the proposed expansion of the church and associated parking lot onsite. SVC investigated the site to evaluate the presence of potentially regulated wetlands, streams, or other fish and wildlife habitat conservation areas on or adjacent to the subject property. This Technical Memorandum documents the results of that assessment, and provides a description of the proposed project and necessary code analysis. Attachment A shows the onsite findings and proposed conditions.

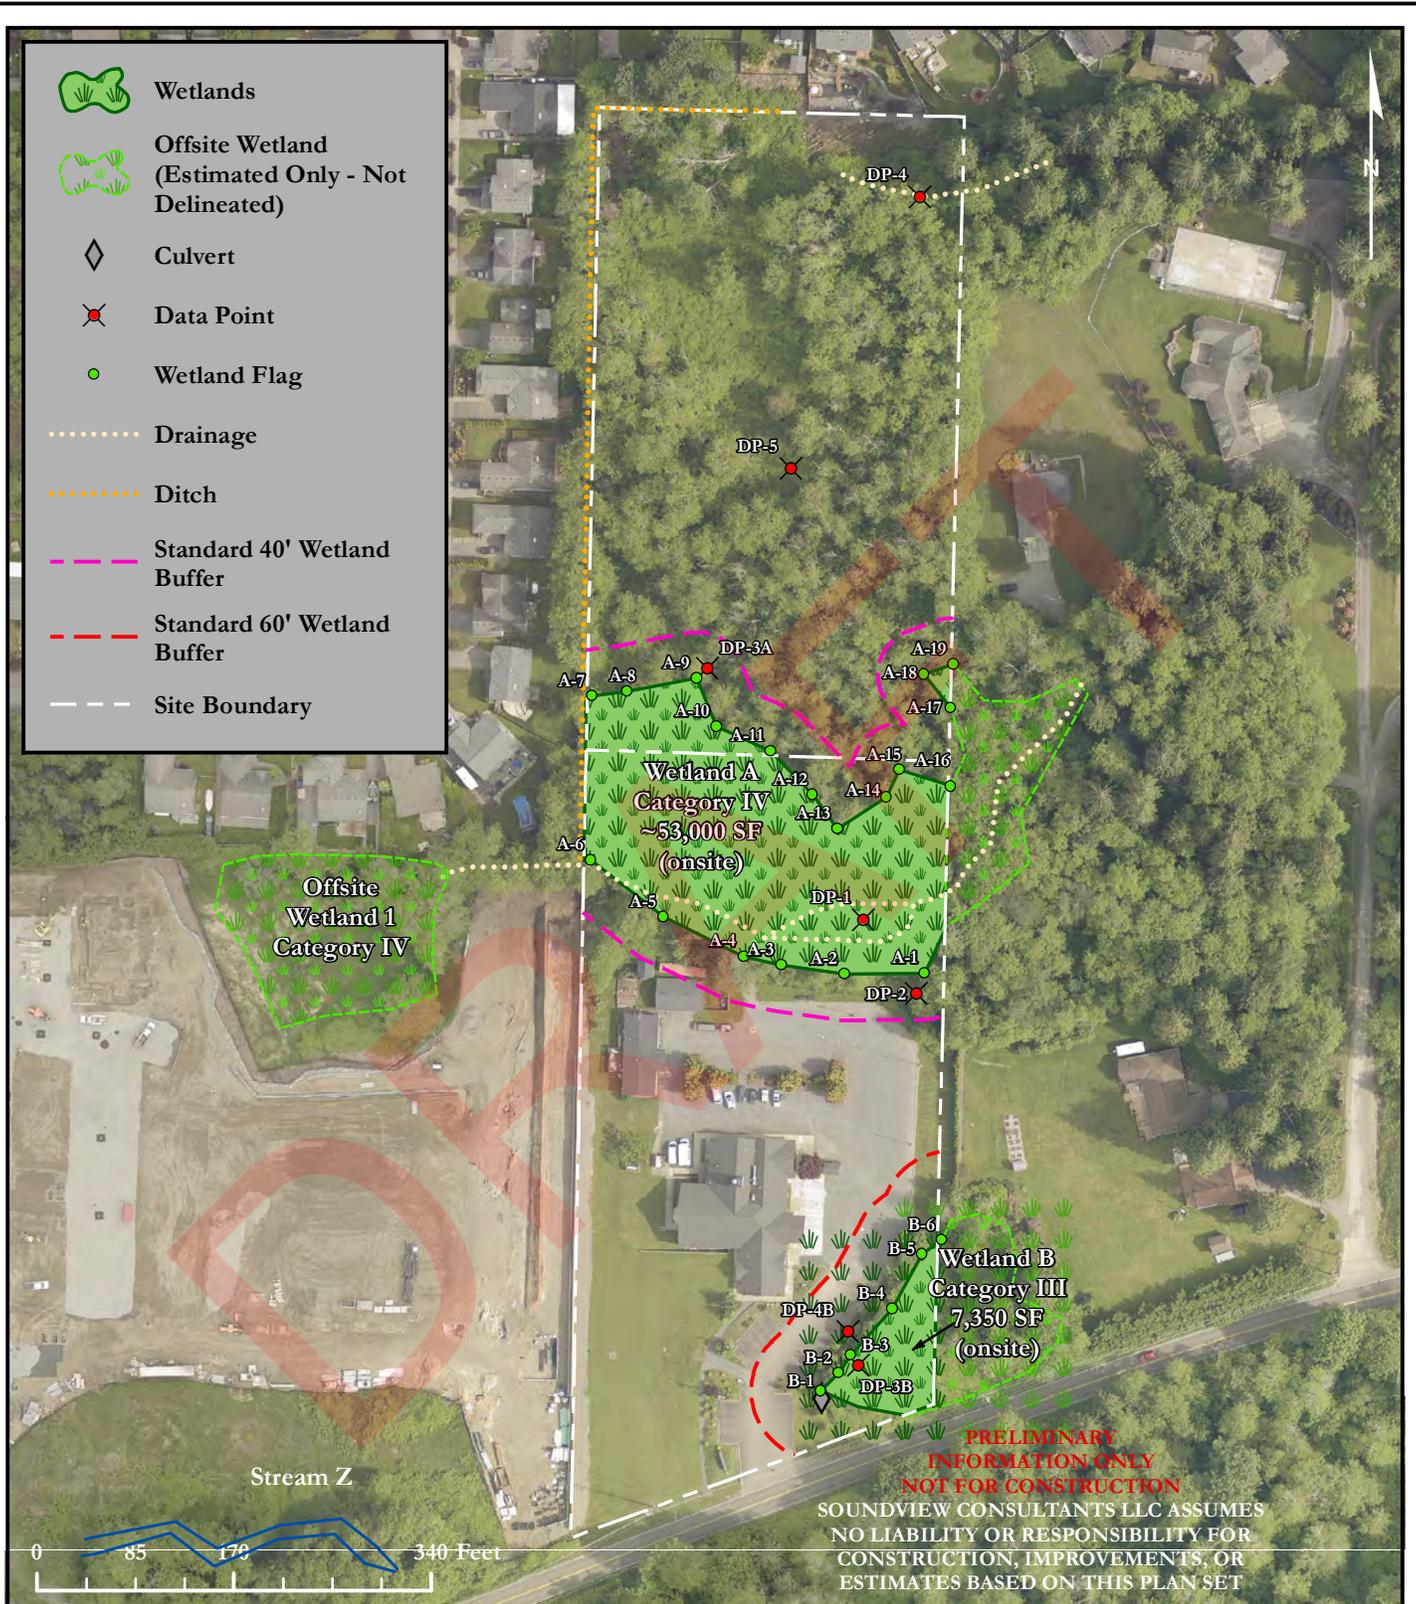
Wetland A is located in northern portion of the site, extending offsite to the east, and Wetland B is located in the southeastern portion of the site, extending offsite to the east. Offsite Wetland C is located approximately 120 feet west of the subject property. Edgecomb Creek, a Type F stream, was identified offsite south of the subject property, south of SR-531. Stream Z is an old side channel from Edgecomb Creek and is located on the adjacent property to the west. A drainage ditch was also identified onsite, running east to west through Wetland A. The onsite wetlands are depicted on the site plan in Attachment A. Table 1 summarizes the wetlands identified during the site investigation.

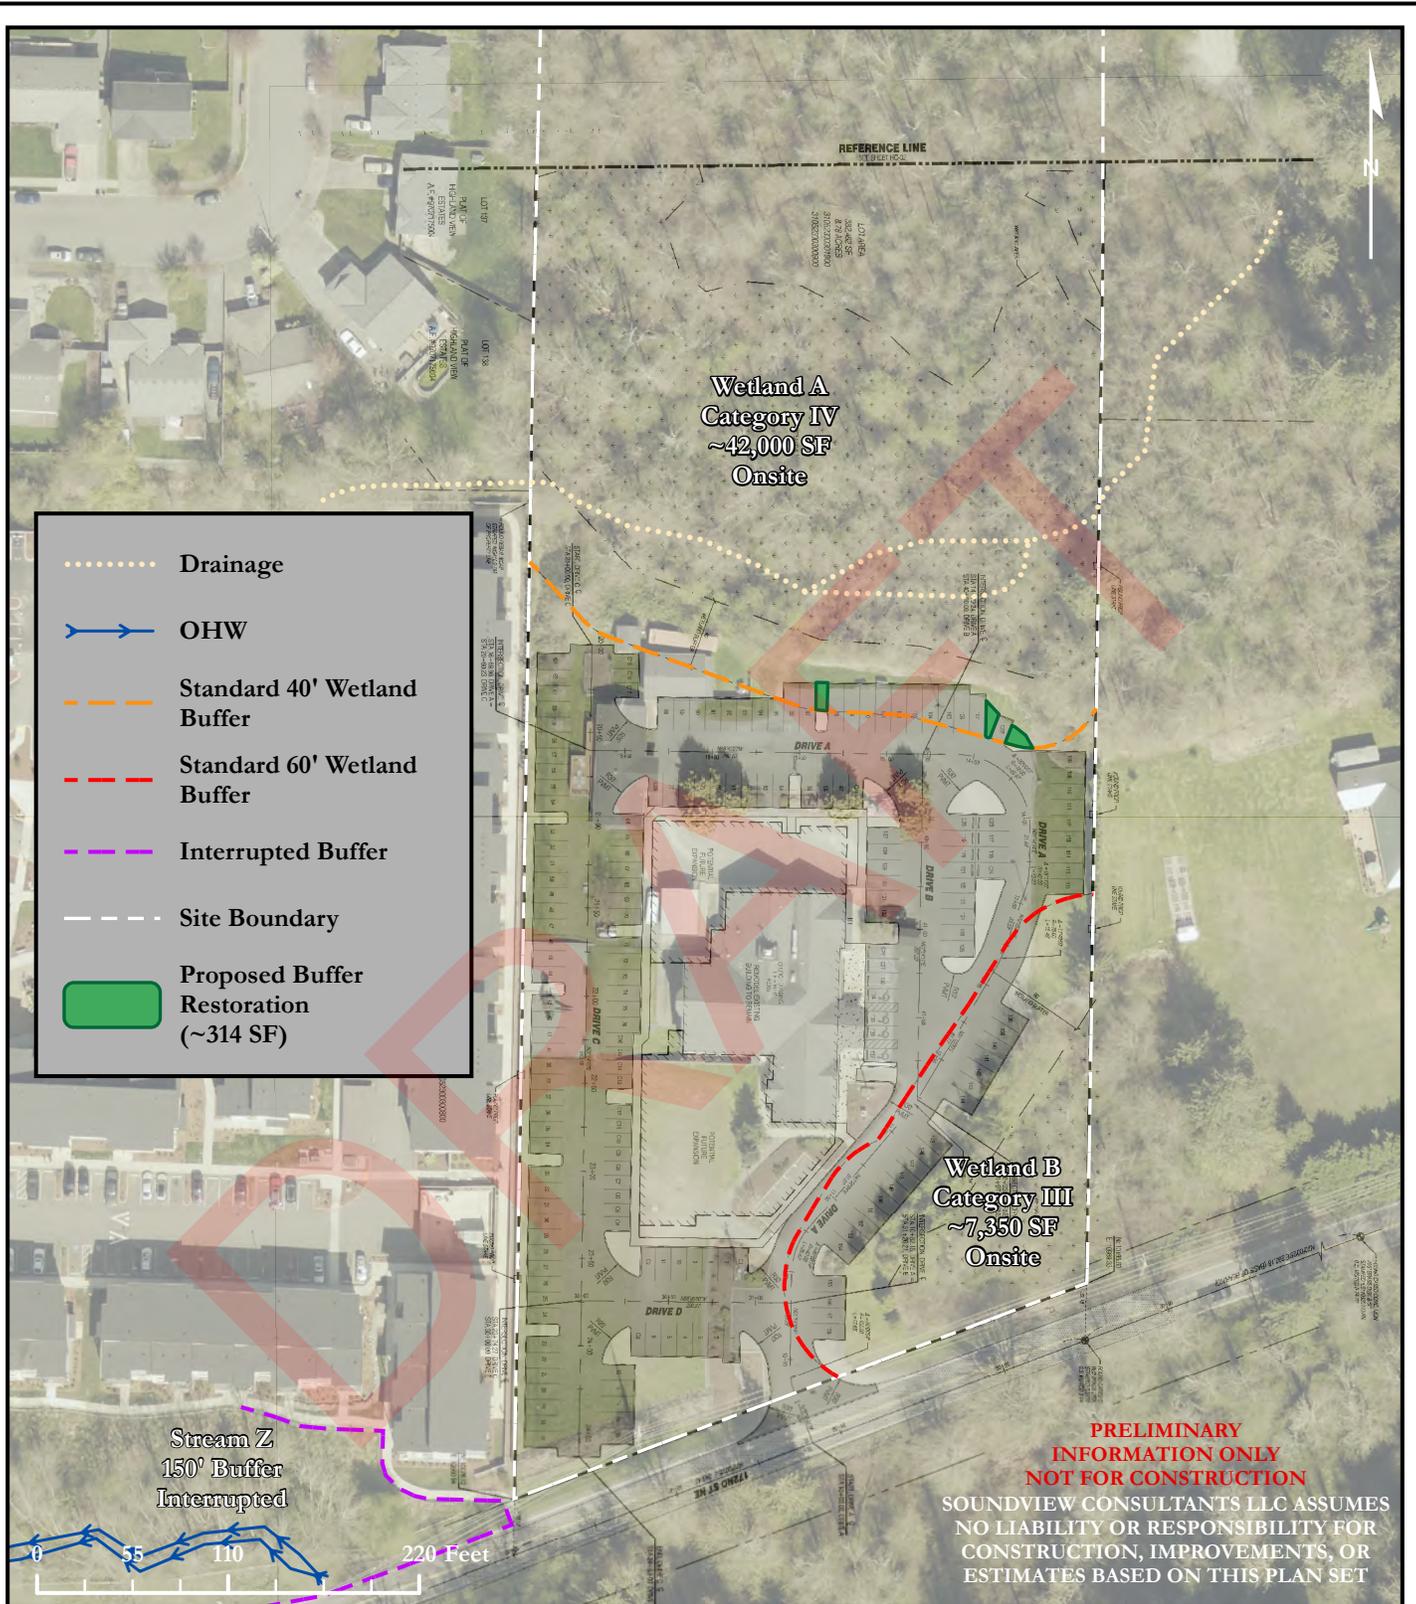
PROPOSED CONDITIONS

In addition to paving the existing gravel parking area within the buffer, three areas within the buffer of Wetland A are proposed to be restored with native vegetation. Buffer restoration will result in 314 square feet of native trees and shrubs to enhance on site conditions and restore vegetation to an area that has been previously provided little to no buffer functions. These buffer restoration actions are intended to result in a net zero increase of impacts within the buffers of Wetlands A and B from the proposed church development activities. The impervious surface definition in AMC 20.93.100 “Definitions”, does not differentiate between gravel, asphalt, parking lots, or driveways as they all impeded the natural infiltration of stormwater. Therefore, it does not appear that there is an increase in non-conformity. The new parking lot design will need to comply with current stormwater design

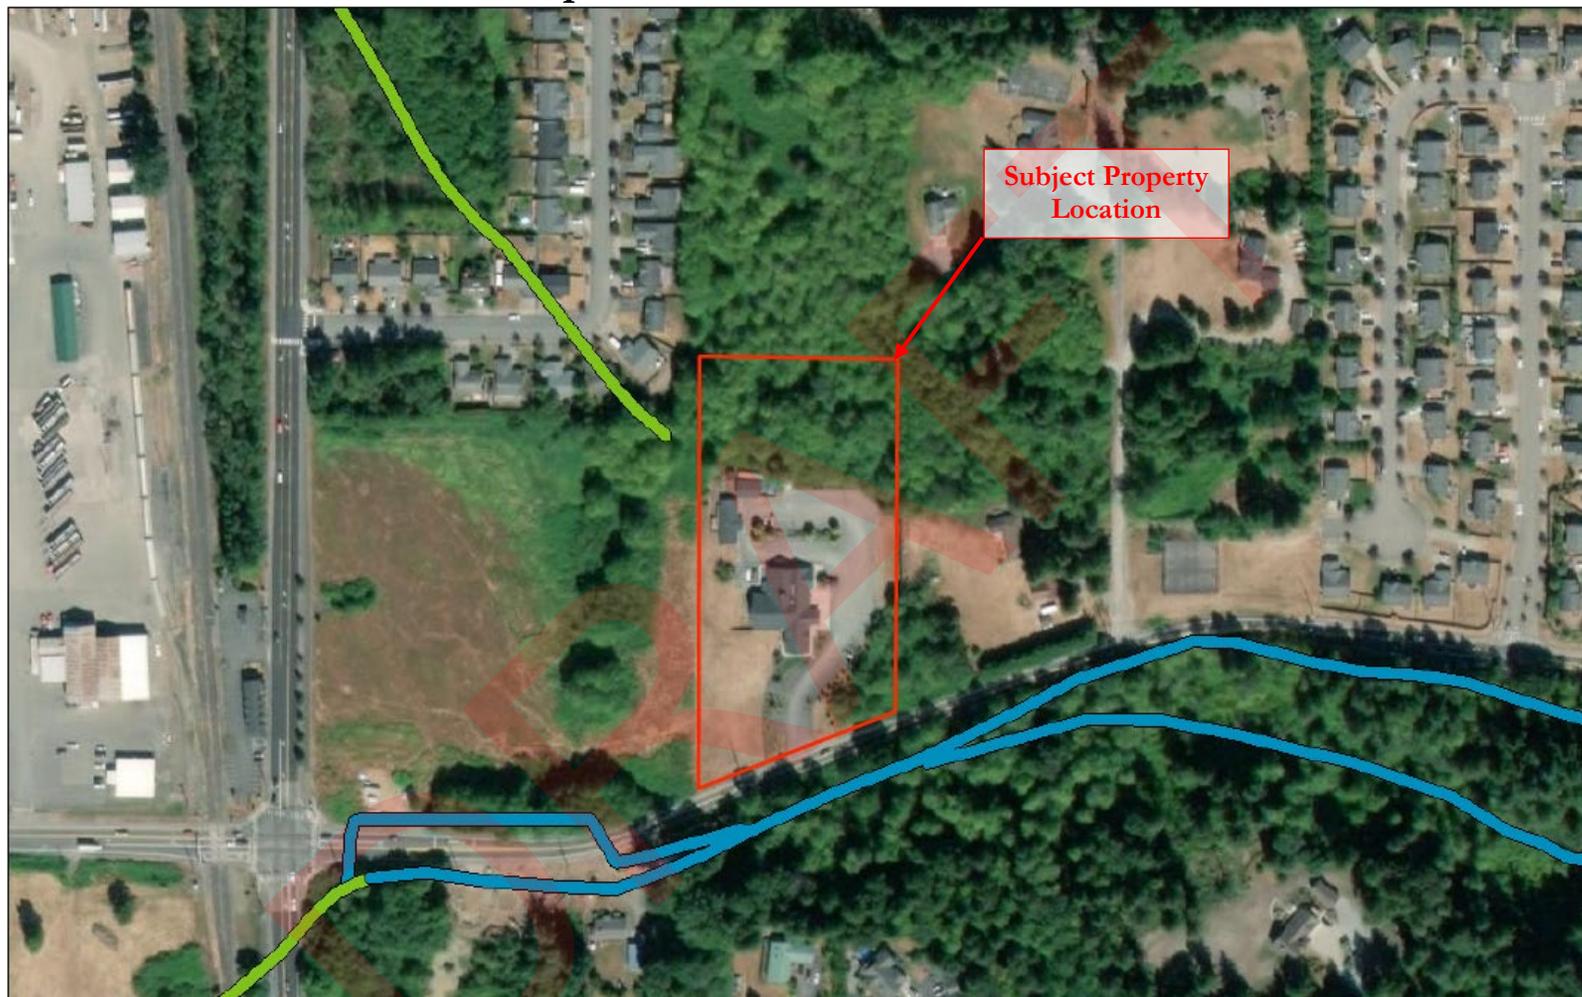
Attachment B1 – USFWS NWI Map

Neither the USFWS NWI map (Attachment B1) nor the Snohomish County Critical Areas Inventory map (Attachment B2) identify any potential wetlands onsite. NWI does show a potential linear wetland northwest of the subject property, and the County identifies a potential wetland west of the subject property.

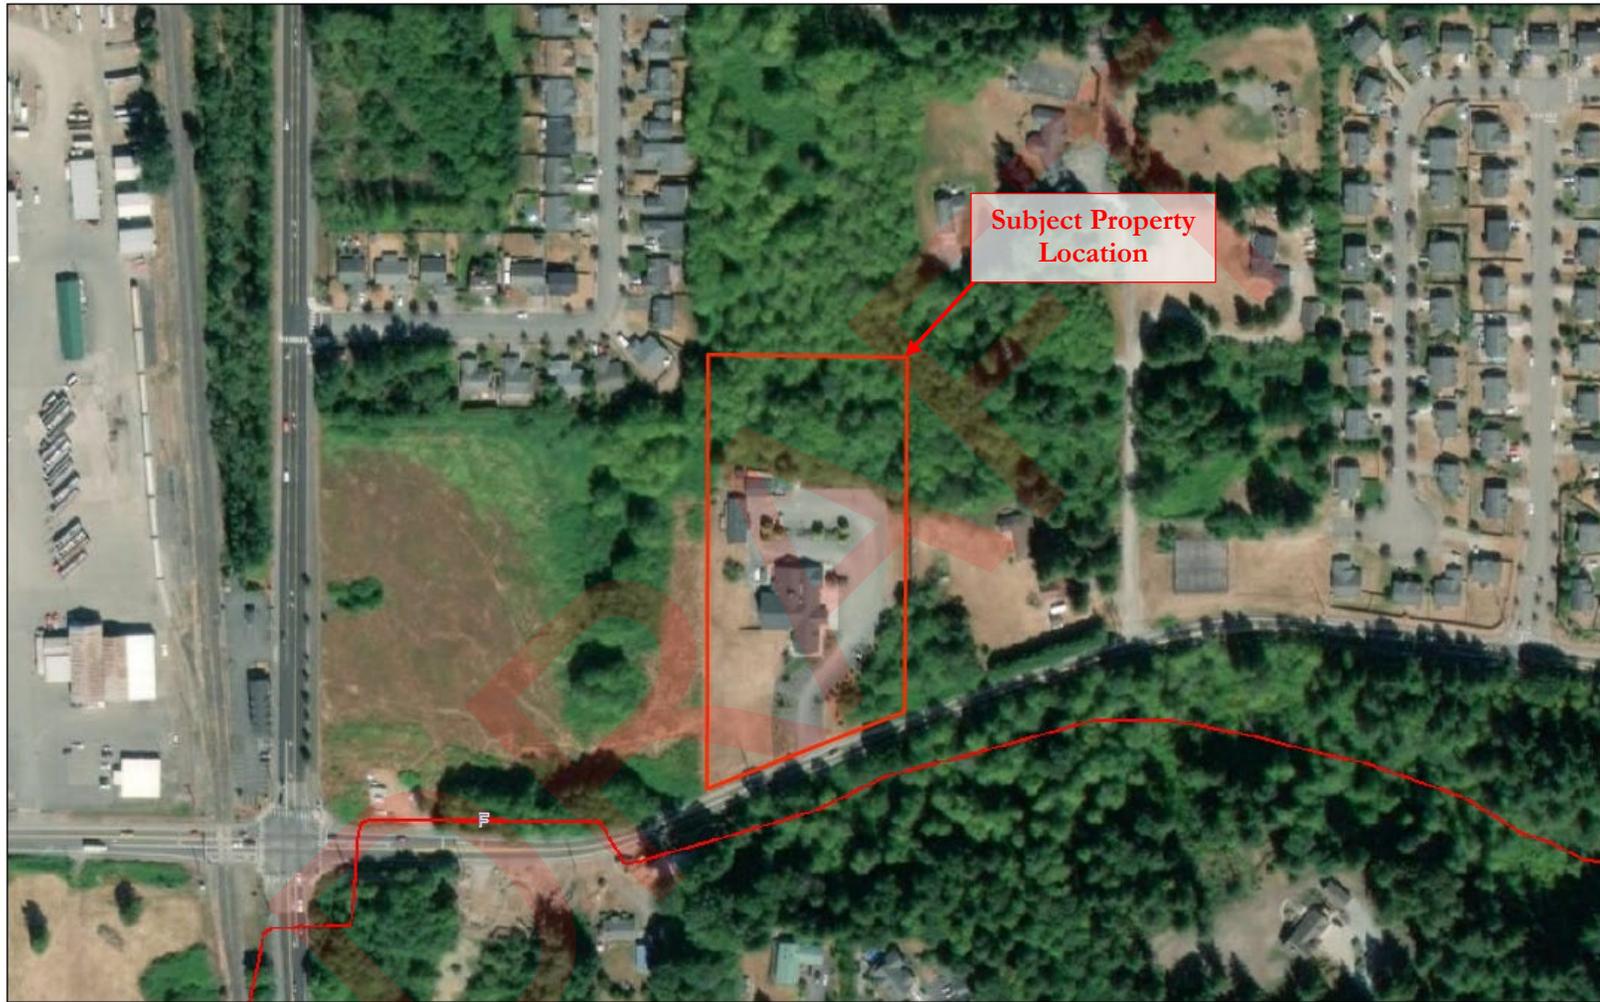
Attachment B3 – DNR Stream Typing Map

DNR Stream Typing map (Attachment B3), WDFW SalmonScape map (Attachment B4), WDFW PHS map (Attachment B5), NWI, and Snohomish County all identify a potential stream south of the subject property. The County, DNR, and SalmonScape identify the stream as Type F. SalmonScape identifies the presence of coho and fall chum within the channel. Moreover, it indicates that the stream is gradient accessible to Dolly Varden/bull trout, fall chinook, pink, and winter steelhead. PHS indicates a documented occurrence of coho, Dolly Varden/bull trout, and fall chum.

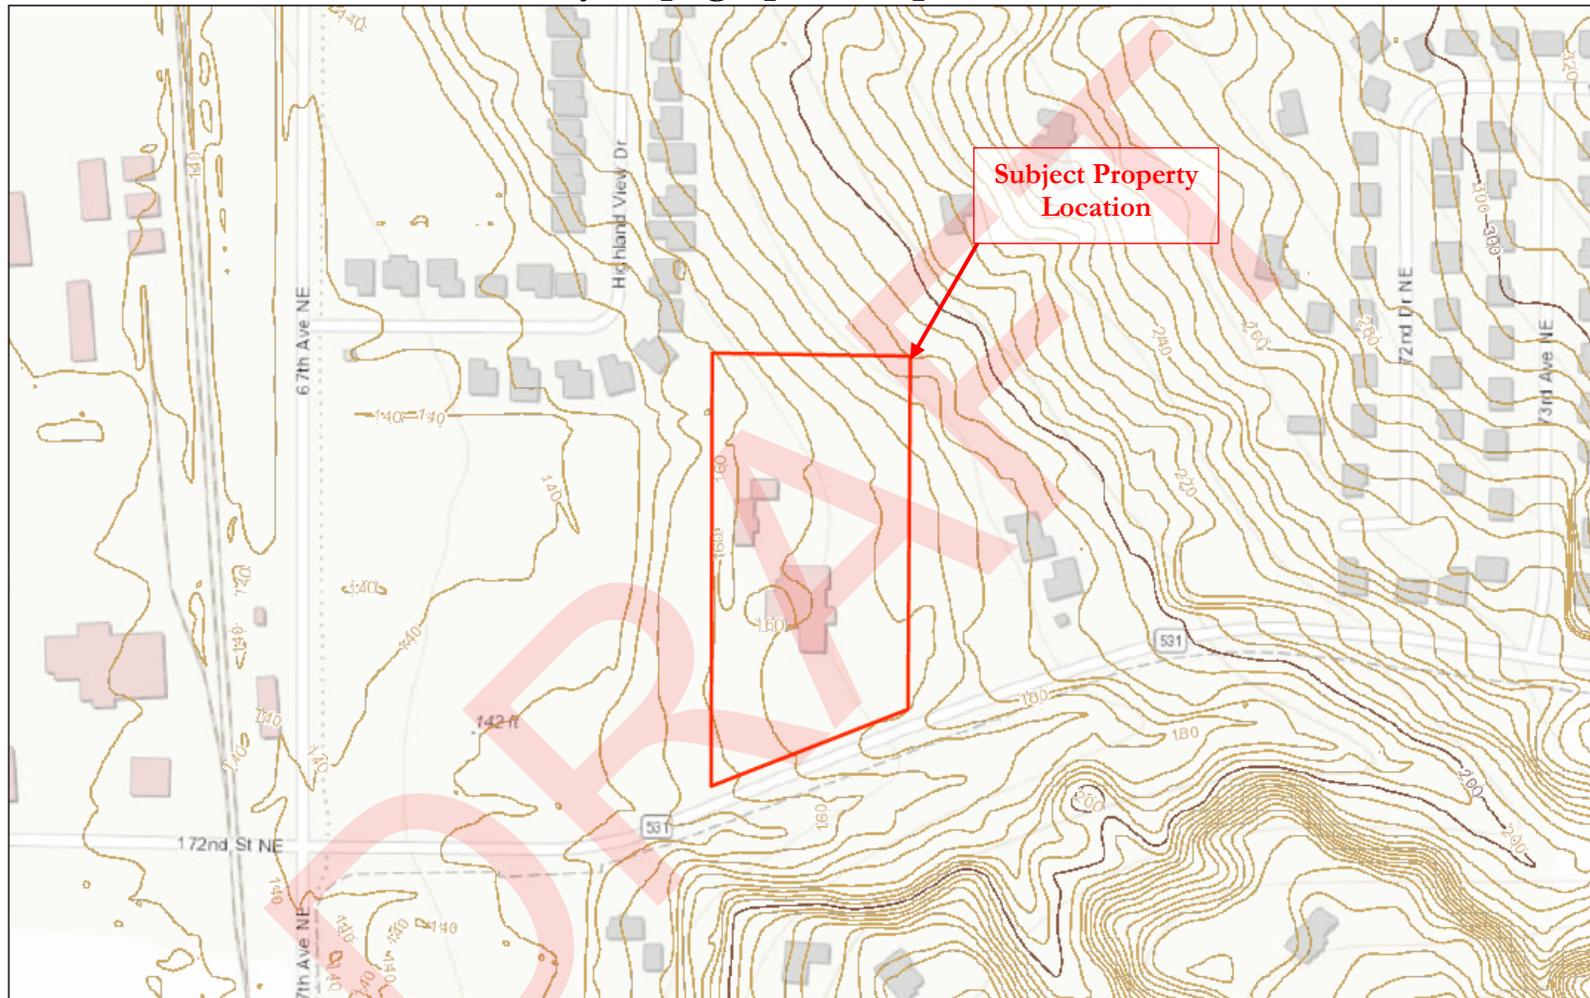
Attachment B7 – Snohomish County Topographic Map

The NRCS soil map (Attachment B6) identifies Everett very gravelly sandy loam, 8 to 15 percent (18), Tokul gravelly medial loam, 15 to 30 percent (74), and Norma loam (39) in the project area. Everett very gravelly sandy loam is listed as non-hydric, Tokul gravelly medial loam is listed as partially hydric, and Norma loam is listed as hydric on the Snohomish County Hydric Soils List (NRCS, 1995). Generally, topography onsite slopes gently from east to west (Attachment B7).

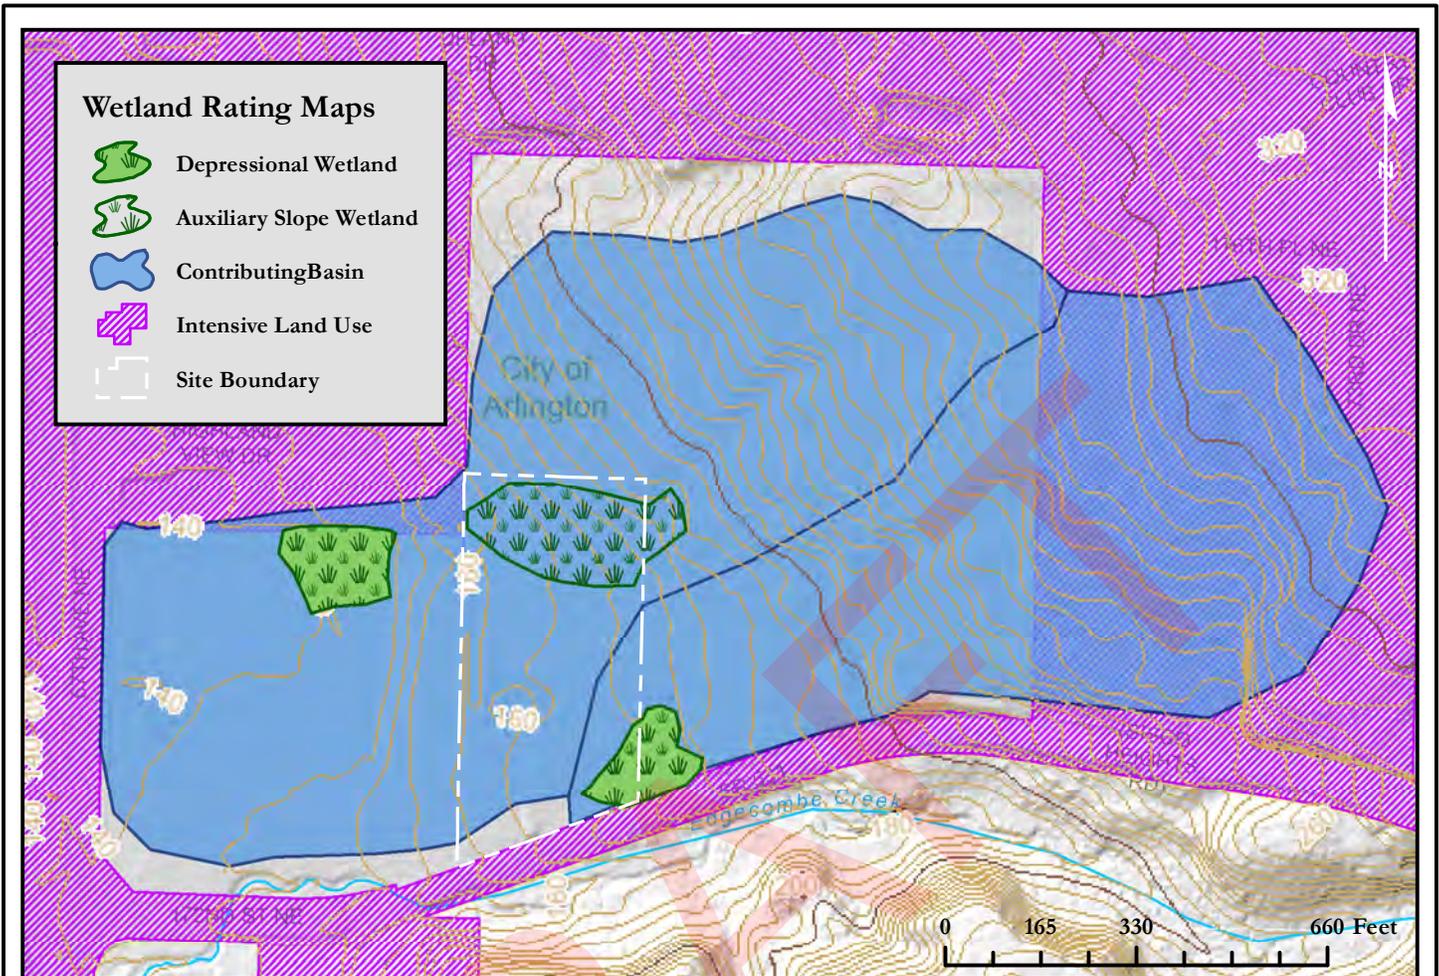
ATONEMENT CHURCH - CONTRIBUTING BASIN MAP

D.4		
D.4.3		
Area of Contributing Basin (SF)		679,110
Area of Wetland B (SF)		19,358
Percent of Wetland B within Contributing Basin		2.850%
Area of Intensive Human Land Uses (SF)		366,000
Percent of Intensive Human Land Use within Contributing Basin for Wetland B		54%
Area of Contributing Basin (SF)		945,678
Area of Wetland C (SF)		23,002
Percent of Wetland C within Contributing Basin		2.432%
Area of Intensive Human Land Uses (SF)		20,453
Percent of Intensive Human Land Use within Contributing Basin for Wetland C		2%

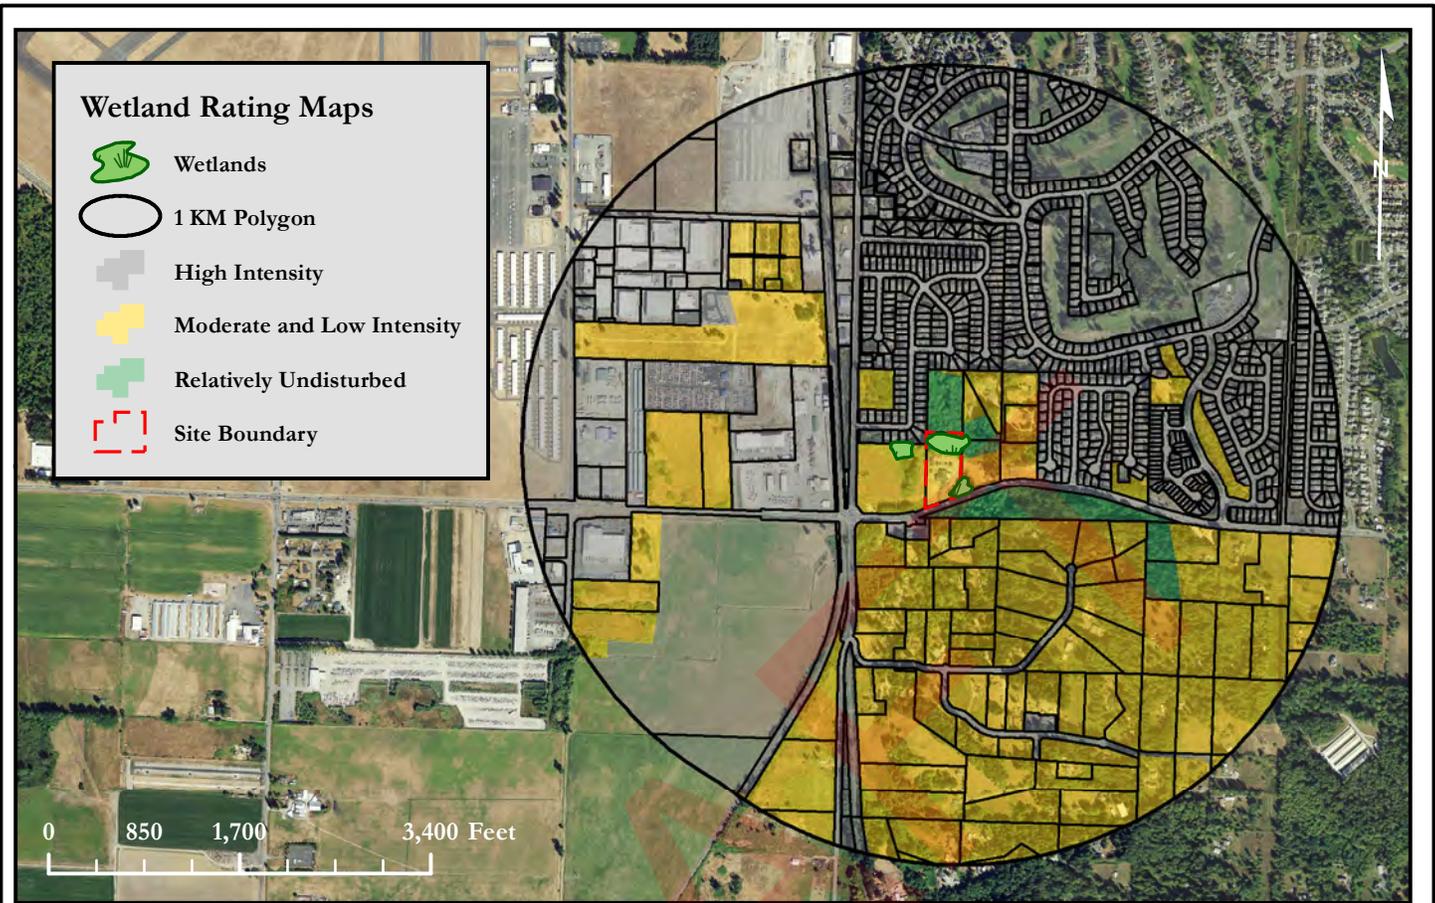
ATONEMENT CHURCH - HABITAT MAP

H.2		
H.2.1	Wetland A	
	Abutting Undisturbed Habitat	0.77%
	Abutting Moderate & Low Intensity Land Uses	2.71%
	Accessible Habitat	2.12%
H.2.1	Wetlands B & C	
	Abutting Undisturbed Habitat	0.00%
	Abutting Moderate & Low Intensity Land Uses	2.71%
	Accessible Habitat	1.35%
H.2.2		
	Undisturbed Habitat	2.19%
	Moderate & Low Intensity Land Uses	36.39%
	Undisturbed Habitat in 1 KM Polygon	20.39%
H.2.3		
	High Intensity Land Use in 1 KM Polygon	61.42%
