GEOTECHNICAL ENGINEERING REPORT

RGI PROJECT NO. 2021-574-2

**ARLINGTON AIRPORT BUSINESS PARK DEVELOPMENT II
51ST AVENUE NORTHEAST AND 43RD AVENUE NORTHEAST
ARLINGTON, WASHINGTON**

OCTOBER 8, 2021

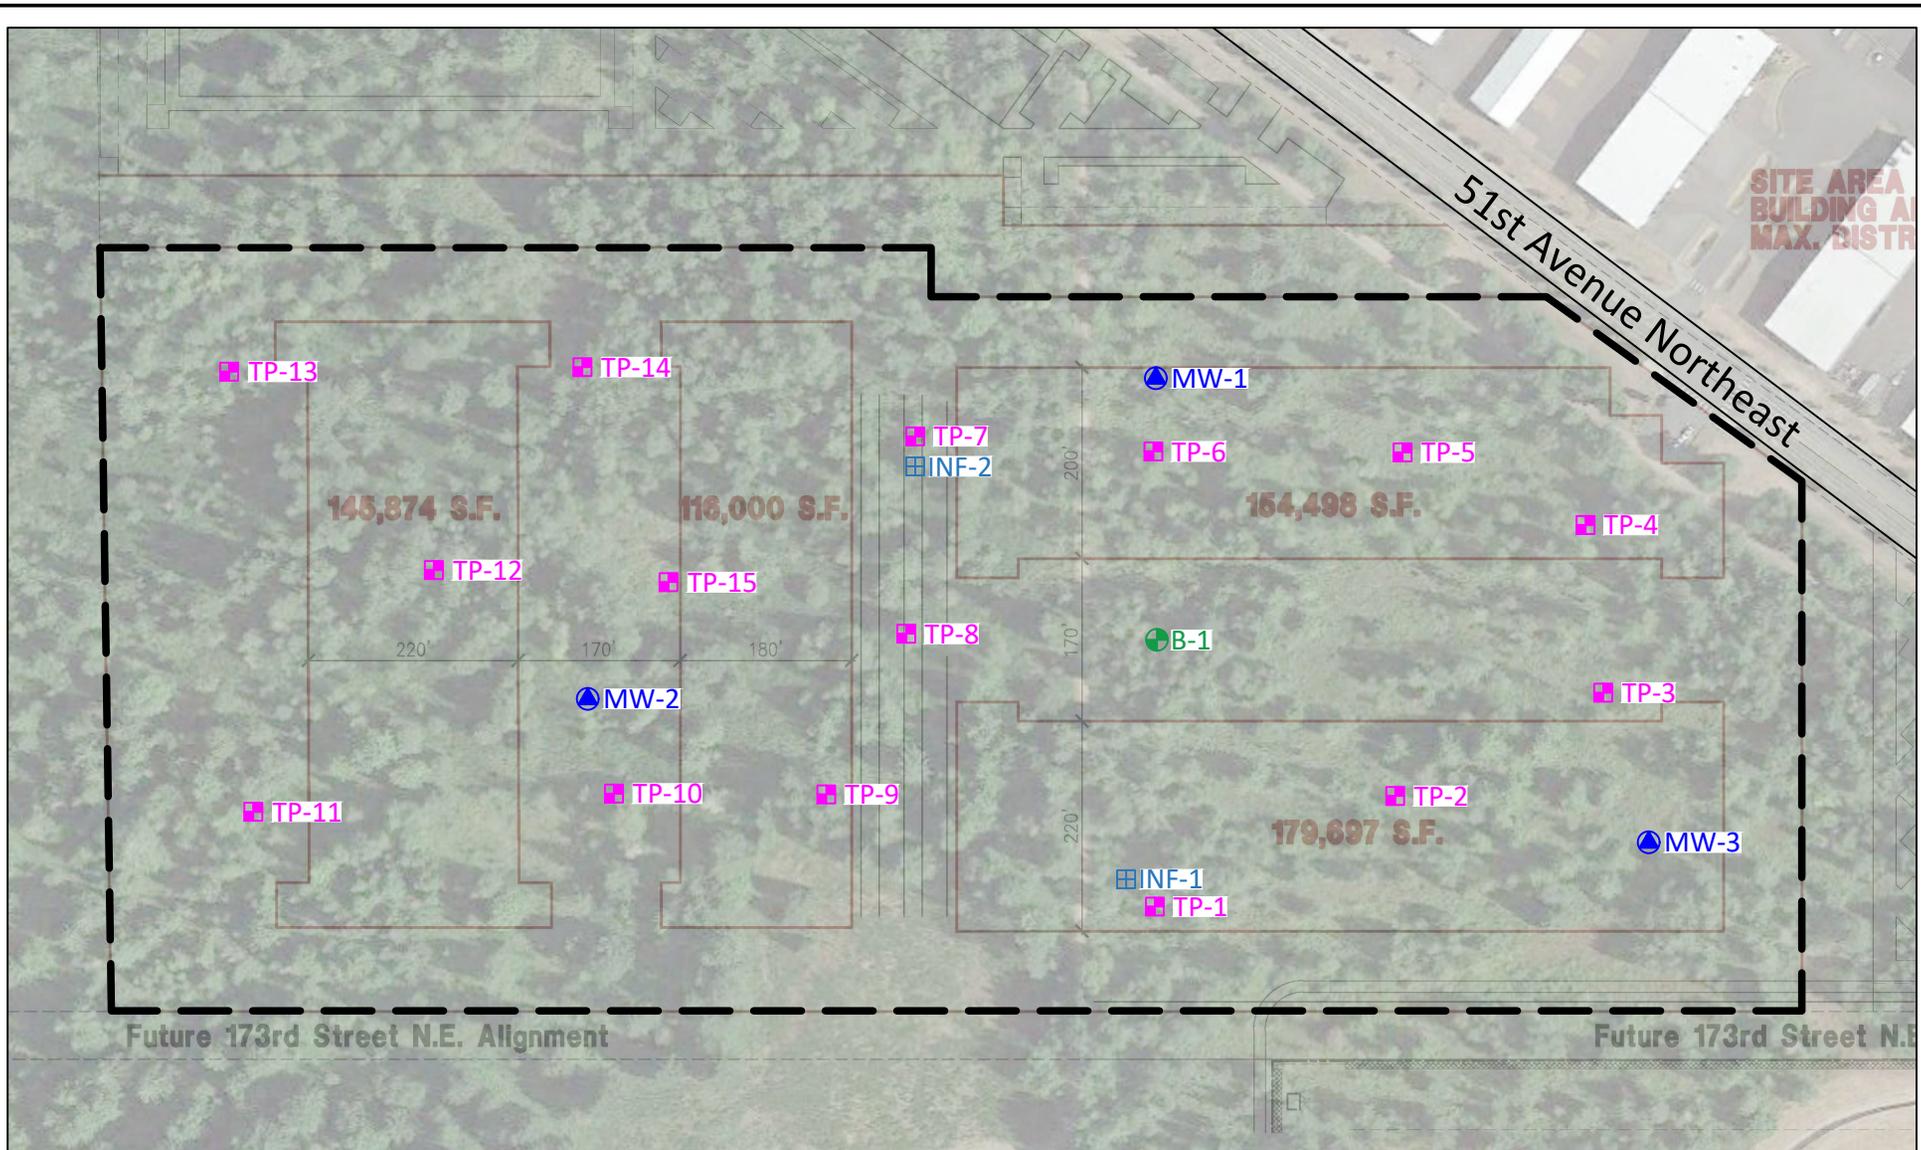
Proposed Arlington Airport Business Park Development II		Figure 2
RGI Project Number: 2021-574-2	Geotechnical Exploration Plan	Date Drawn: 10/2021
Address: 51st Avenue Northeast & 43rd Avenue Northeast, Arlington, Washington 98223

On September 16, 17, 23, and 24, RGI observed the excavation of 17 test pits and drilling of 4 borings. The approximate exploration locations are shown on Figure 2.

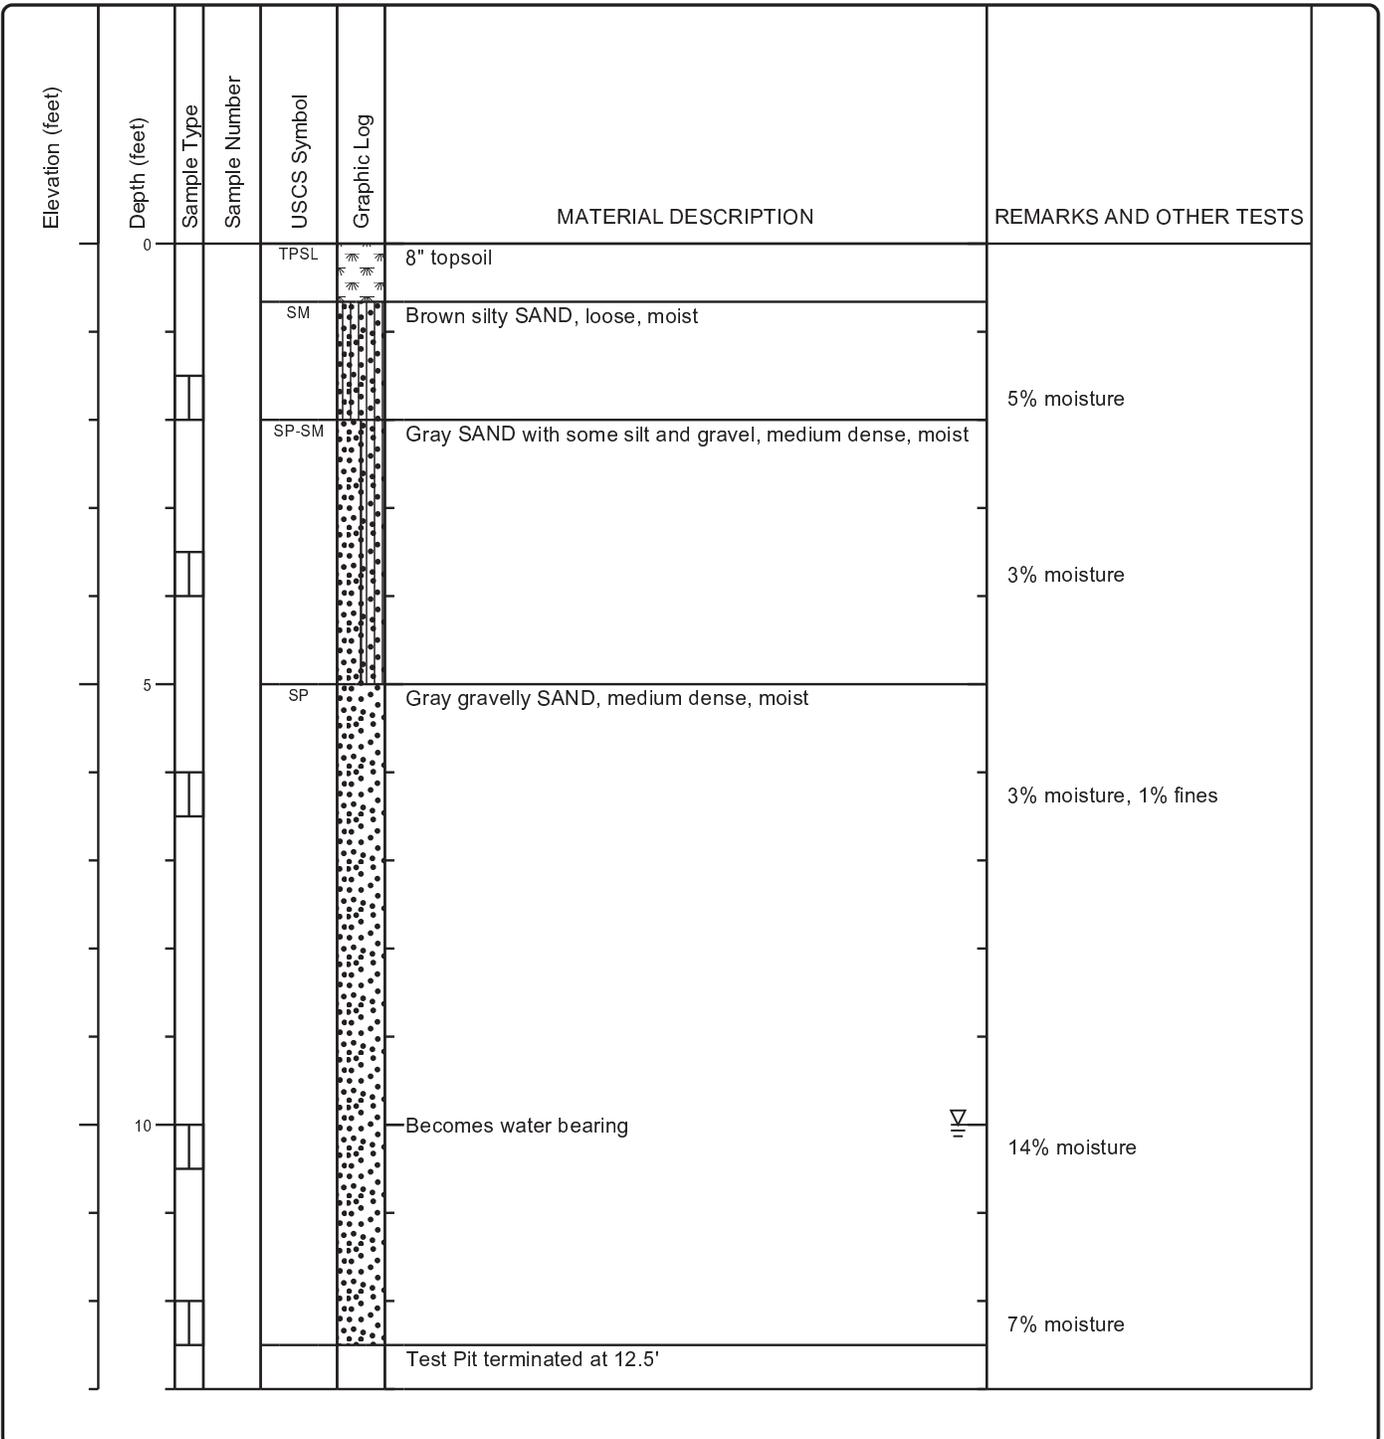
Test Pit No.: **TP-1**
 Sheet 1 of 1

Date(s) Excavated: 9/16/2021	Logged By ELW	Surface Conditions: Mixed Brush
Excavation Method: Test Pit	Bucket Size: N/A	Total Depth of Excavation: 12.5 feet bgs
Excavator Type: Tracked Excavator	Excavating Contractor: NW Excavating	Approximate Surface Elevation: N/A
Groundwater Level: 10'	Sampling Method(s): Grab	Compaction Method: Bucket
Test Pit Backfill: Cuttings	Location: 51st Avenue Northeast & 43rd Avenue Northeast, Arlington, Washington

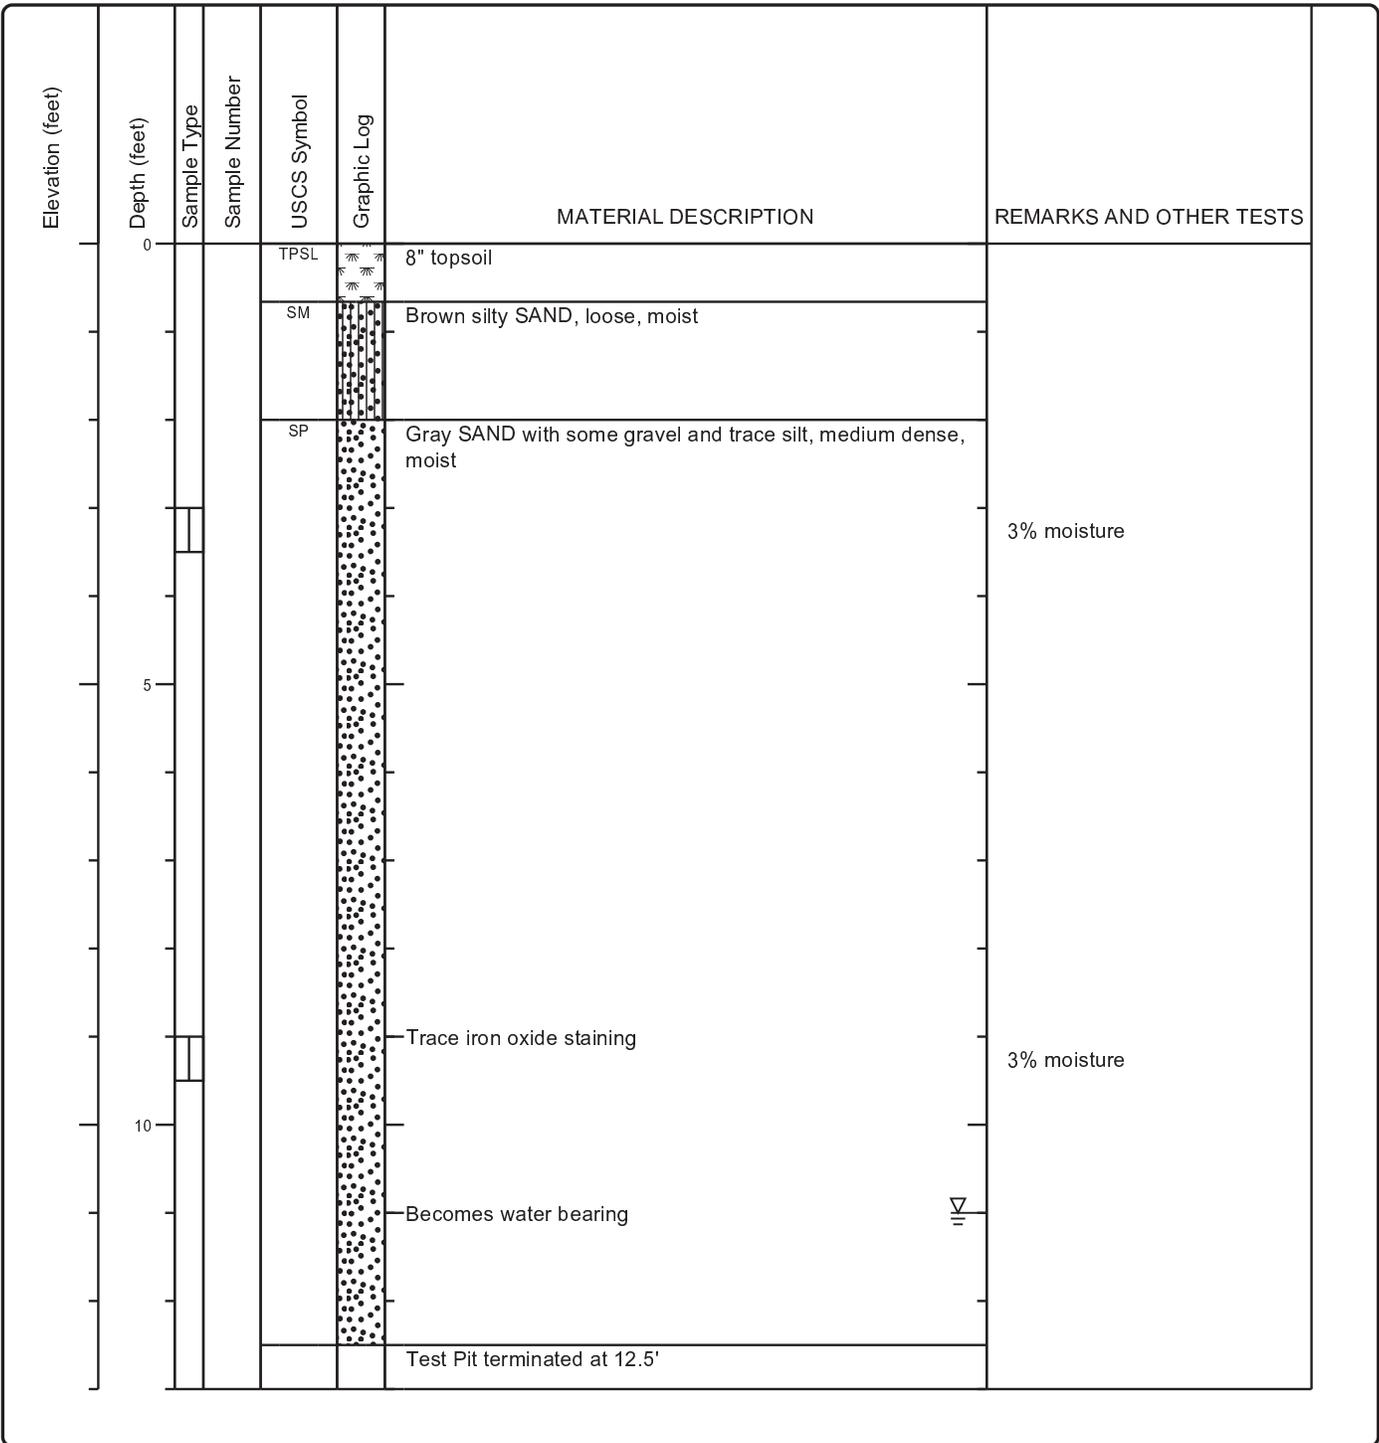
Test Pit No.: **TP-3**
 Sheet 1 of 1

Date(s) Excavated: 9/16/2021	Logged By ELW	Surface Conditions: Mixed Brush
Excavation Method: Test Pit	Bucket Size: N/A	Total Depth of Excavation: 12.5 feet bgs
Excavator Type: Tracked Excavator	Excavating Contractor: NW Excavating	Approximate Surface Elevation: N/A
Groundwater Level: 11'	Sampling Method(s): Grab	Compaction Method: Bucket
Test Pit Backfill: Cuttings	Location: 51st Avenue Northeast & 43rd Avenue Northeast, Arlington, Washington

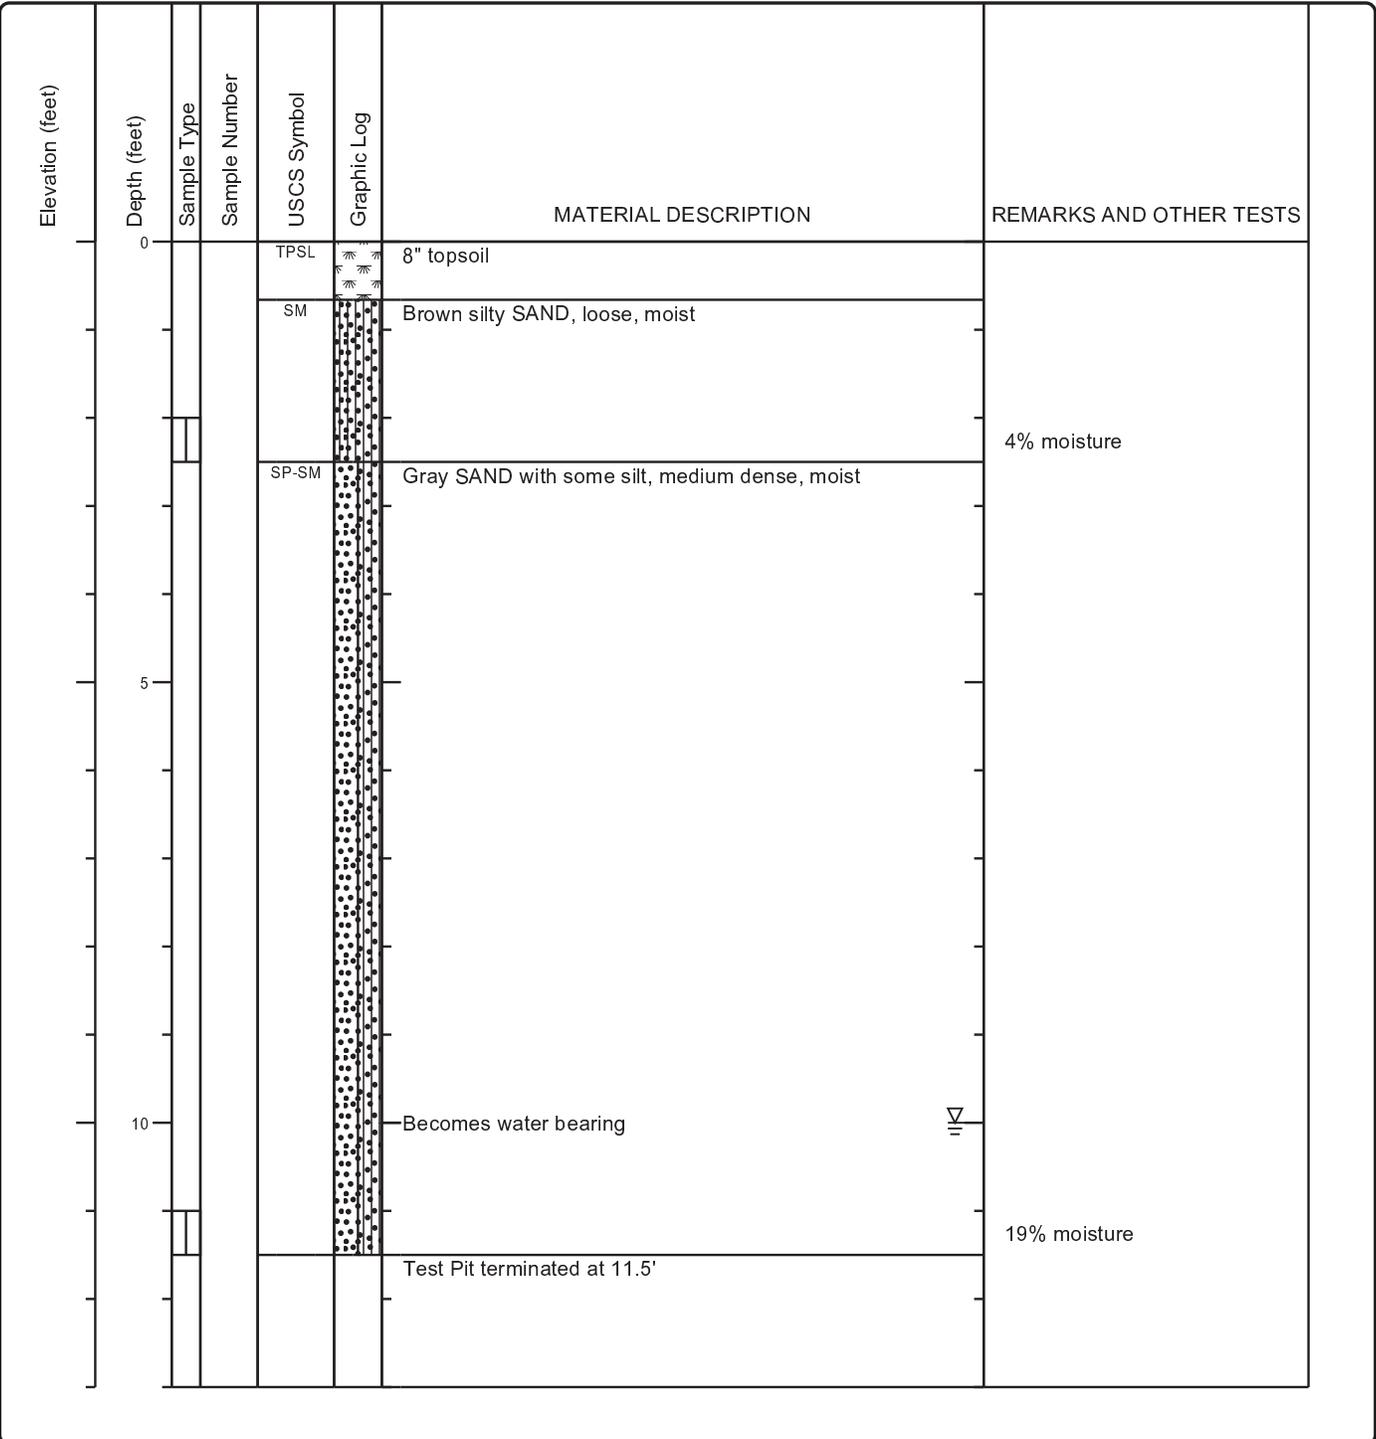
Test Pit No.: **TP-11**
 Sheet 1 of 1

Date(s) Excavated: 9/16/2021	Logged By ELW	Surface Conditions: Mixed Brush, Scotch Broom
Excavation Method: Test Pit	Bucket Size: N/A	Total Depth of Excavation: 11.5 feet bgs
Excavator Type: Tracked Excavator	Excavating Contractor: NW Excavating	Approximate Surface Elevation: N/A
Groundwater Level: 10'	Sampling Method(s) Grab	Compaction Method Bucket
Test Pit Backfill: Cuttings	Location 51st Avenue Northeast & 43rd Avenue Northeast, Arlington, Washington

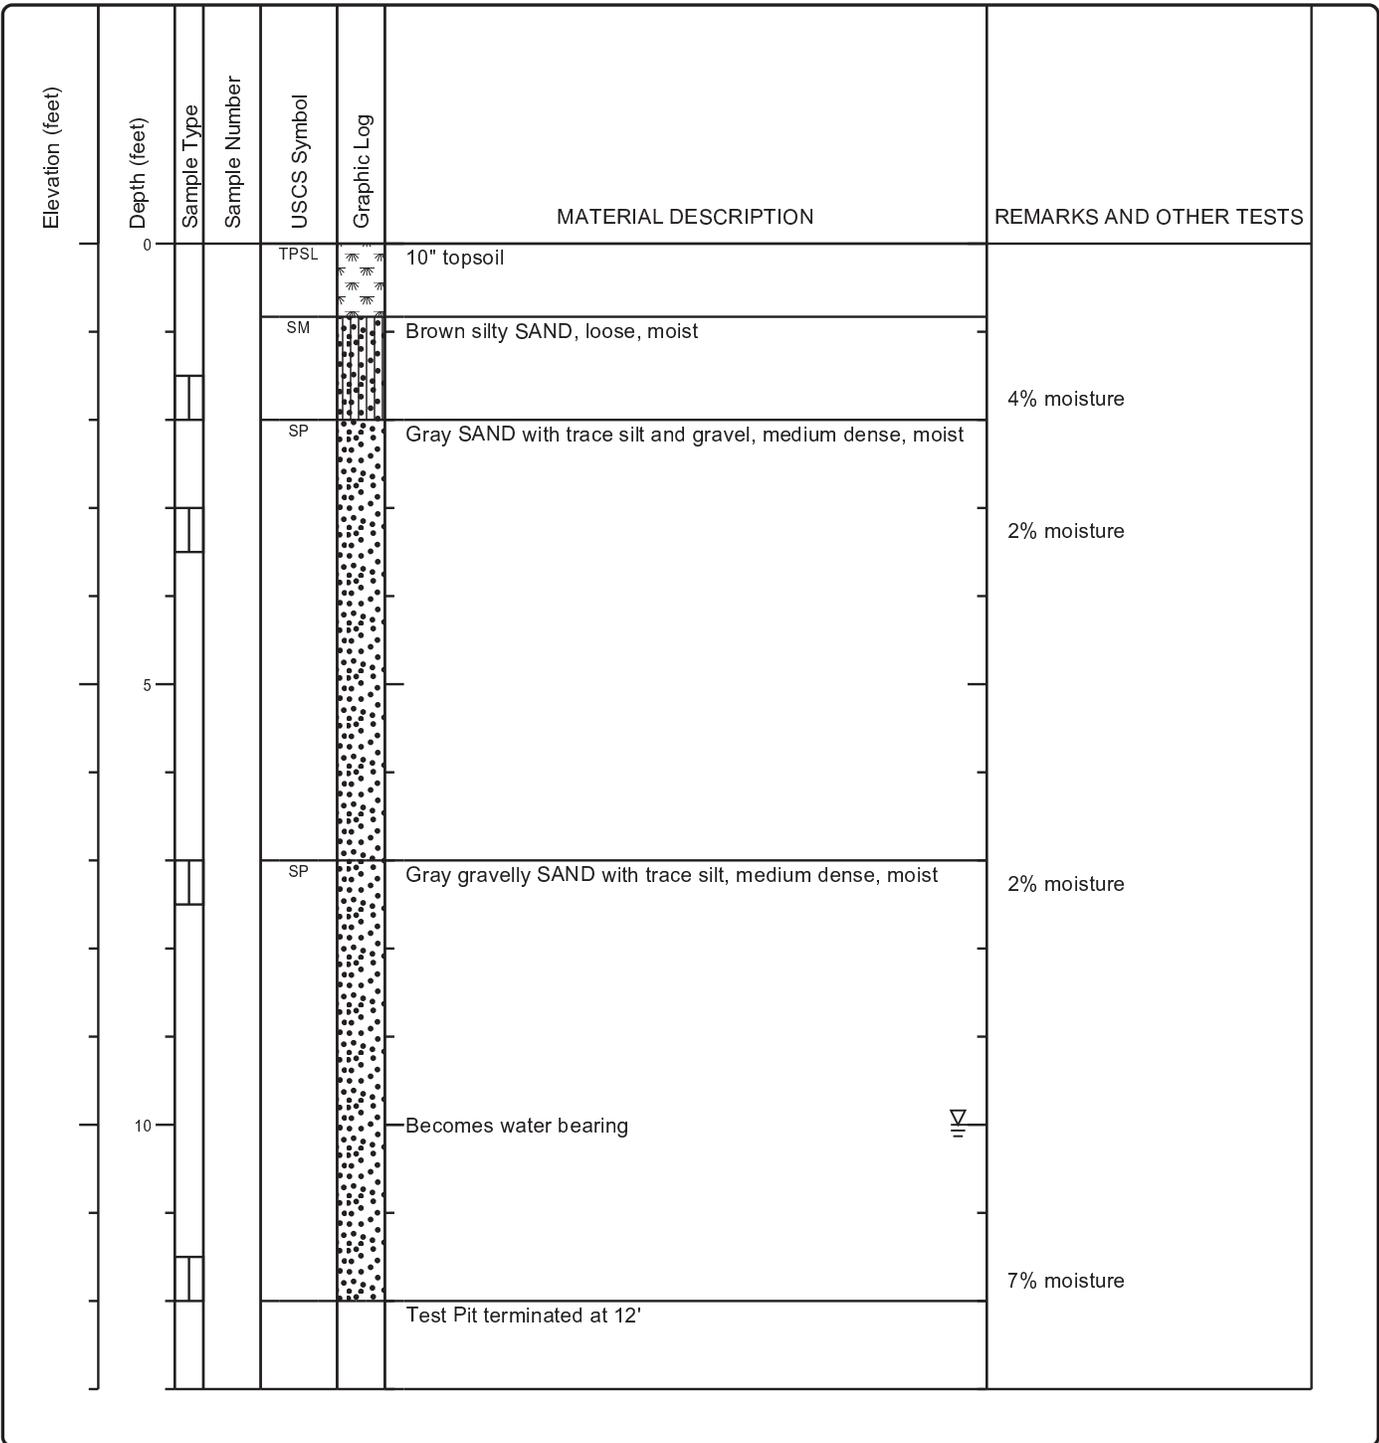
Test Pit No.: **TP-13**
 Sheet 1 of 1

Date(s) Excavated: 9/16/2021	Logged By ELW	Surface Conditions: Mixed Brush
Excavation Method: Test Pit	Bucket Size: N/A	Total Depth of Excavation: 12 feet bgs
Excavator Type: Tracked Excavator	Excavating Contractor: NW Excavating	Approximate Surface Elevation: N/A
Groundwater Level: 10'	Sampling Method(s) Grab	Compaction Method Bucket
Test Pit Backfill: Cuttings	Location 51st Avenue Northeast & 43rd Avenue Northeast, Arlington, Washington

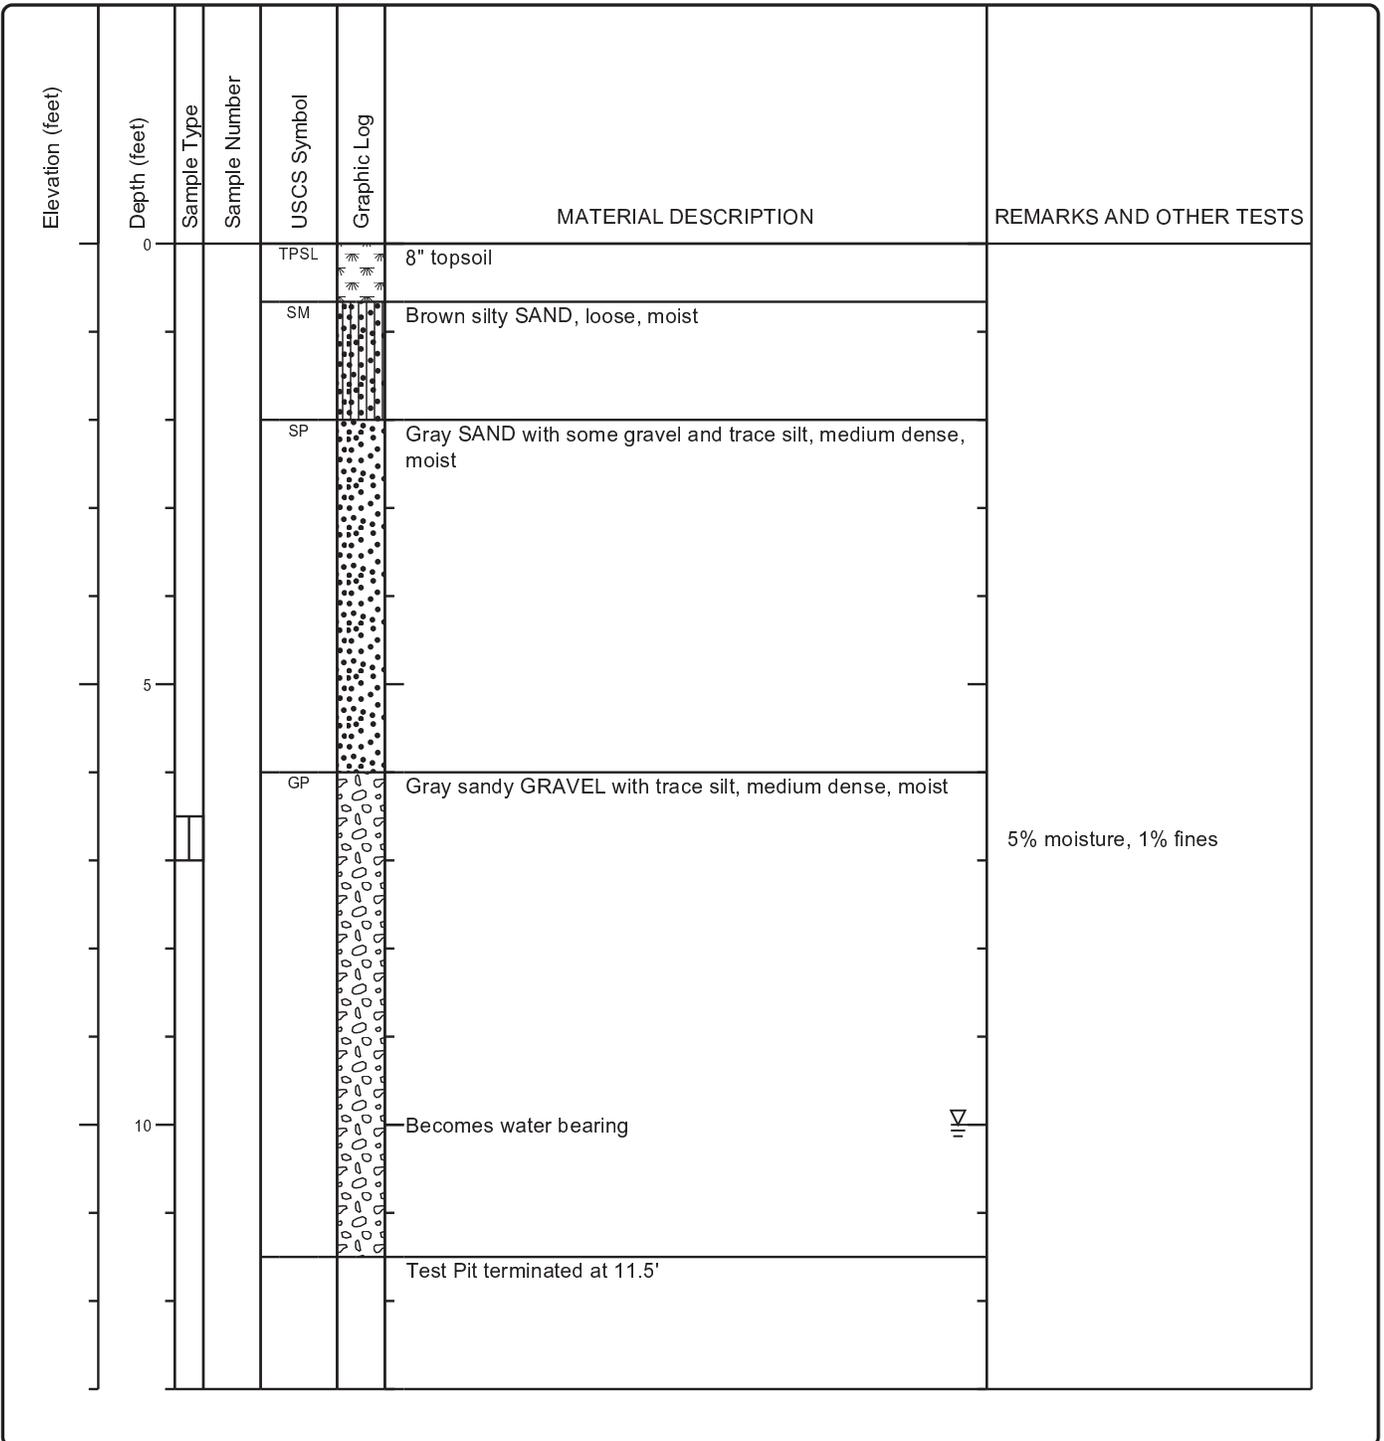
Test Pit No.: **INF-1**
 Sheet 1 of 1

Date(s) Excavated: 9/16/2021	Logged By ELW	Surface Conditions: Mixed Brush
Excavation Method: Test Pit	Bucket Size: N/A	Total Depth of Excavation: 11.5 feet bgs
Excavator Type: Tracked Excavator	Excavating Contractor: NW Excavating	Approximate Surface Elevation: N/A
Groundwater Level: 10'	Sampling Method(s) Grab	Compaction Method Bucket
Test Pit Backfill: Cuttings	Location 51st Avenue Northeast & 43rd Avenue Northeast, Arlington, Washington

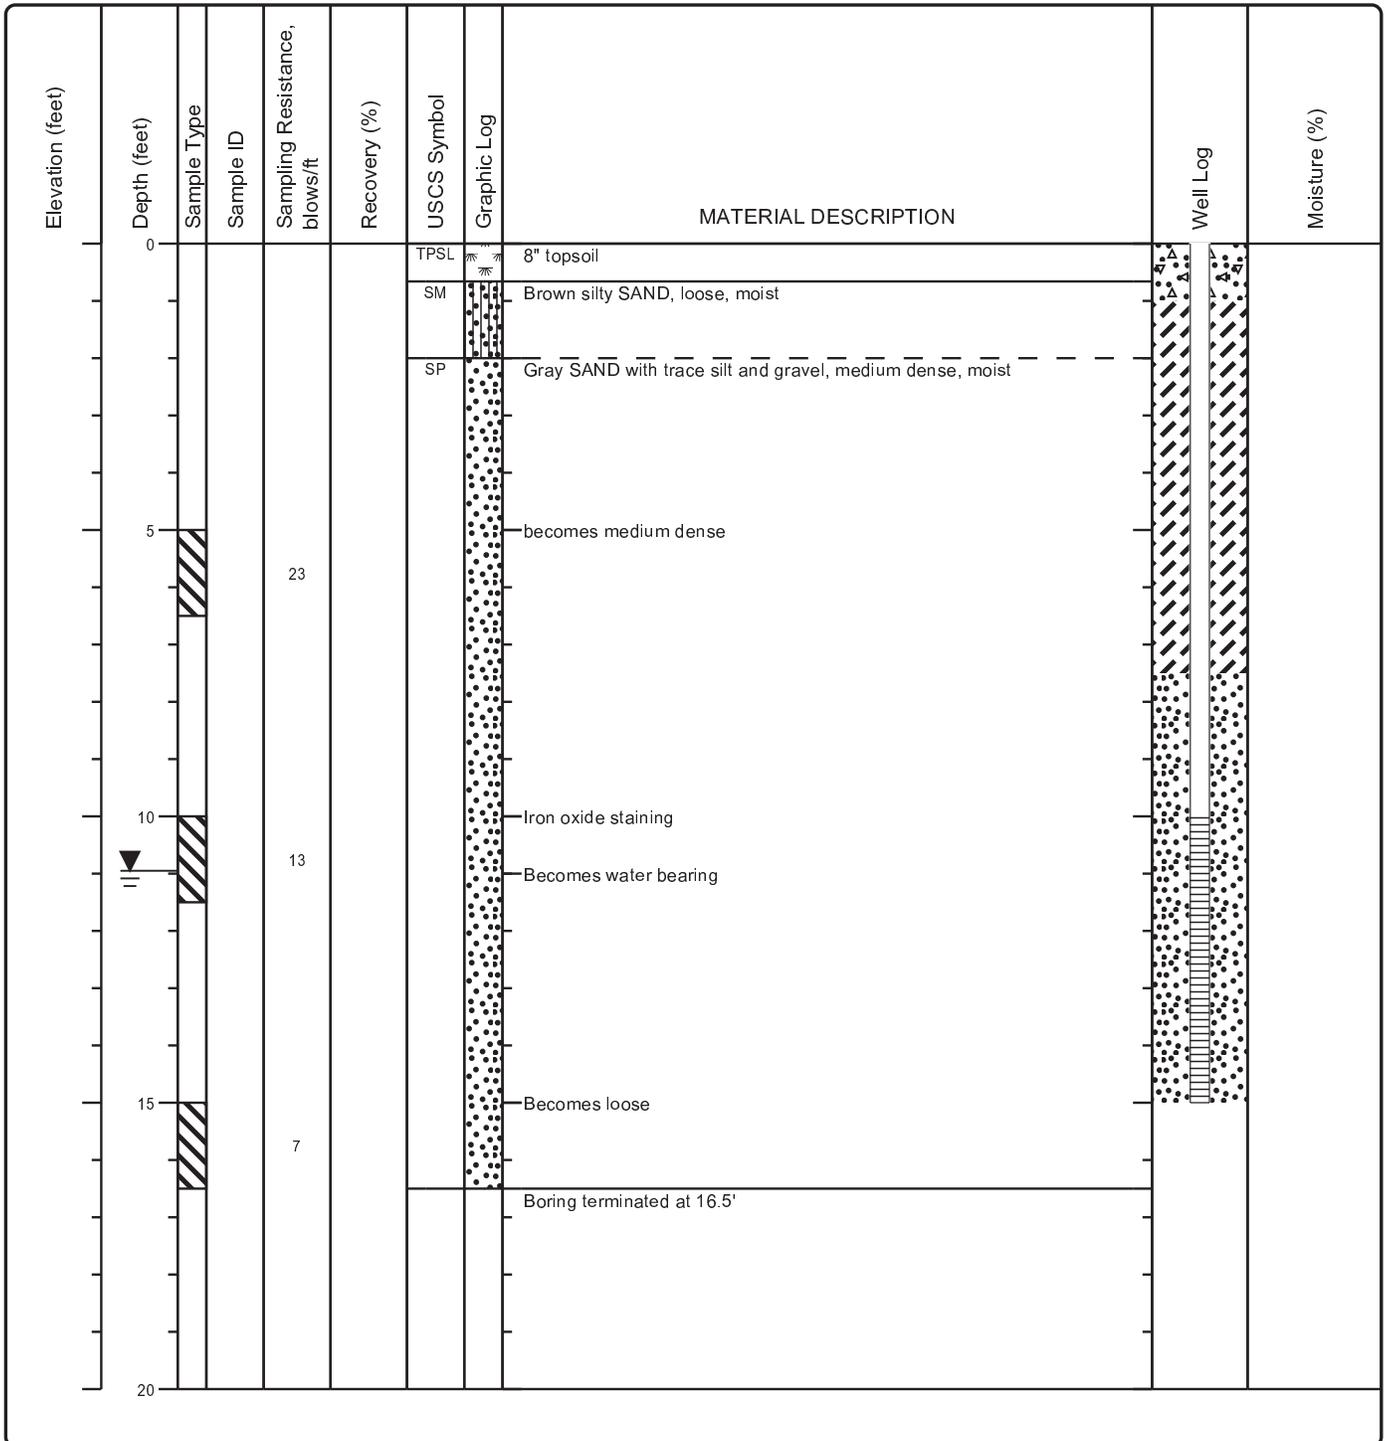
Boring No.: **MW-1**
 Sheet 1 of 1

Date(s) Drilled: 9/23/2021	Logged By: ELW	Surface Conditions: Mixed Brush
Drilling Method(s): Hollow Stem Auger	Drill Bit Size/Type: N/A	Total Depth of Borehole: 16.5 feet bgs
Drill Rig Type: Track Rig	Drilling Contractor: Bortec	Approximate Surface Elevation: N/A
Groundwater Level: 10.95'	Sampling Method(s): SPT	Hammer Data : 140 lb, 30" drop, rope and cathead
Borehole Backfill: Well Installed	Location: 51st Avenue Northeast & 43rd Avenue Northeast, Arlington, Washington

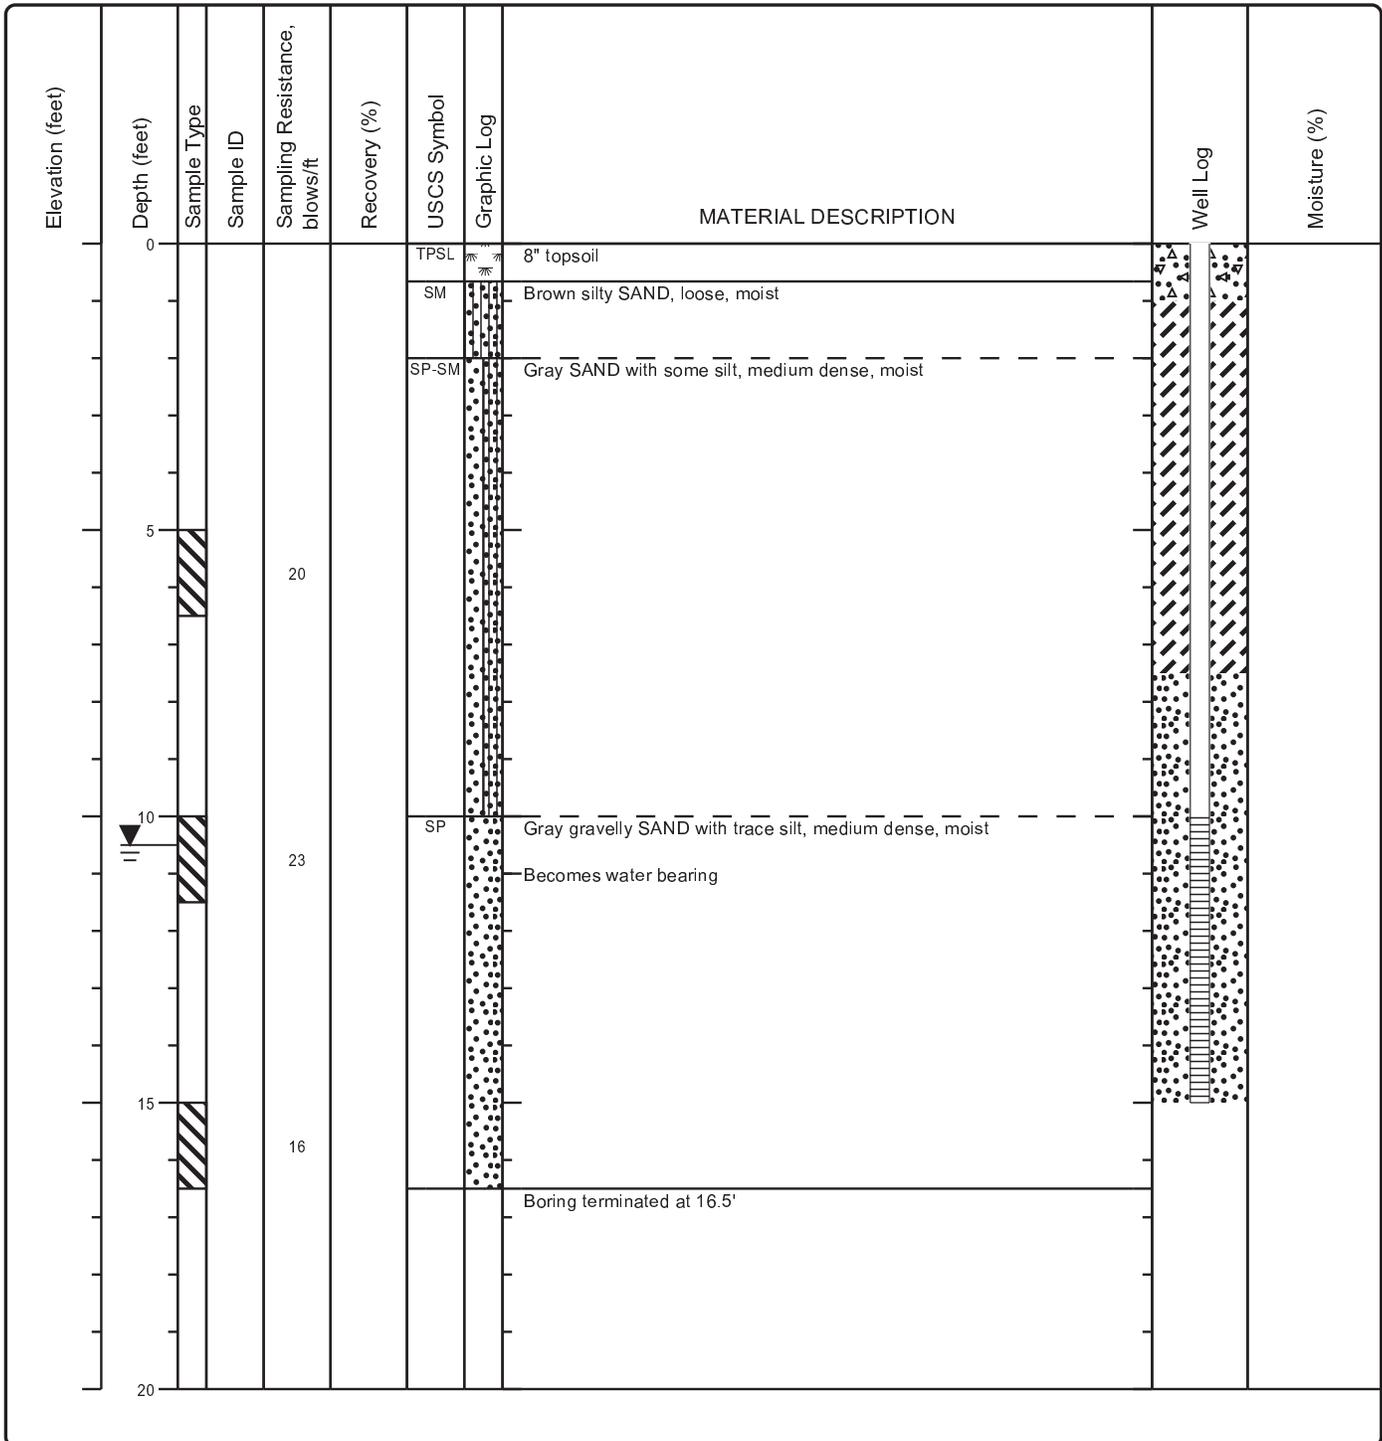
Boring No.: **MW-2**
 Sheet 1 of 1

Date(s) Drilled: 9/24/2021	Logged By: ELW	Surface Conditions: Mixed Brush
Drilling Method(s): Hollow Stem Auger	Drill Bit Size/Type: N/A	Total Depth of Borehole: 16.5 feet bgs
Drill Rig Type: Track Rig	Drilling Contractor: Bortec	Approximate Surface Elevation: N/A
Groundwater Level: 10.50'	Sampling Method(s): SPT	Hammer Data : 140 lb, 30" drop, rope and cathead
Borehole Backfill: Well Installed	Location: 51st Avenue Northeast & 43rd Avenue Northeast, Arlington, Washington

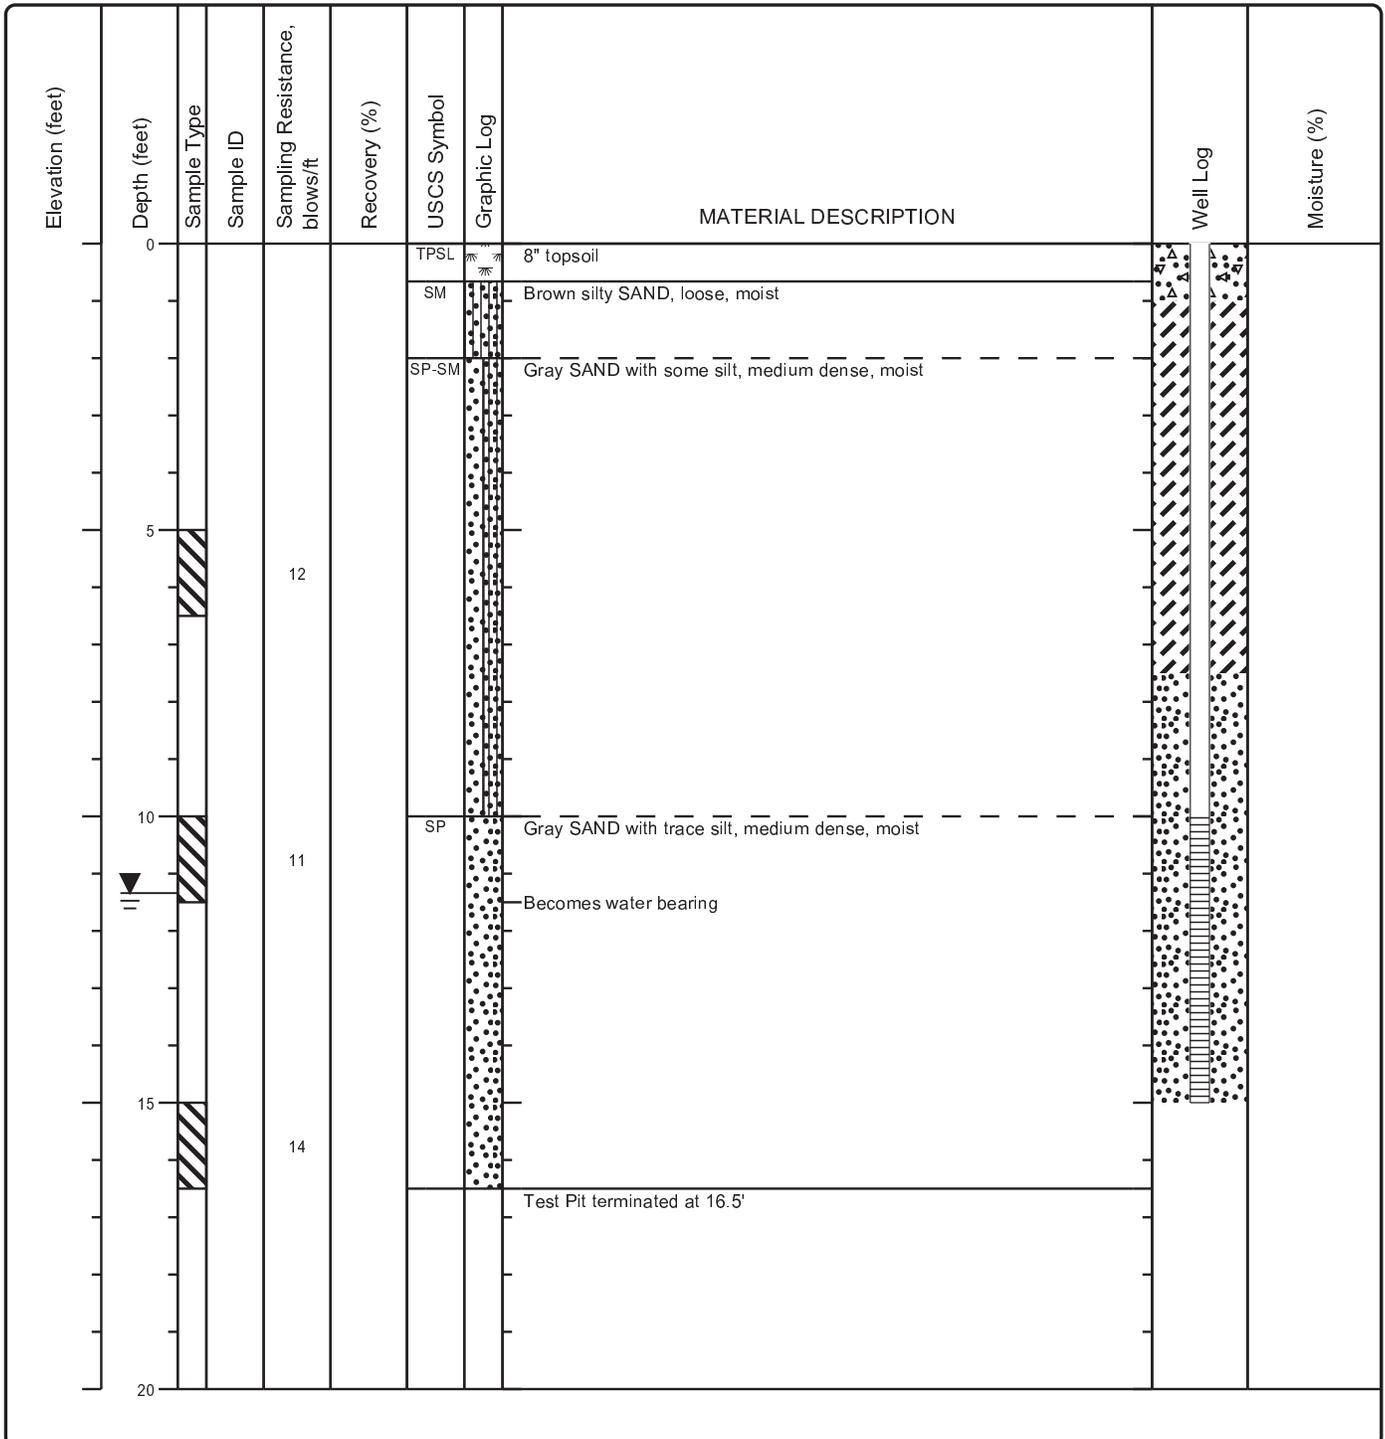
Boring No.: **MW-3**
 Sheet 1 of 1

Date(s) Drilled: 9/24/2021	Logged By: ELW	Surface Conditions: Mixed Brush
Drilling Method(s): Hollow Stem Auger	Drill Bit Size/Type: N/A	Total Depth of Borehole: 16.5 feet bgs
Drill Rig Type: Track Rig	Drilling Contractor: Bortec	Approximate Surface Elevation: N/A
Groundwater Level: 11.34'	Sampling Method(s): SPT	Hammer Data : 140 lb, 30" drop, rope and cathead
Borehole Backfill: Well Installed	Location: 51st Avenue Northeast & 43rd Avenue Northeast, Arlington, Washington

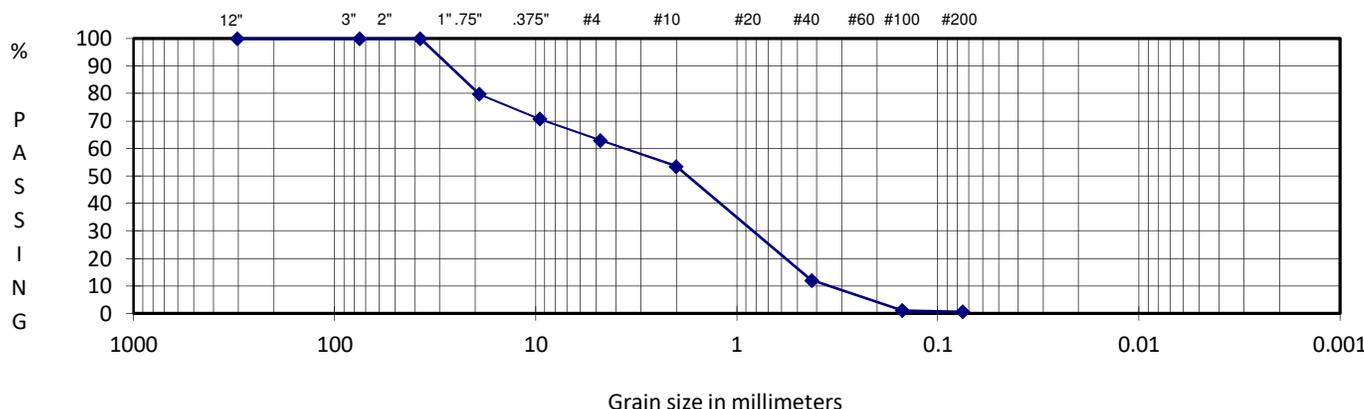
DESCRIPTION: Gravelly SAND
 USCS: SP

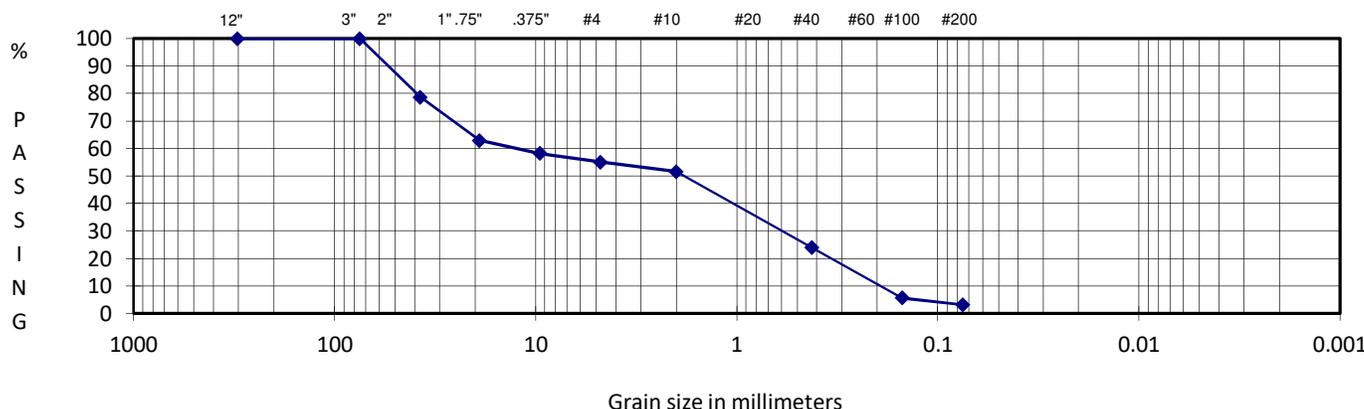
DESCRIPTION: Gravelly SAND with trace silt
 USCS: SP

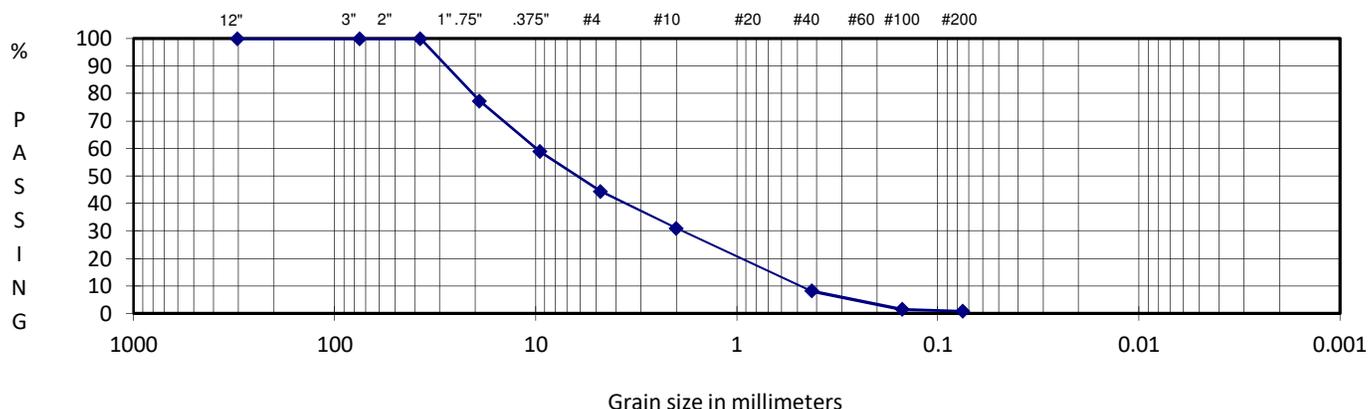
D10 (mm)	0.5
D30 (mm)	1.9
D60 (mm)	10
Cu	20.0
Cc	0.7

DESCRIPTION: Sandy GRAVEL
 USCS: GP

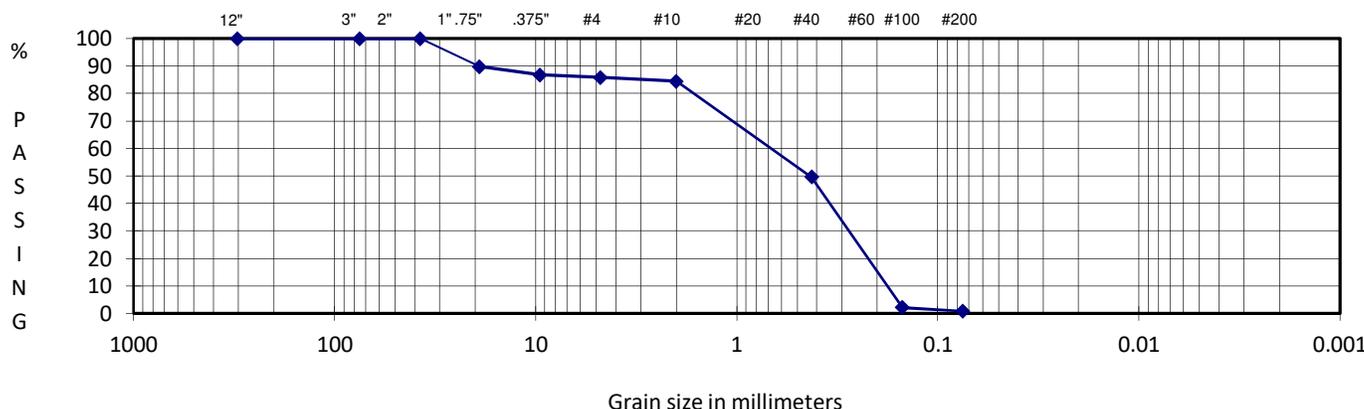
DESCRIPTION: SAND with trace gravel
 USCS: SP

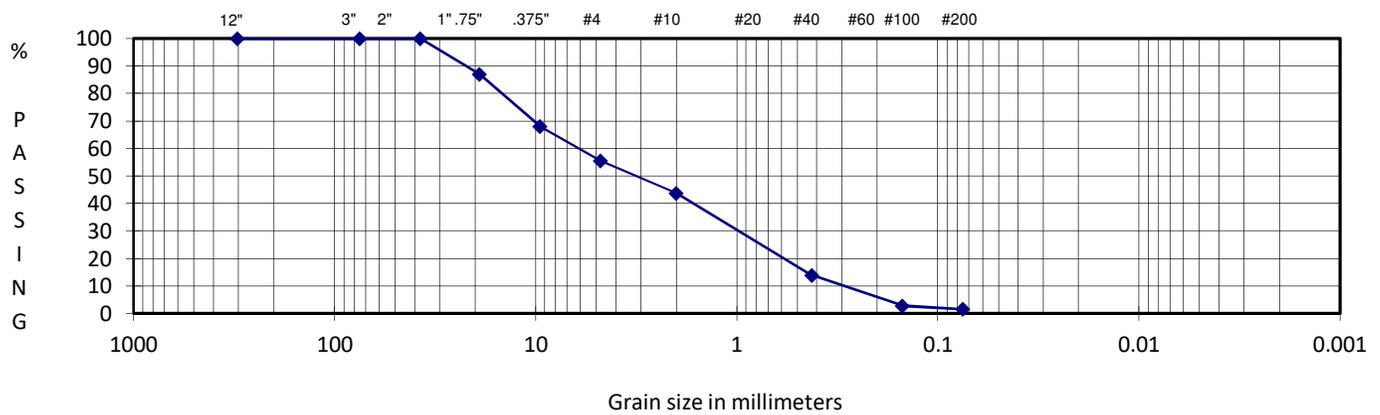
D10 (mm)	0.3
D30 (mm)	1
D60 (mm)	6.1
Cu	20.3
Cc	0.5

DESCRIPTION: Gravelly SAND with trace silt
 USCS: SP

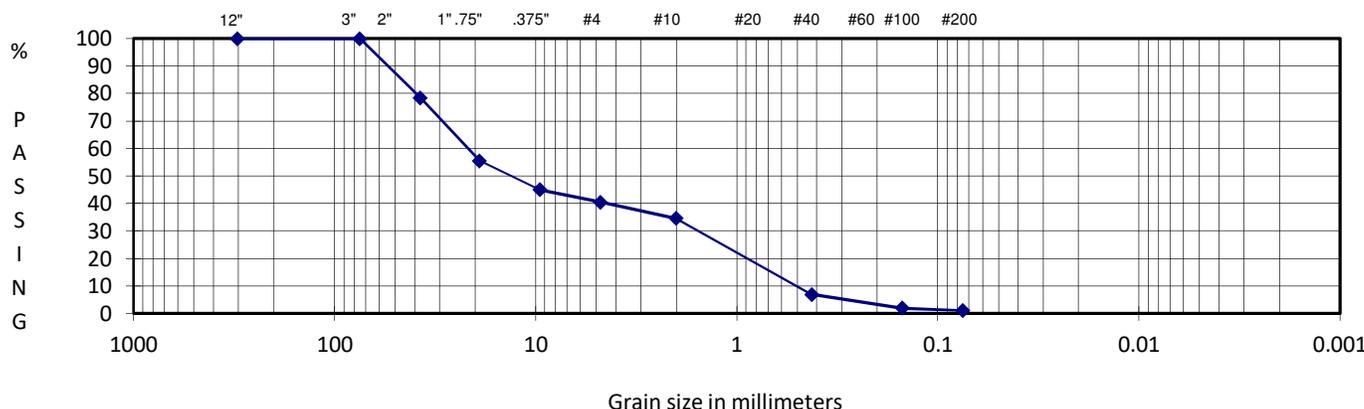
DESCRIPTION: Sandy GRAVEL with trace silt
 USCS: GP
