GEOTECHNICAL ENGINEERING REPORT

RGI PROJECT NO. 2021-574-2

**ARLINGTON AIRPORT BUSINESS PARK DEVELOPMENT II
51ST AVENUE NORTHEAST AND 43RD AVENUE NORTHEAST
ARLINGTON, WASHINGTON**

OCTOBER 8, 2021

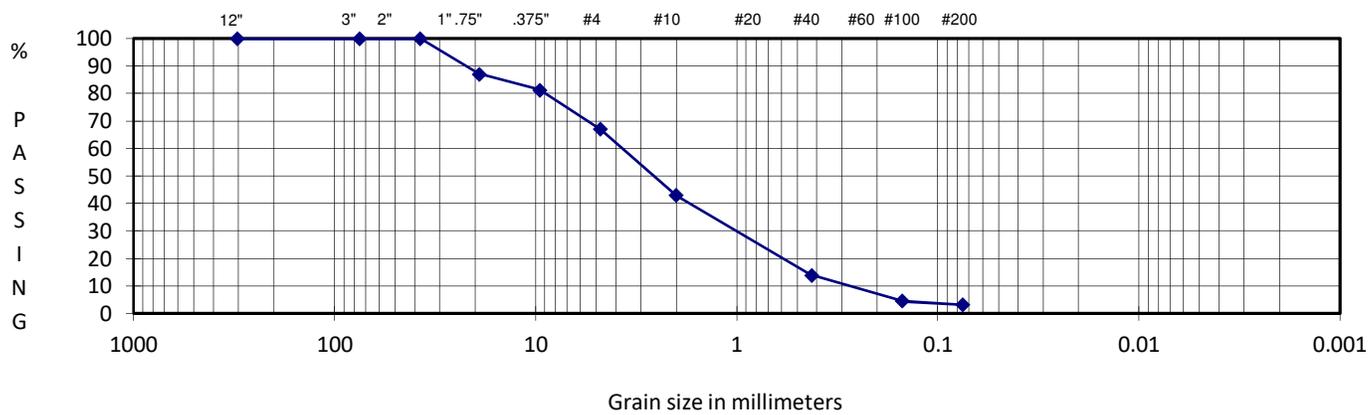
D10 (mm)	0.27
D30 (mm)	1.1
D60 (mm)	3.9
Cu	14.4
Cc	1.1

DESCRIPTION: Gravelly SAND with trace silt
 USCS: SW

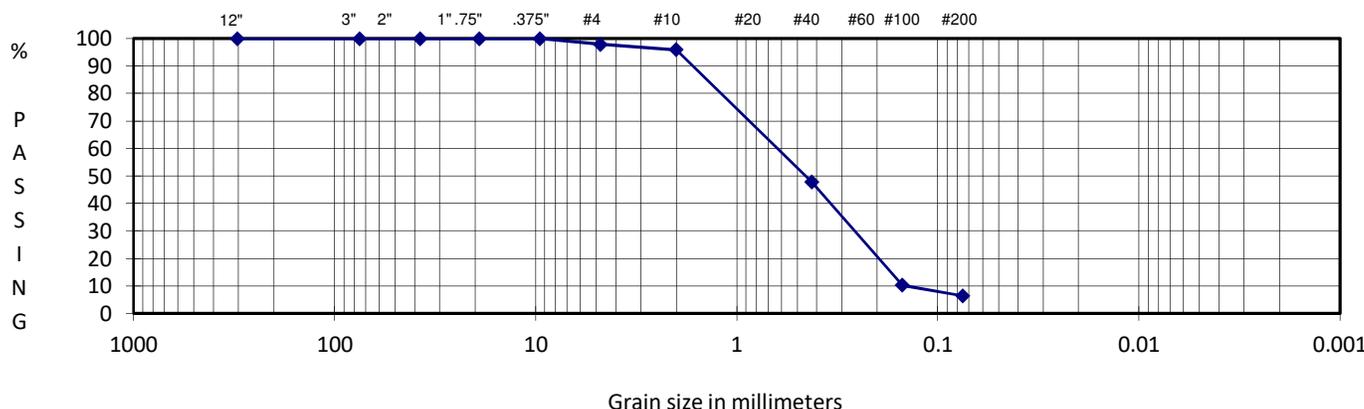
DESCRIPTION: SAND with some silt
 USCS: SP-SM

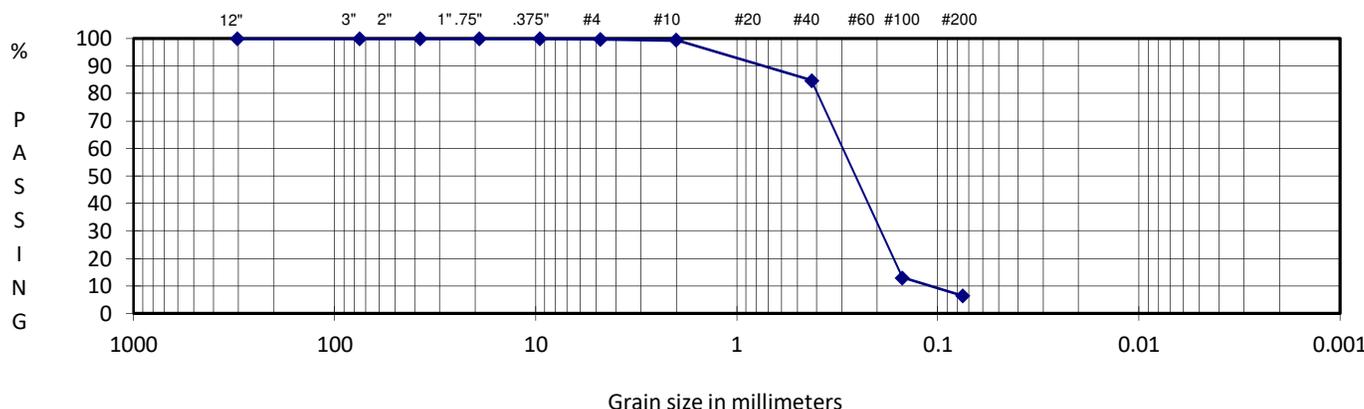
DESCRIPTION: SAND with some silt
 USCS: SW-SM

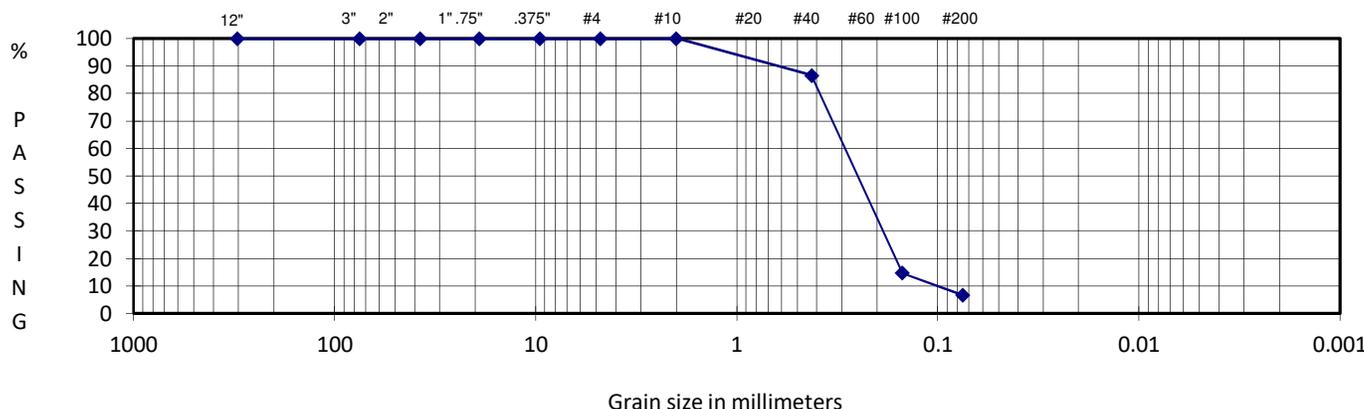
DESCRIPTION SAND with some silt

USCS SW-SM

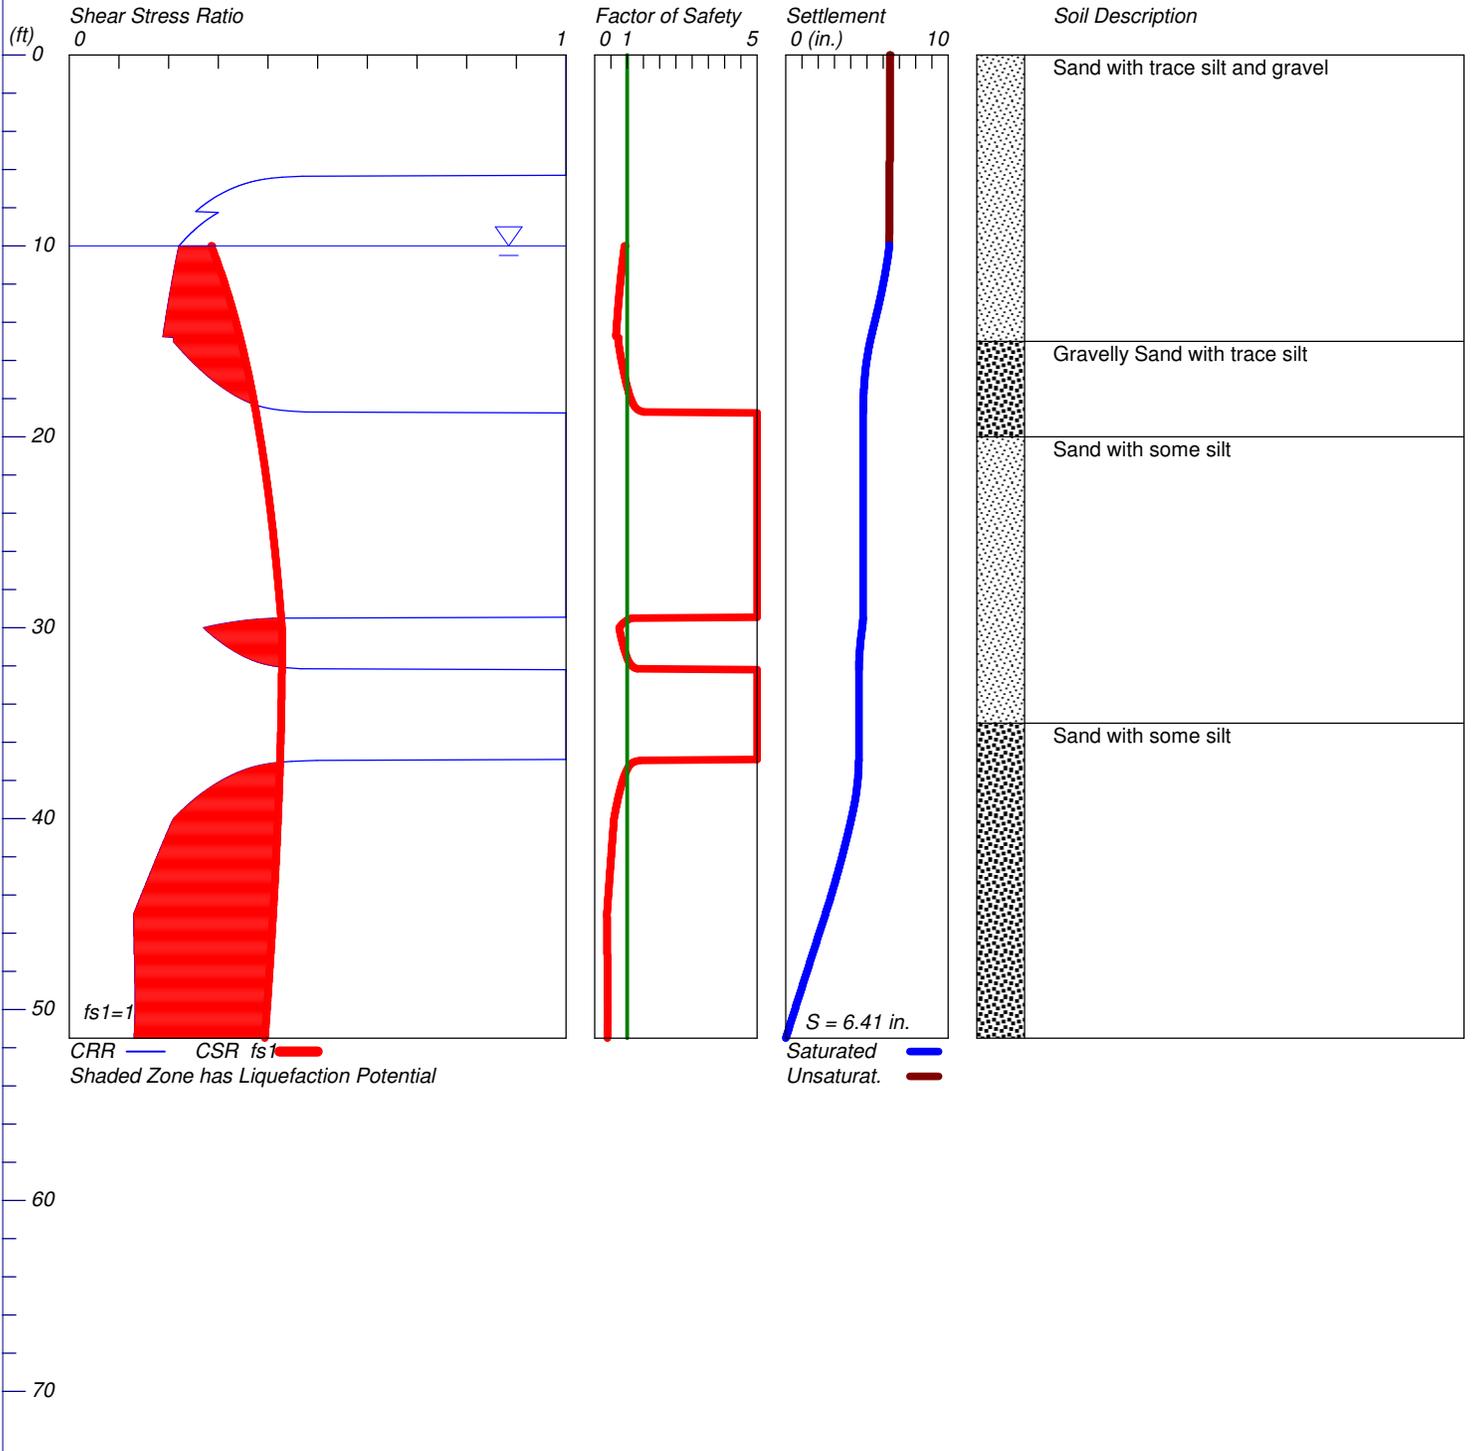
Hole No.=B-1 Water Depth=10 ft Surface Elev.=124

**Magnitude=7
Acceleration=0.45g**

For liquefaction analysis, soil information was obtained from boring B-1. The groundwater was assumed to be 10 feet. Analysis indicates the native soil below the groundwater table will liquefy under severe earthquake ground motions (Magnitude 7 and horizontal acceleration 0.45g, with settlement in the range of 6 to 7 inches. The subsurface conditions are relatively consistent, therefore; the differential settlements should not exceed 3 inches in 100 feet. The analysis is attached in Appendix B.
